**Re: CI# 33942 - Coon Pond Pipeline Replacement - NSPI - Responses to Third Set of Information Requests (IRs) - P – 510**

Coon Pond Pipeline  
Woodstave Cores (Collected June 18, 2007)  
June 21, 2007.

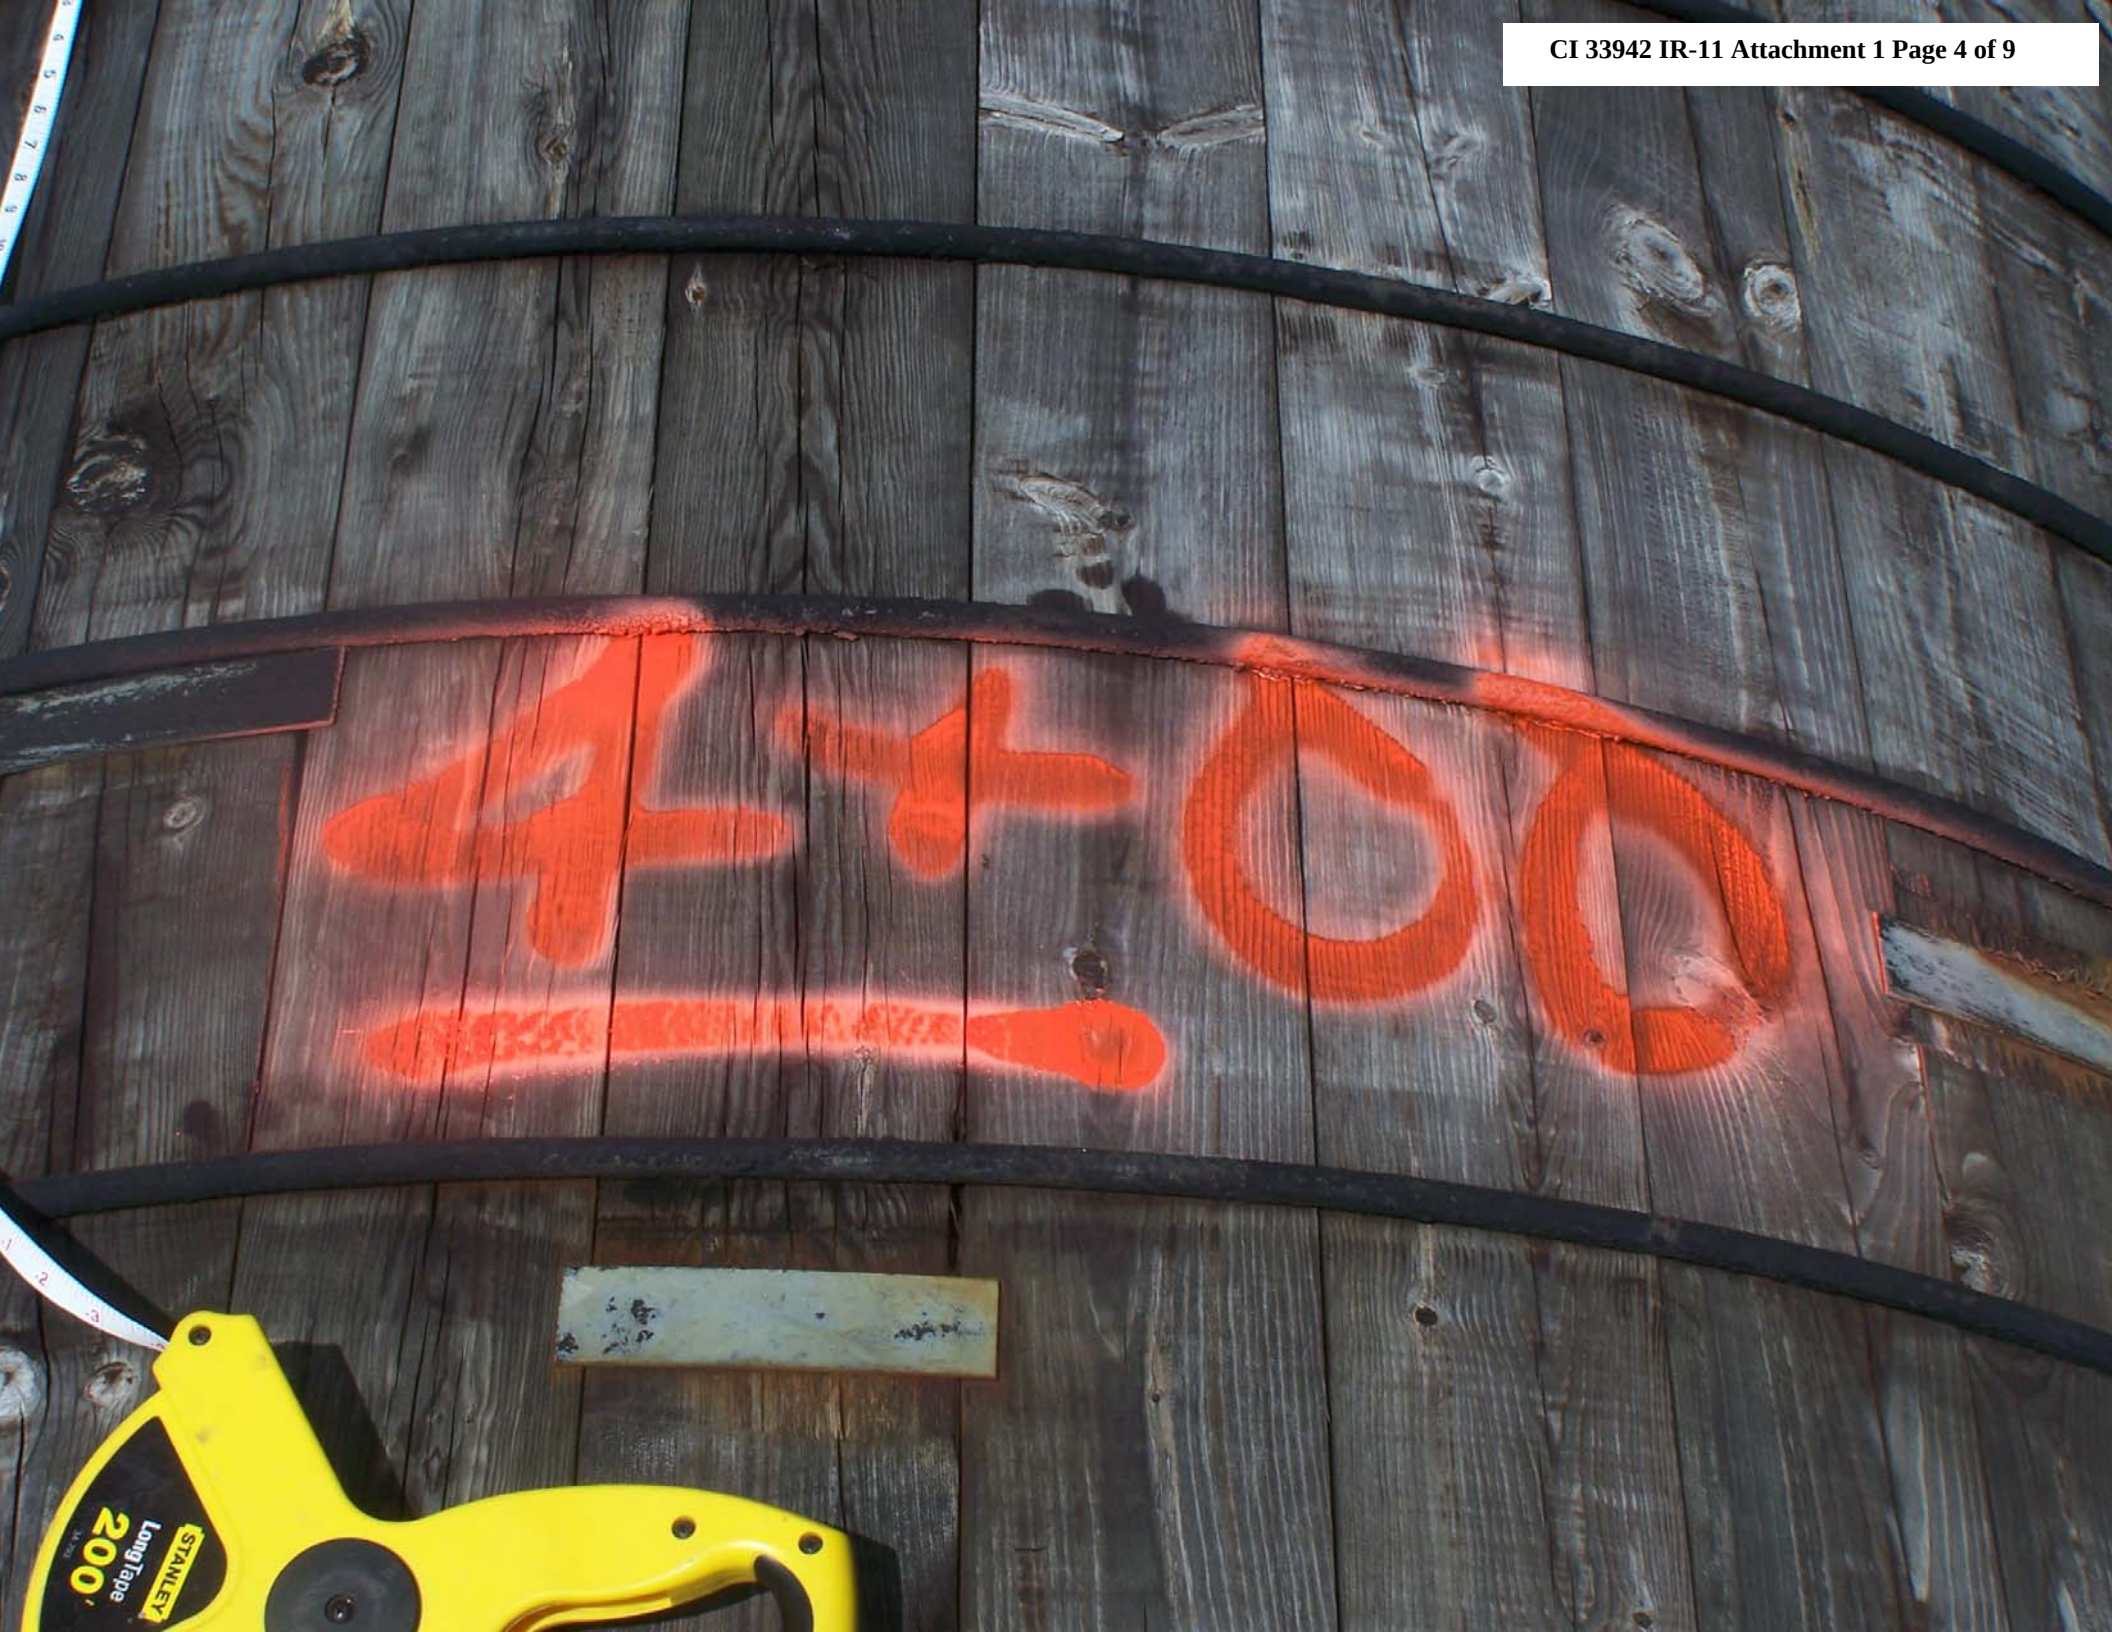
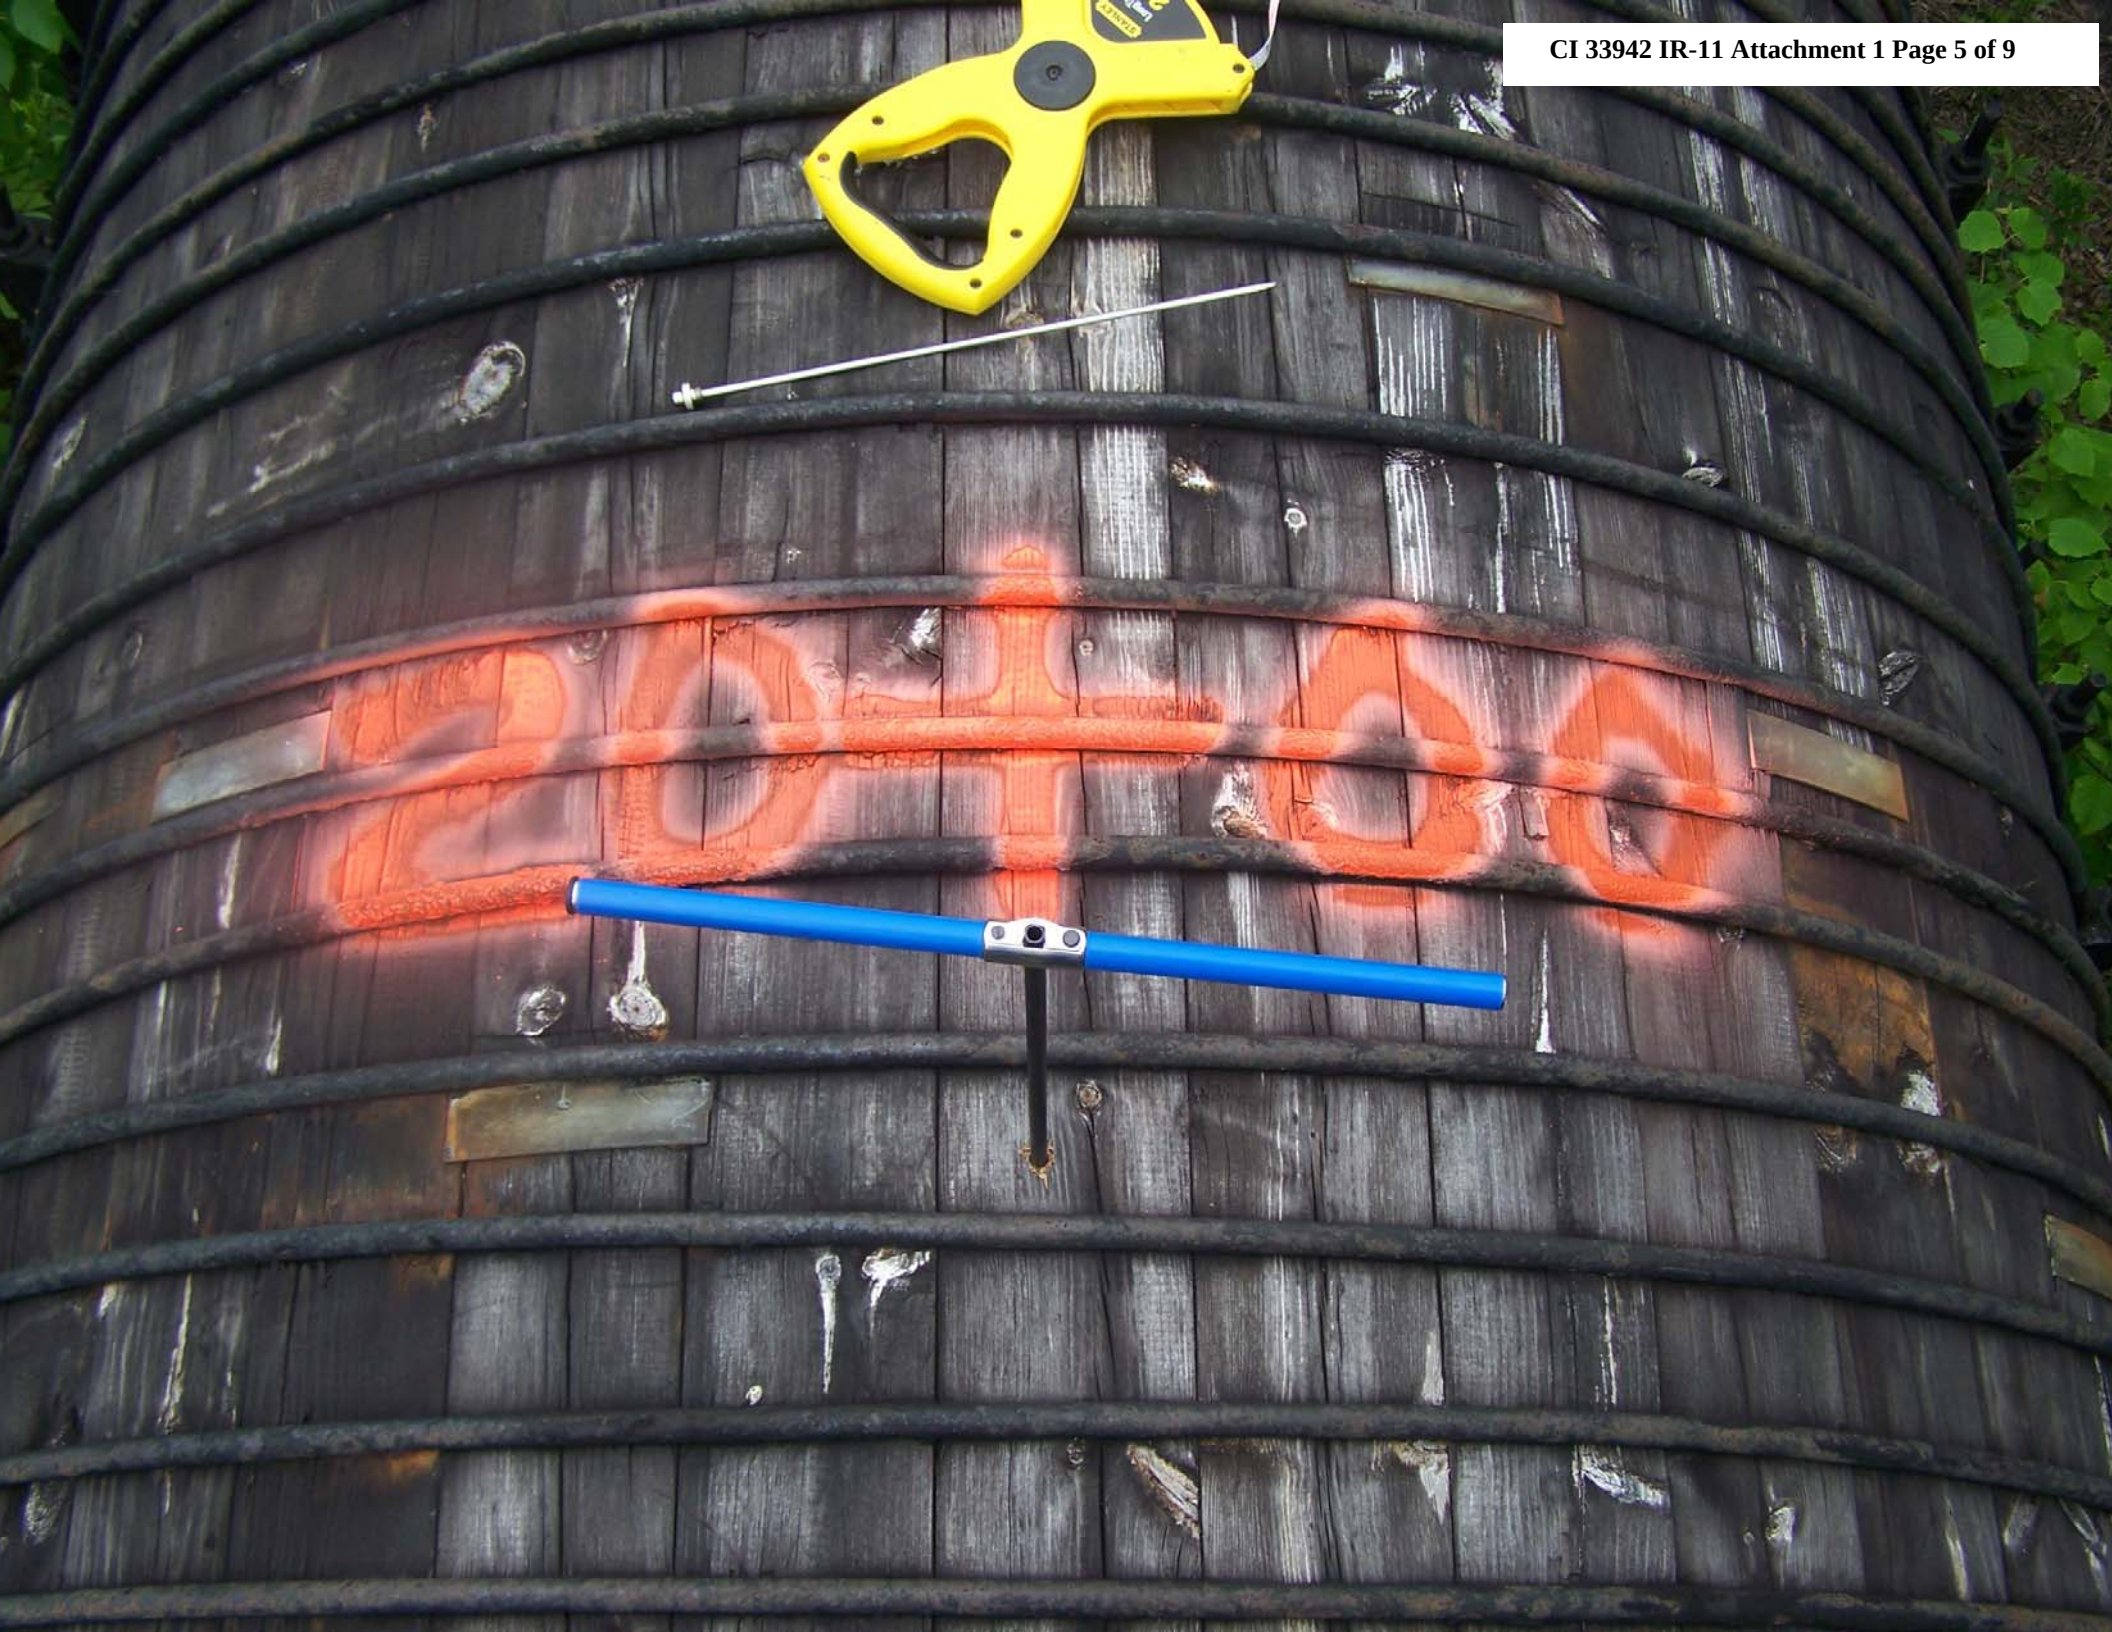
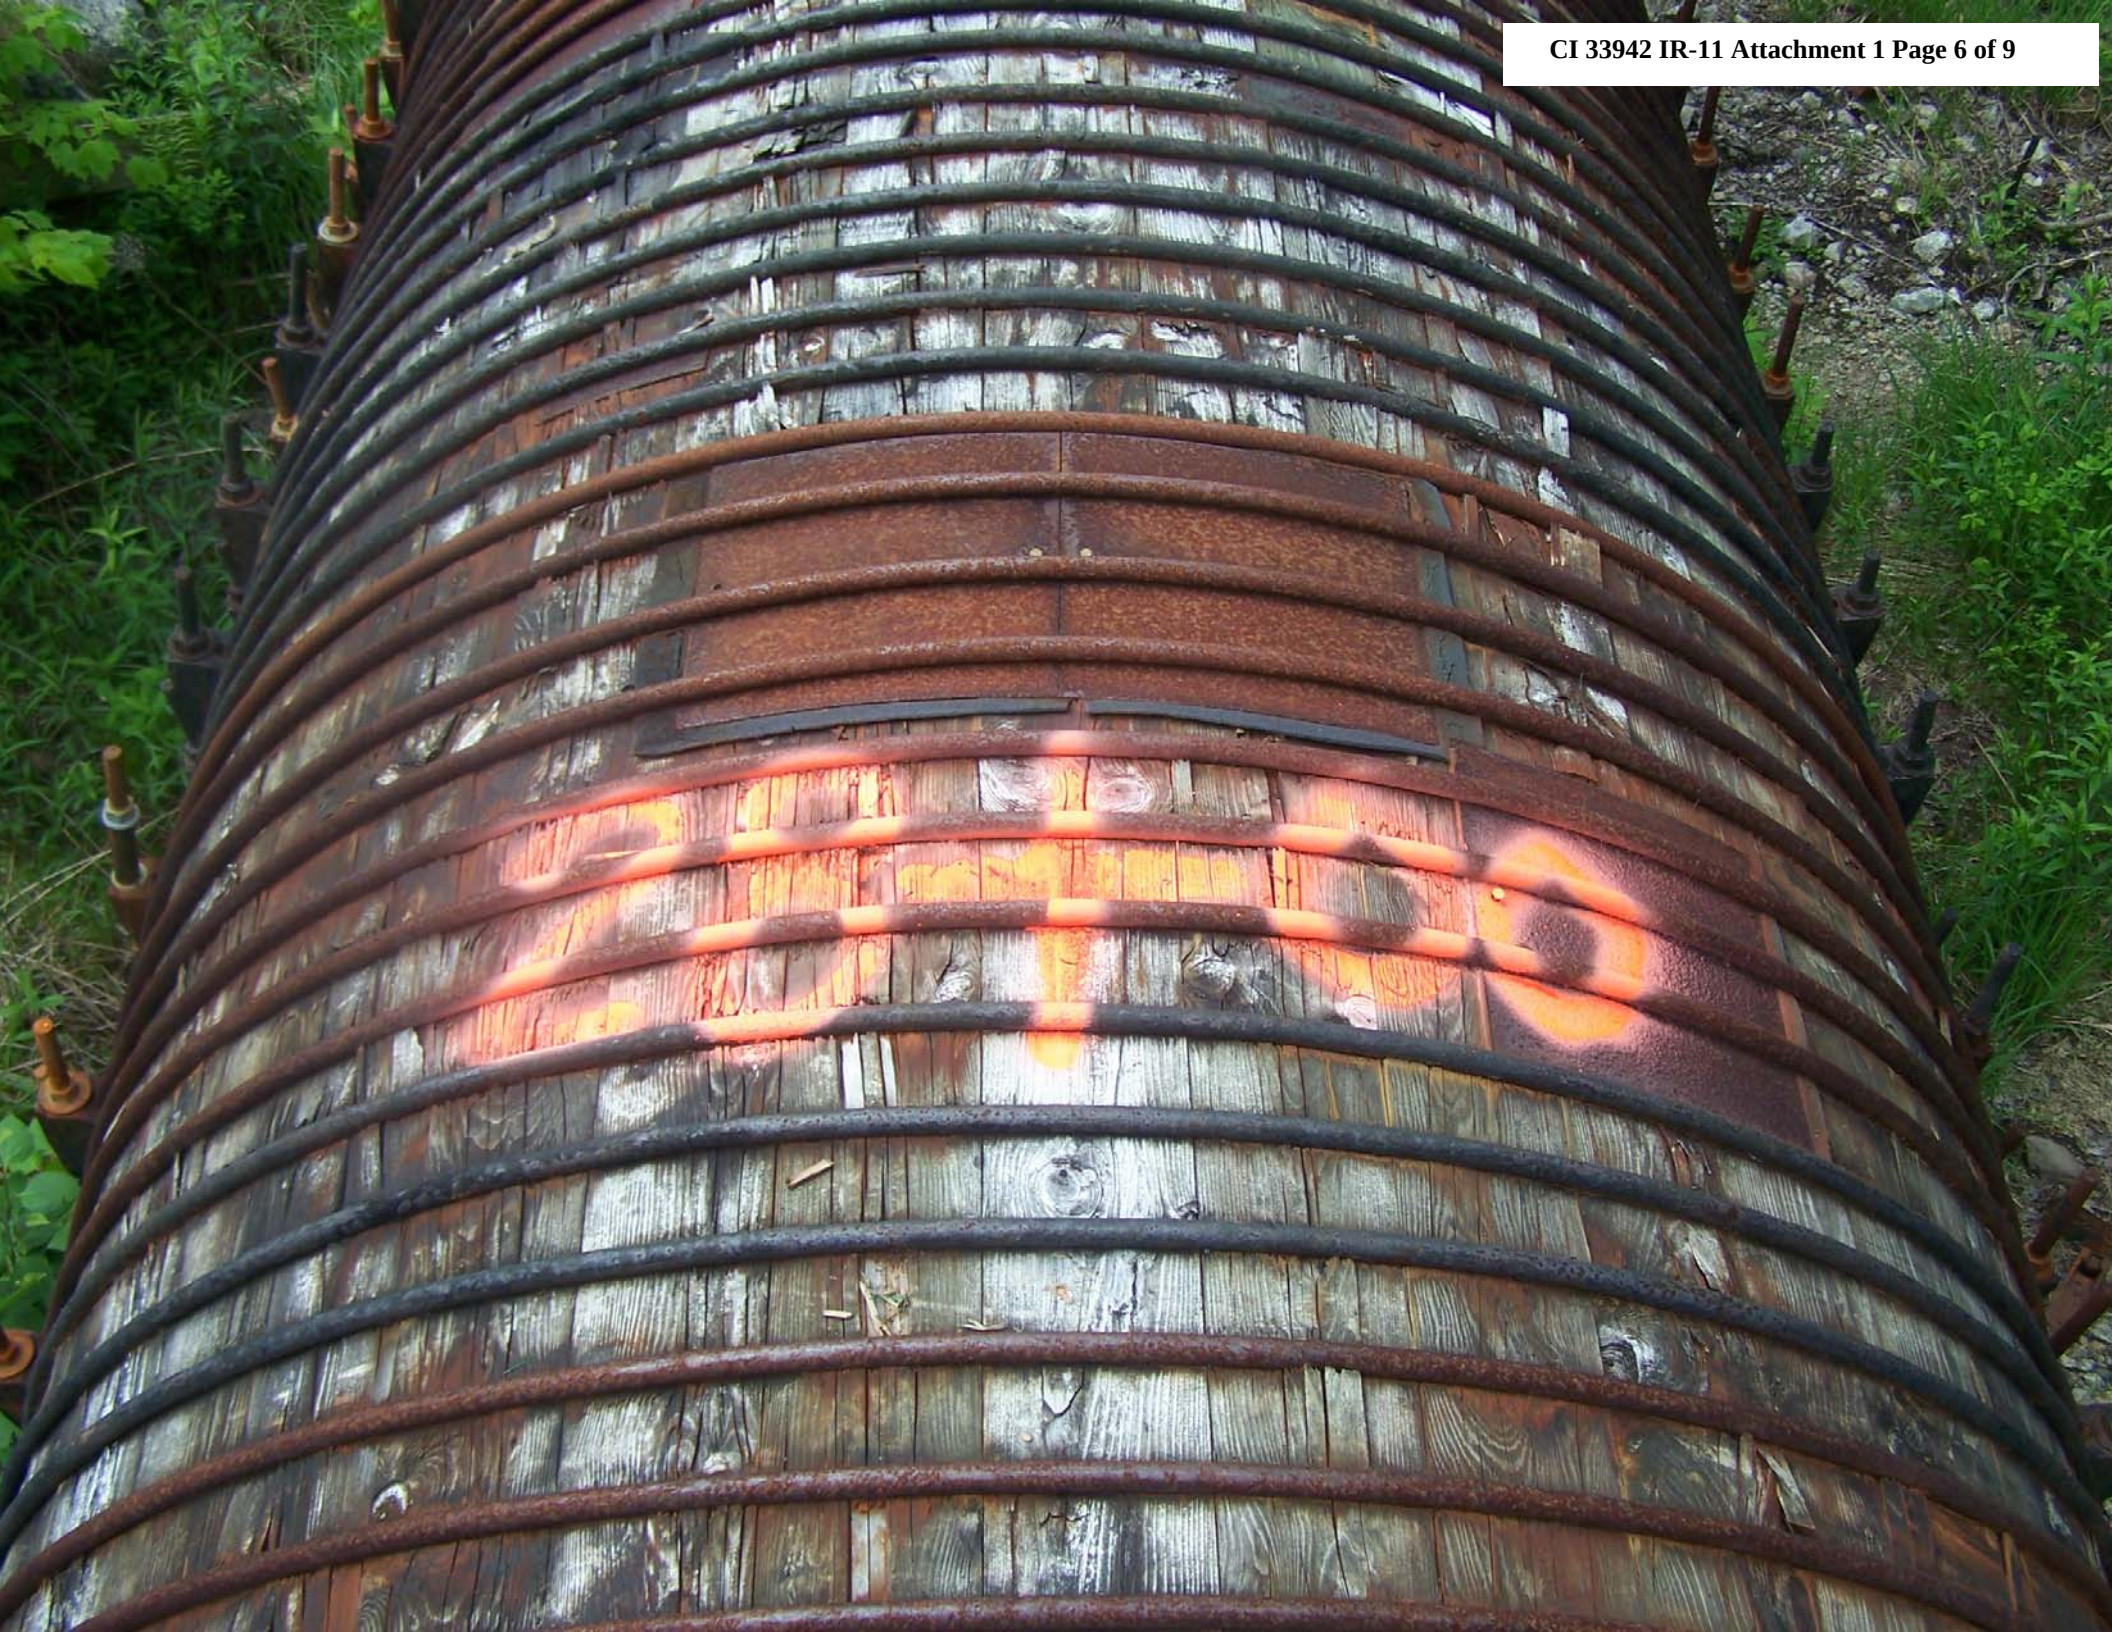
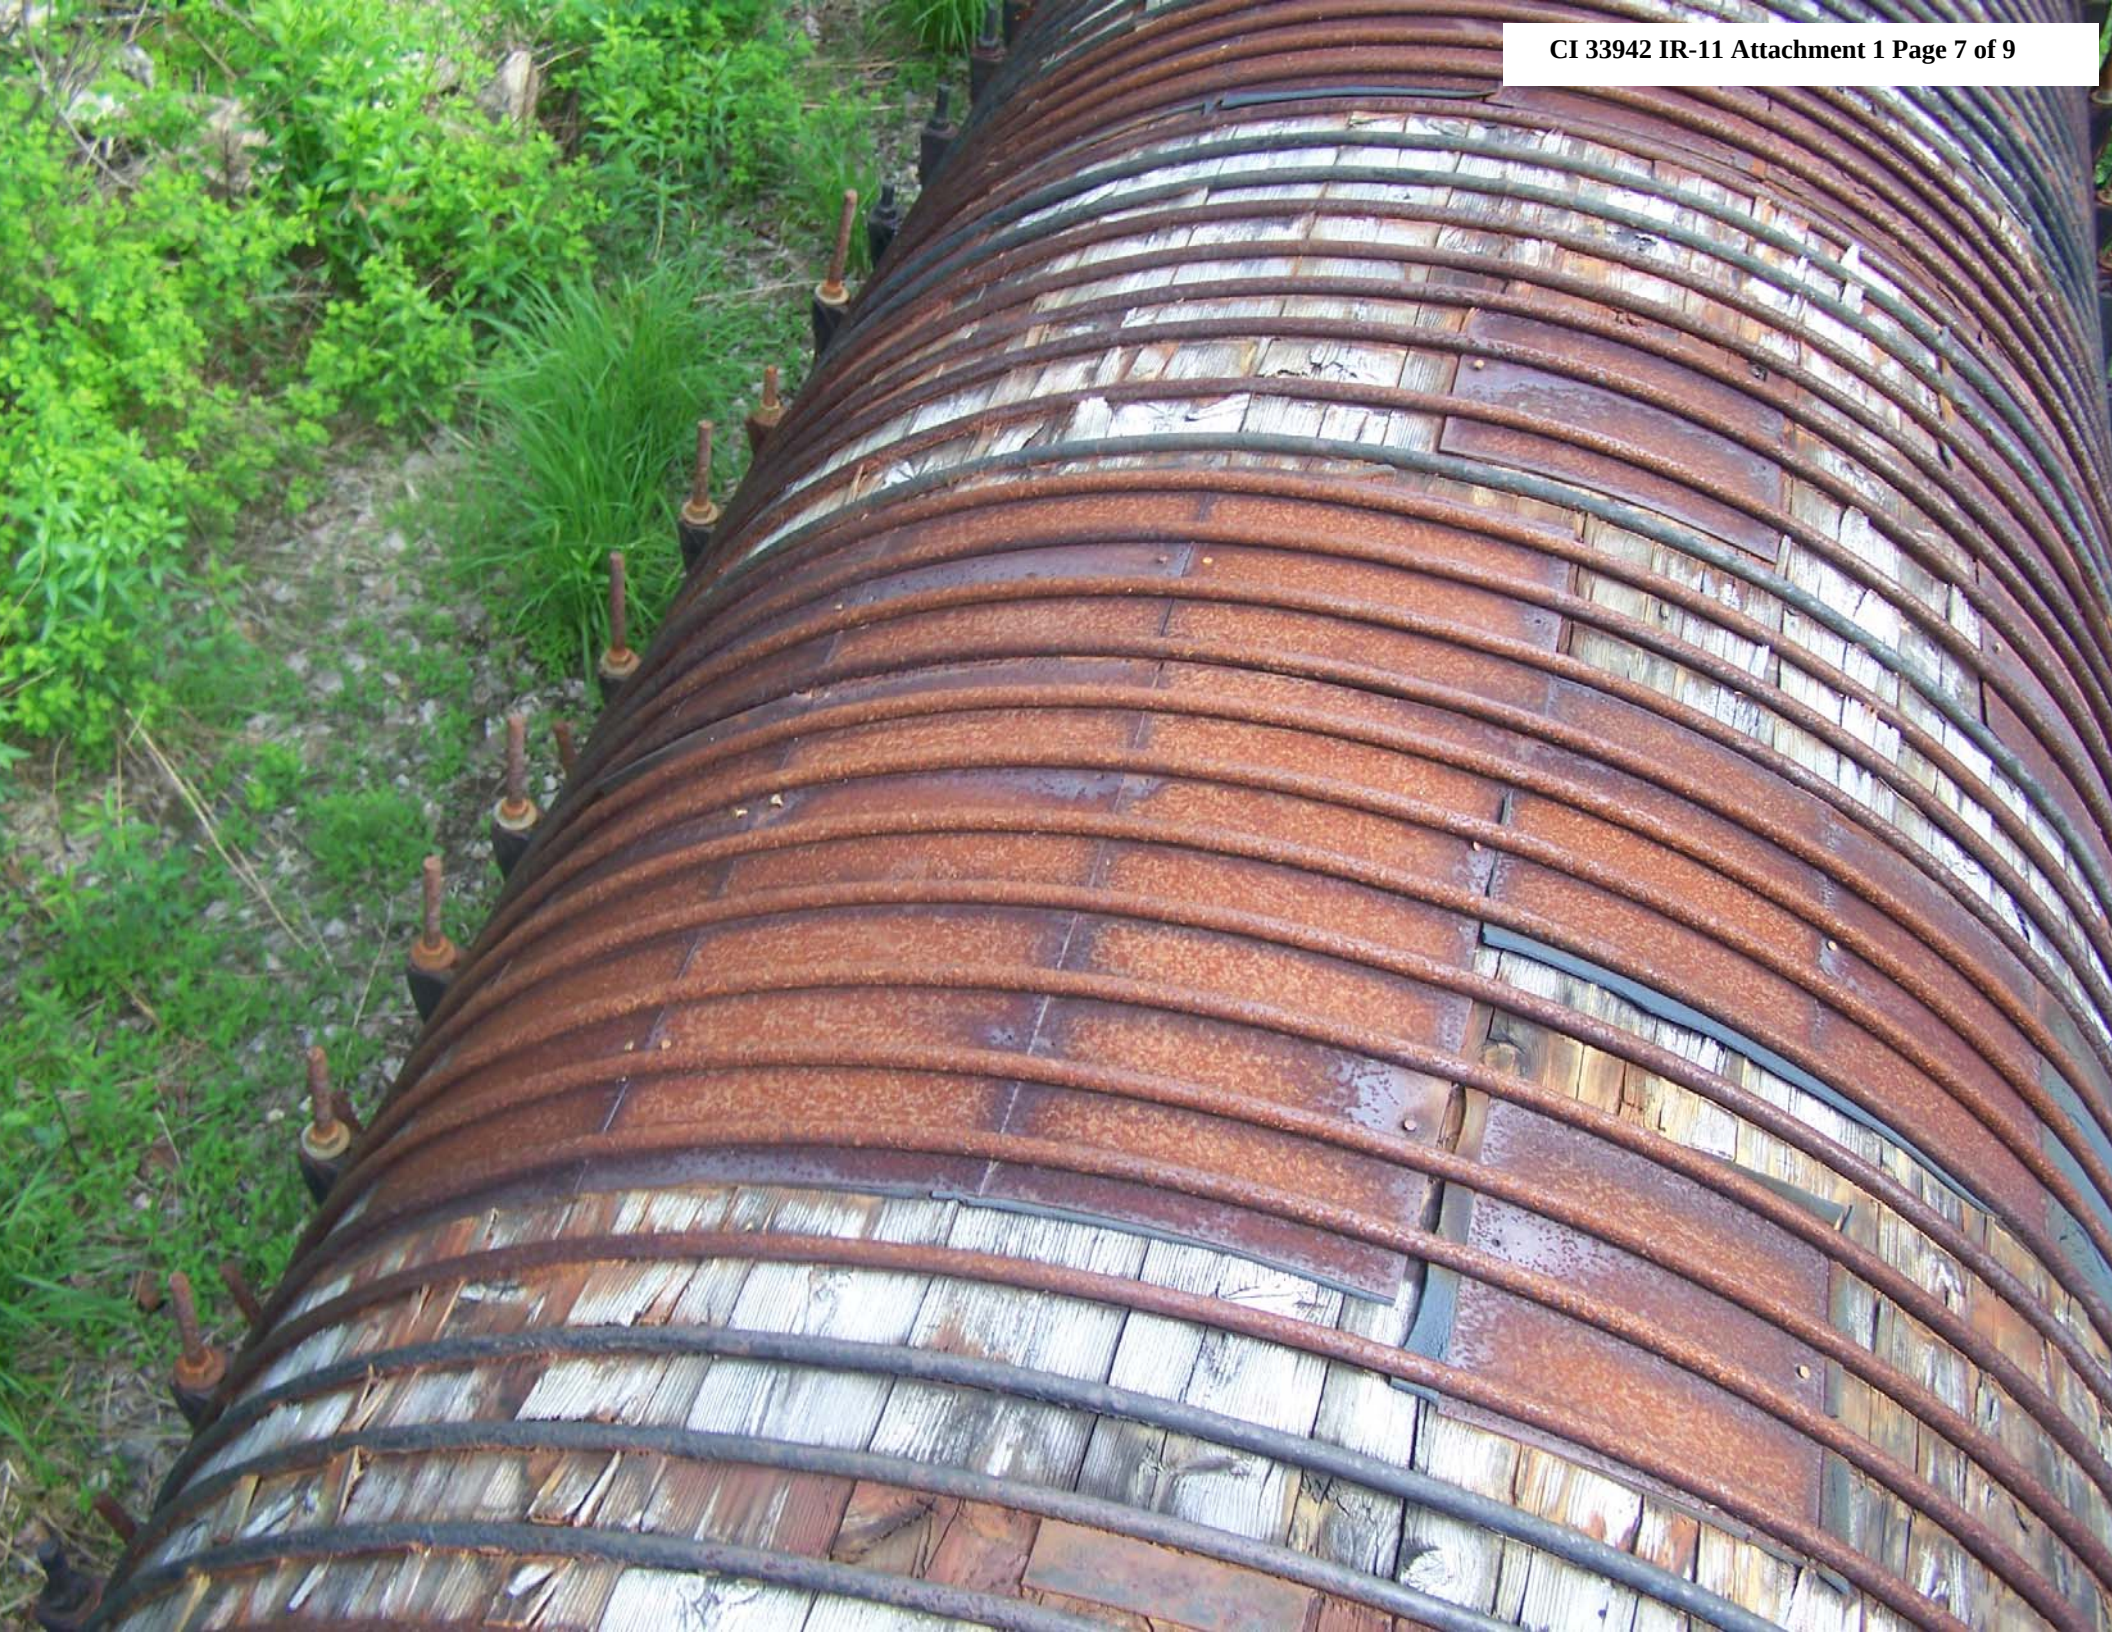
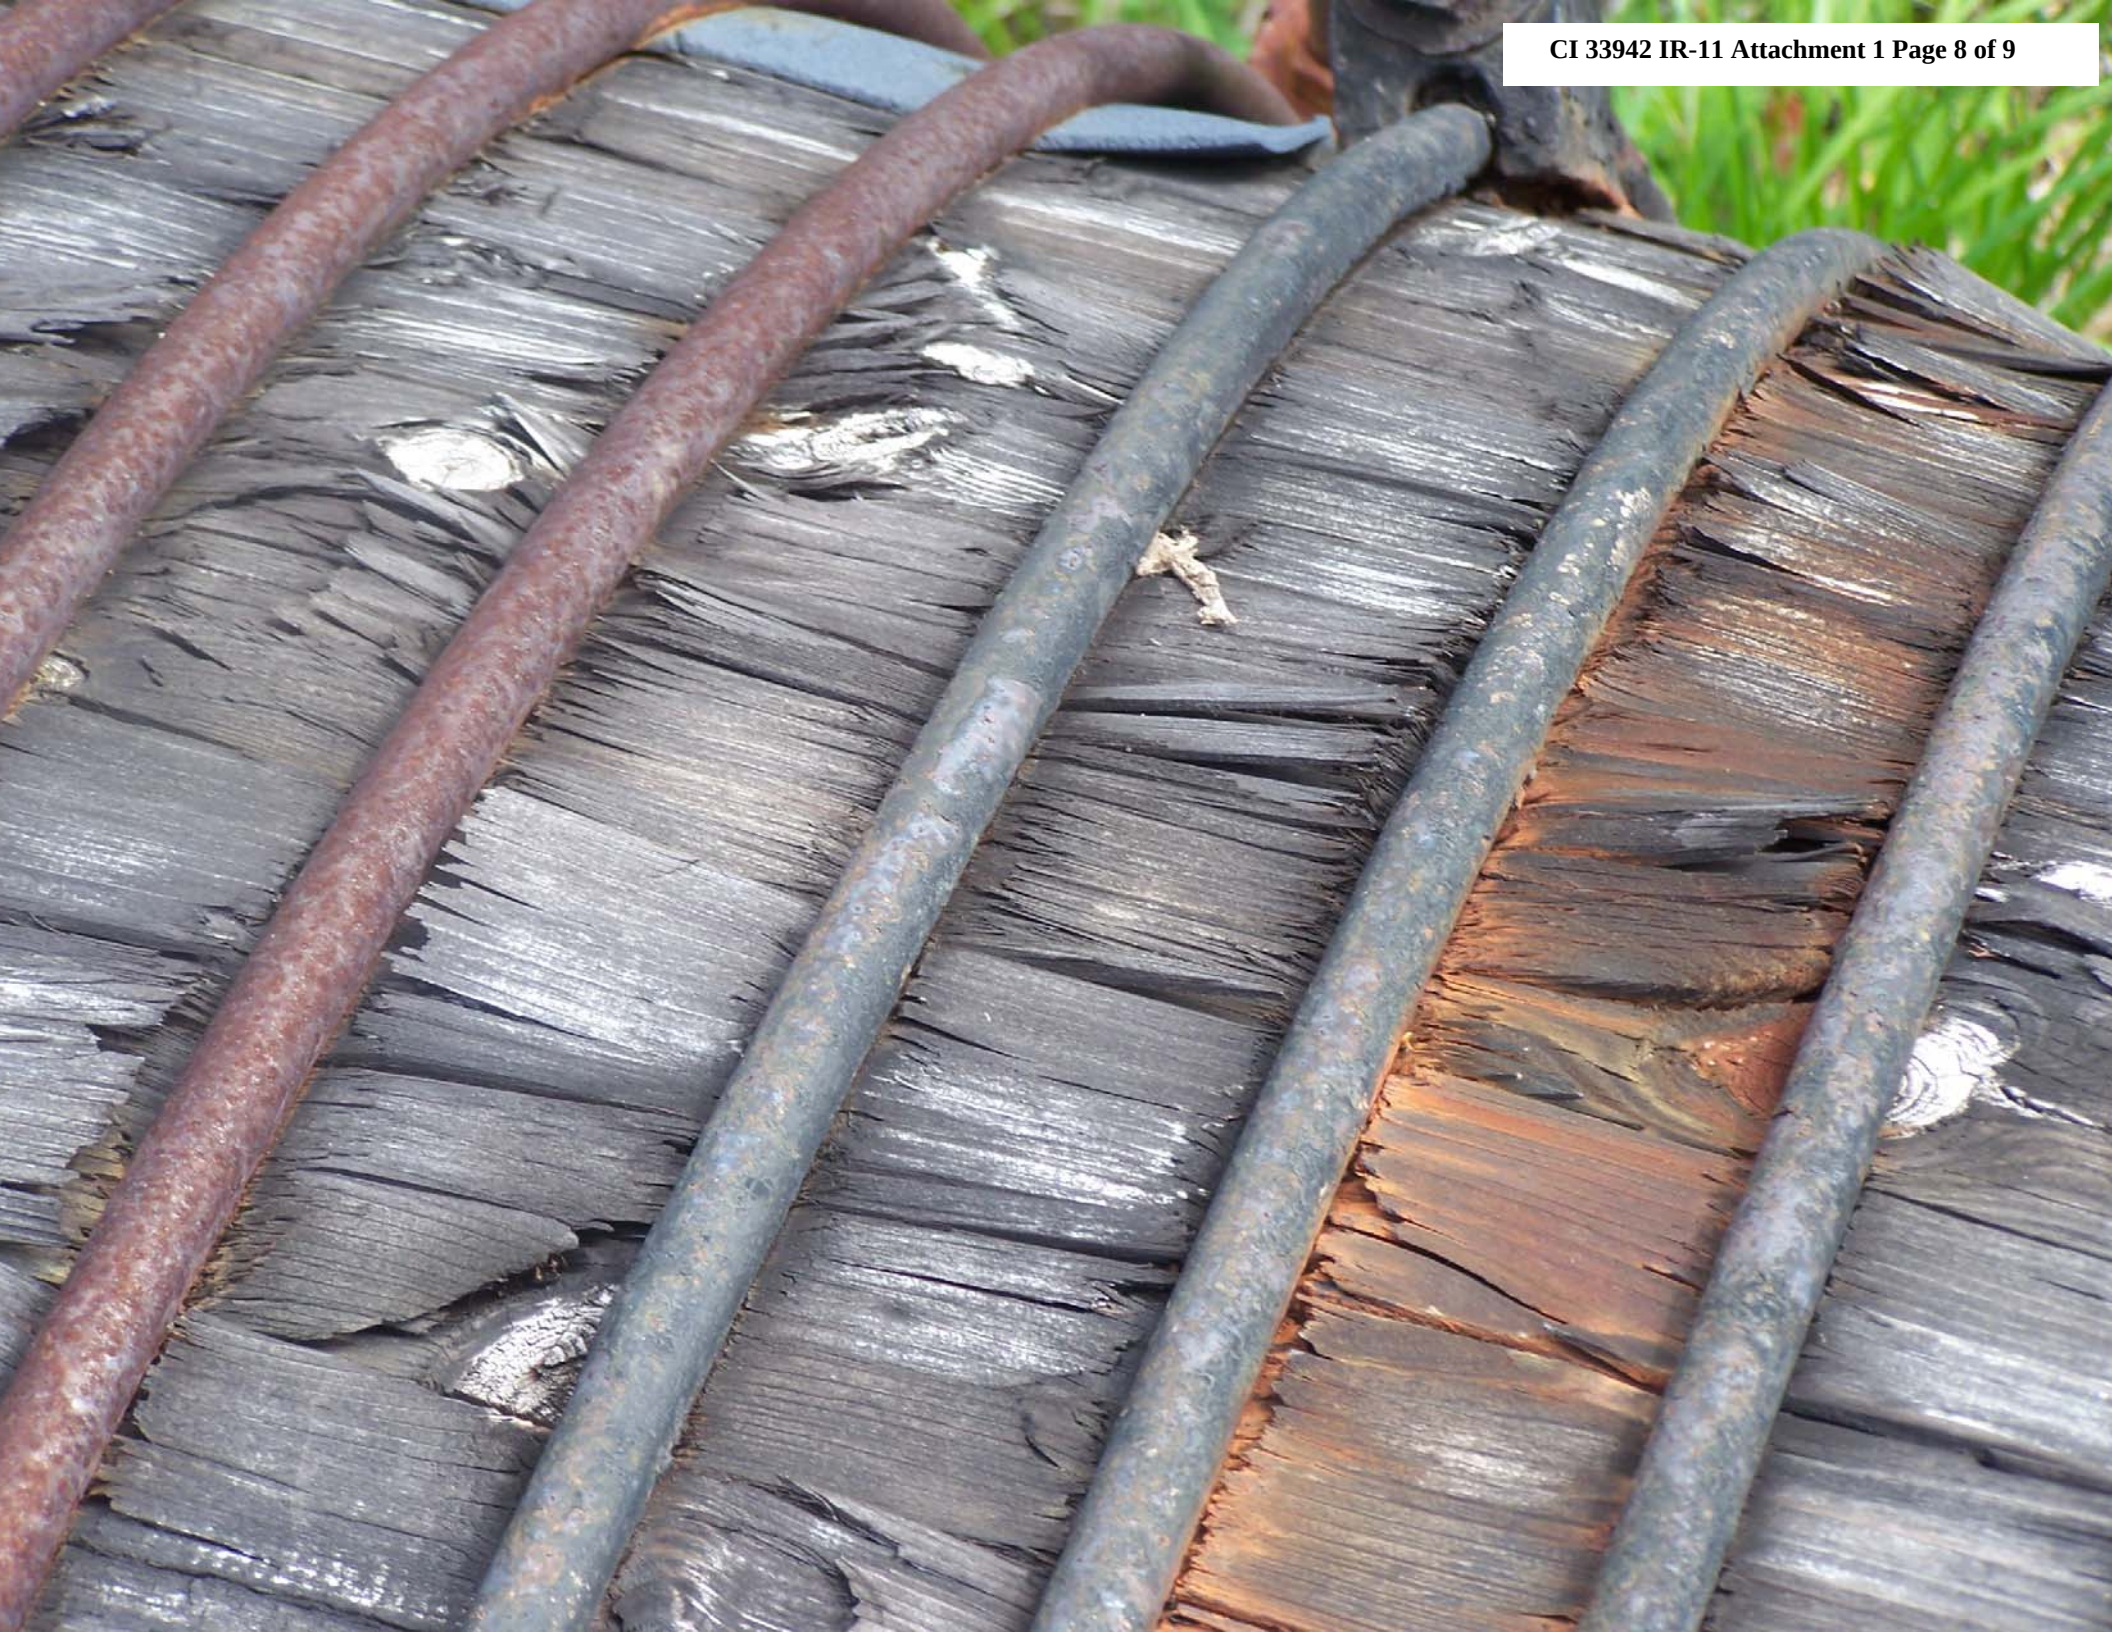
| Station | Observation | Station | Observation | Station | Observation | Station | Observation |
|---|---|---|---|---|---|---|---|
| 2+00 | satisfactory, core sample relatively intact, hard | 12+00 | Fair - moderate wood grain delamination present | 22+00 | Poor to Fair - some delamination, discoloured | 32+00 | Extremely Poor - difficult to retrieve intact cores |

**Notes:** 1.) Where cores are fragmented individual wood grains have separated into sheets. This condition very severely compromises the structural integrity of wood staves in those locations. In the worst cases, the retrieved delaminated circular core samples closely resemble confetti.

5.) Condition transformation from Fair to Very Poor at about chainage 27+50 is sudden and quite remarkable. Wood staves from chainage 28+00 to 33+00 do not appear to be fit for service.
