**TUC2 - HP/IP Turbine Refurbishment  
ATO**

**Project Title:** TUC2 - HP/IP Turbine Refurbishment

**CI Number:** C0051136

**Date:** May 16, 2025

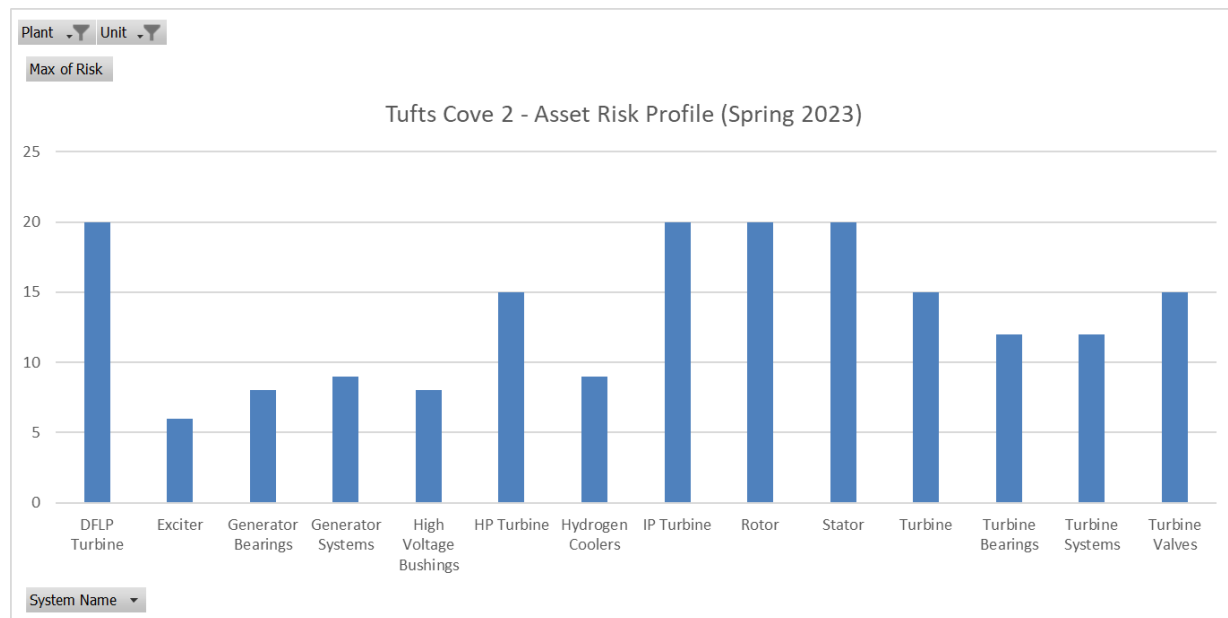
Steam turbine overhauls are scheduled based on accumulated operating hours and cycles and by known conditions within each unit. Below is a risk profile of Tufts Cove 2 steam turbine High Pressure (HP) and Intermediate Pressure (IP) Turbine components that shows risks associated within each. The risk profile shows that while the machine is due for inspection there are also components that require refurbishment, or replacement in the HP & IP sections to reduce operational risk.
