**CI C0067183**

**TUC Wharf Access Bridge Replacement**

**August 5, 2025**

**NSEB APPROVAL SHEET**

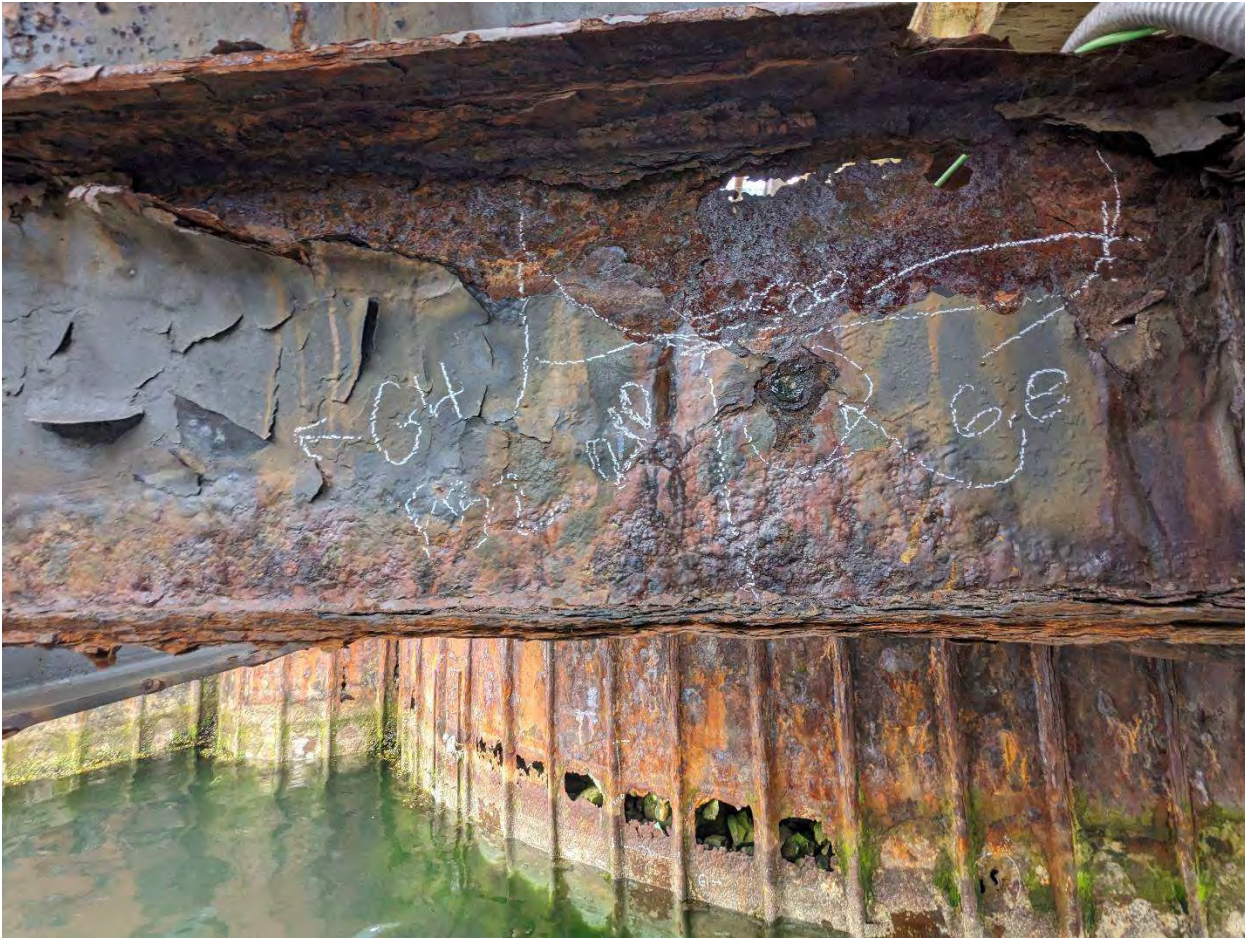
To check FB2 at its location of full section loss, an additional local check was performed where the web had a developed a hole. The moment at the location was decoupled and the top flange was checked as an unbraced compression member for the length of the section loss. The location of full section loss in FB2 is shown in Figure 1. It is between the North girder and the Northernmost stringer on FB2.

*Figure 1: Full Section Loss in Web of FB2*

The additional analysis for FB2 found that under load combination 3, the moment at the location of full section loss was 73 kN-m and under load case 4 it was 52 kN-m. These moments correspond to compression forces of 186 kN and 133 kN in the top flange, respectively. Assuming that the flange can be treated as fixed-fixed, the member is adequate under both loading scenarios. However, a conservative approach would be to assume that it may not be a true fixed-fixed member, resulting in a larger  $k$  value in the analysis. A typical  $k$  value for a fixed-fixed member is 0.5 and for a pinned-pinned member is 1.0. So, the analysis was also completed for a  $k$  value of 0.7. In this scenario, the 2.4 kPa live load exceeds the capacity of FB2 at the location of complete section loss, but the 1.2 kPa live load is still a conservative estimation of the load being applied during operations and FB2 is able to achieve the strength required for this scenario. A summary of the results for the analysis of FB2 is in Table 4, including the compressive resistance for the flange plate, the moment at the location of section loss, the corresponding decoupled compression force in the top flange, and the utilization.

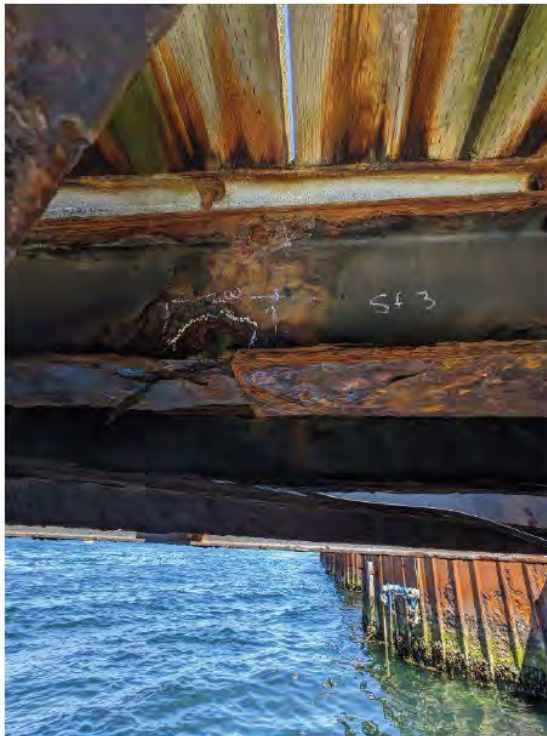
(a) Stringer 3

The stringers were found to be severely deteriorated. Typical stringers were assumed to have a 50% reduced section which was in line with findings in the Stantec inspection report. The locations of the worst section loss on the stringers are shown in Figure 2.

Typical stringers were found to have adequate capacity to meet load combinations 3 and 4 in both flexure and shear based on the estimated 50% reduced section. Where there are locations of excessive section loss, such as in stringer 58, shown in Figure 2d, the adjacent stringers were also checked for their ability to carry the additional load from the deck, in the event a single stringer had deteriorated to the point it did not have any reasonable structural capacity.

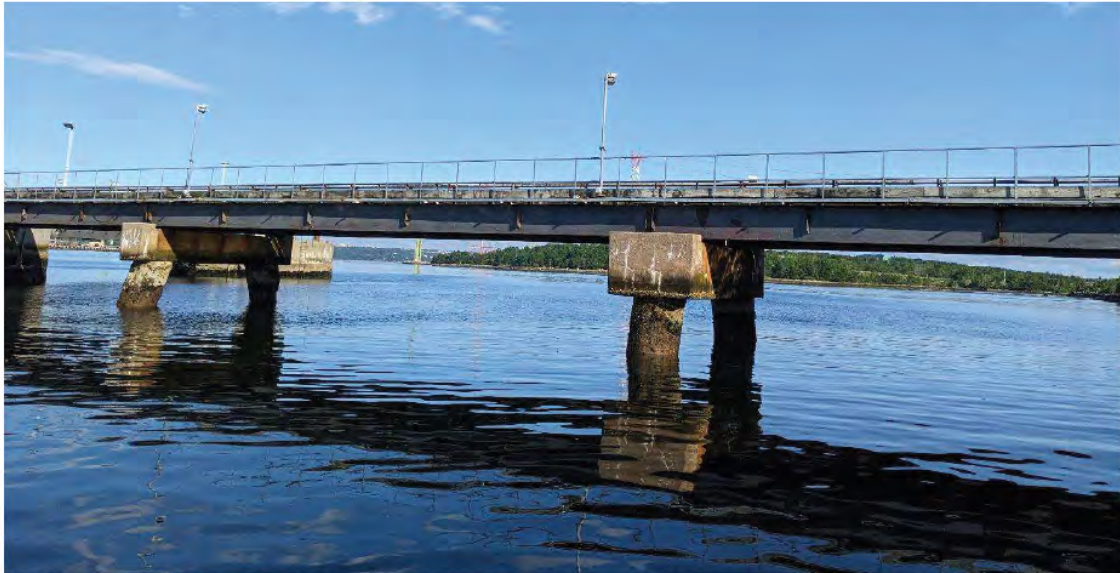
Photo 1: General photo of the configuration of the wharf structure showing the South primary girders and piers 1 and 2.

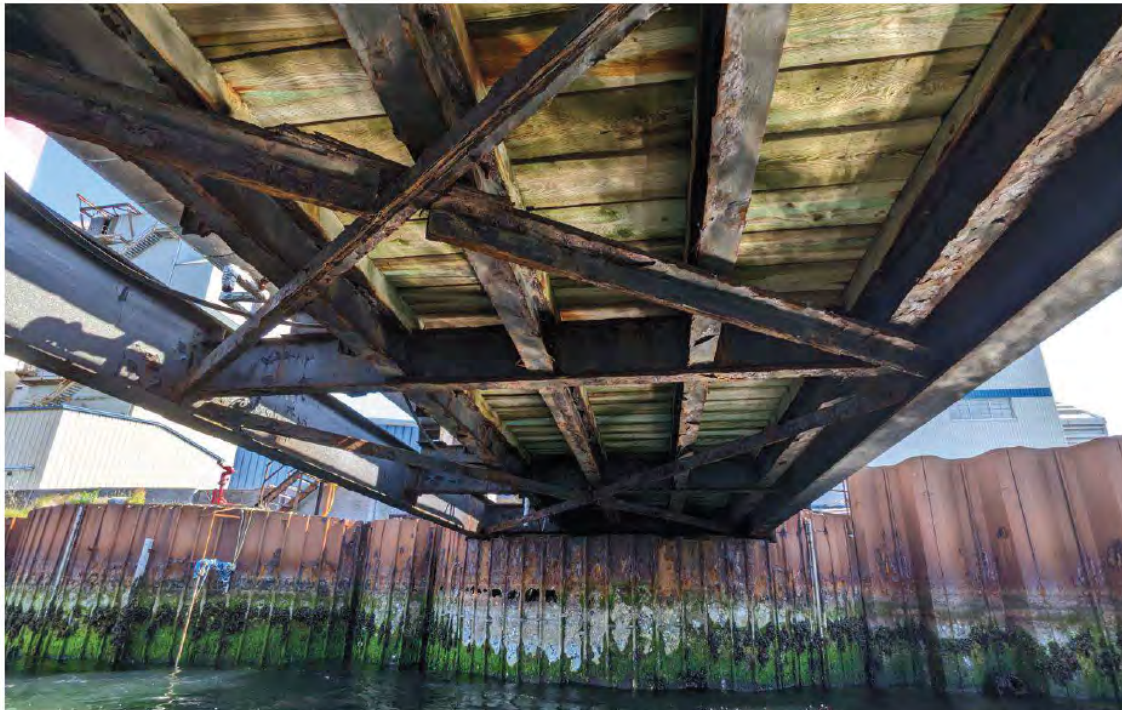
Photo 2: General condition of the superstructure in Span 1. As can be seen in the photo, the stringers and plan bracing have coatings breakdown in various areas over the length of the members. Corrosion is visible, with areas of delamination and flaking steel.

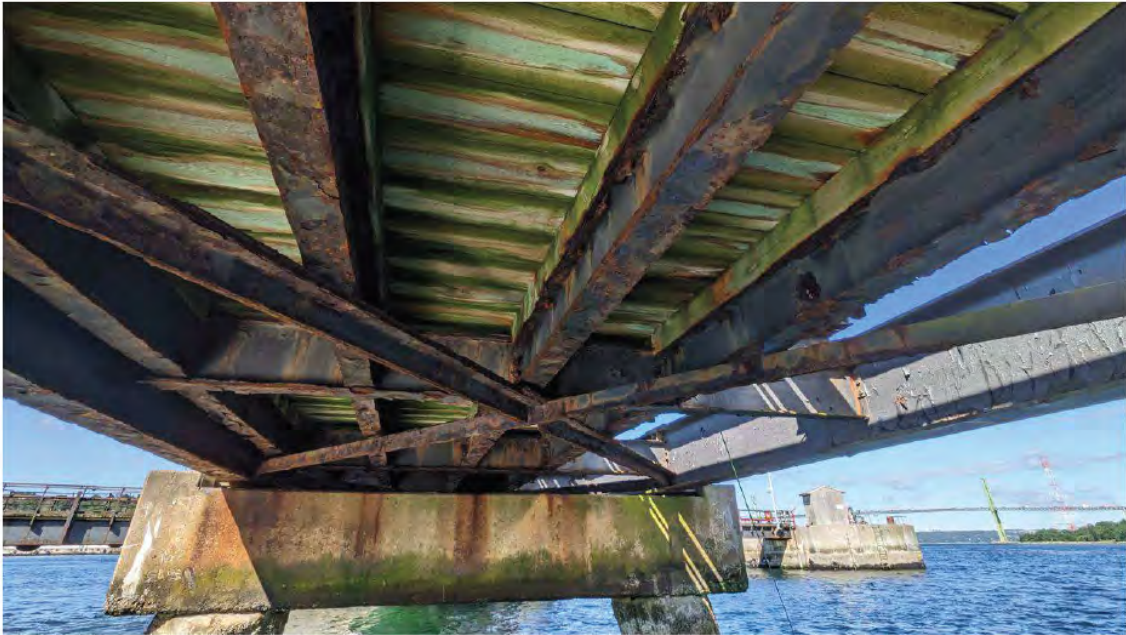
Photo 3: General condition of the superstructure in Span 2. As can be seen in the photo, the stringers and plan bracing have coatings breakdown in various areas over the length of the members. Corrosion is visible, with areas of delamination and flaking steel.

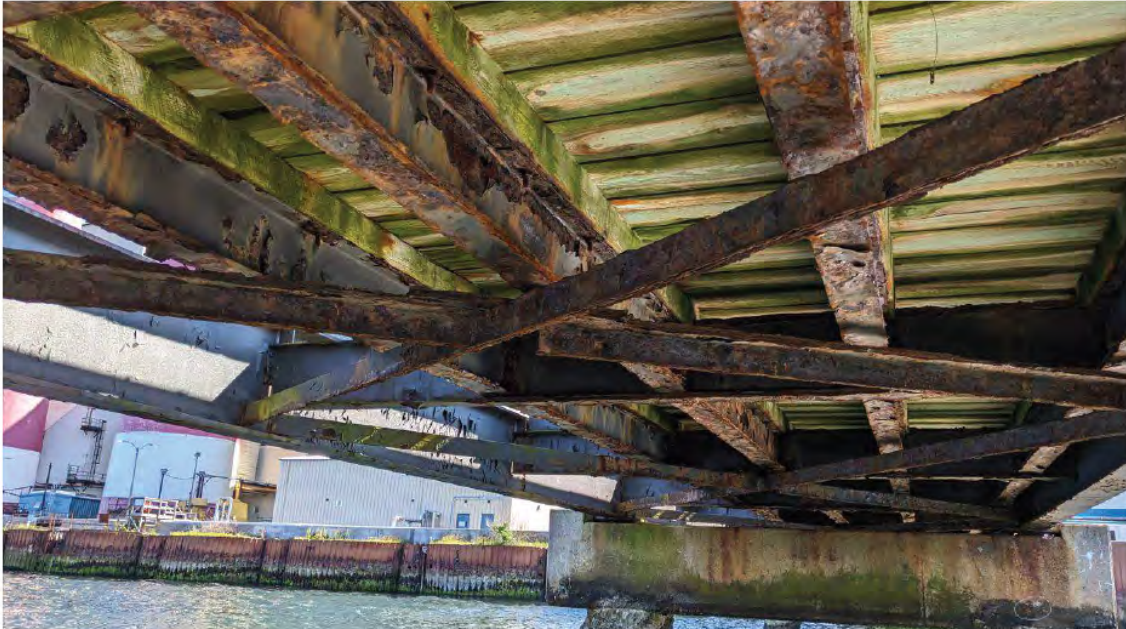
Photo 4: General conditions of the superstructure in Span 3. As can be seen in the photo, the stringers and plan bracing have coatings breakdown in various areas over the length of the members. Corrosion is visible, with areas of delamination and flaking steel.

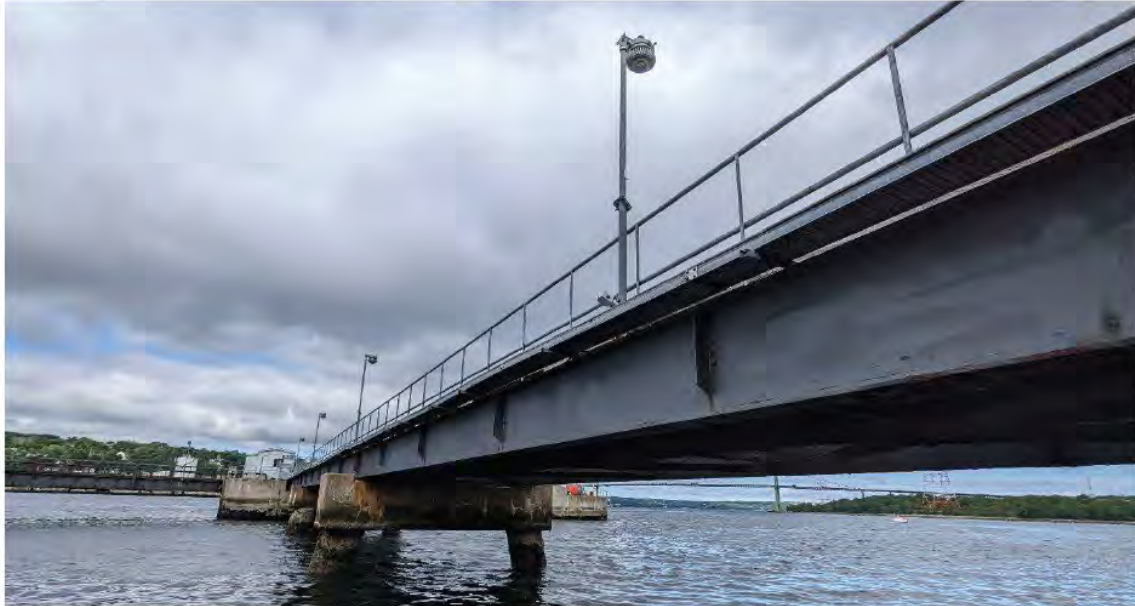
Photo 5: General photo showing the exterior of Girder 1 as identified in the Inspection Layout Sketch found in Appendix A. The coatings appear to be in good condition, with some local breakdown around the corners of the flange, and some local blistering on the webs. Local corrosion observed in various locations along the girder.

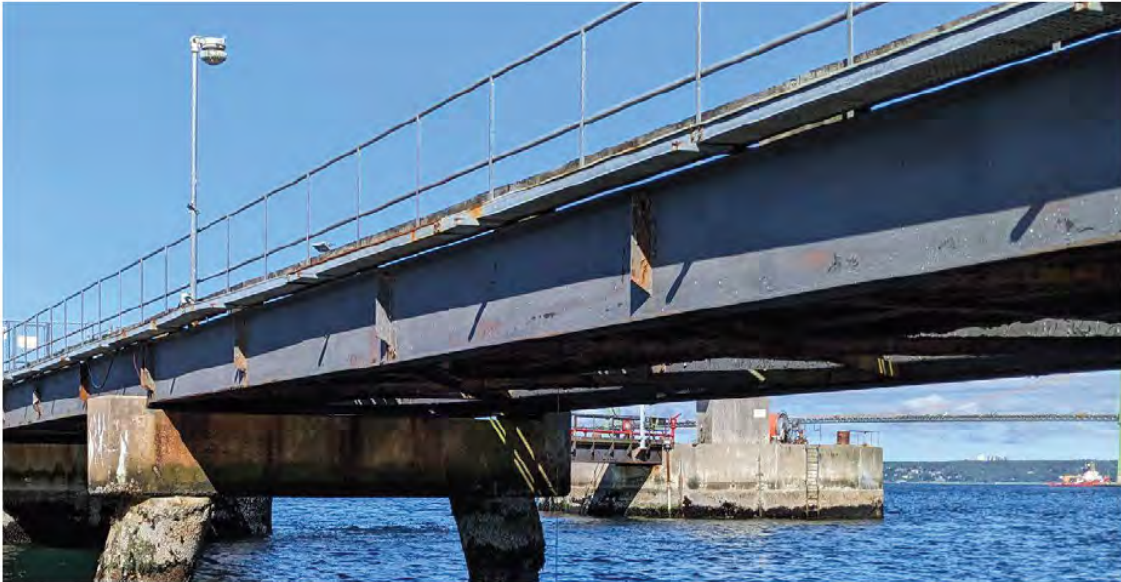
Photo 6: General photo showing the exterior of Girder 2 as identified in the Inspection Layout Sketch found in Appendix A. The coatings appear to be in good condition, with some local breakdown around the corners of the flange, and some local blistering on the webs. Local corrosion observed in various locations along the girder.

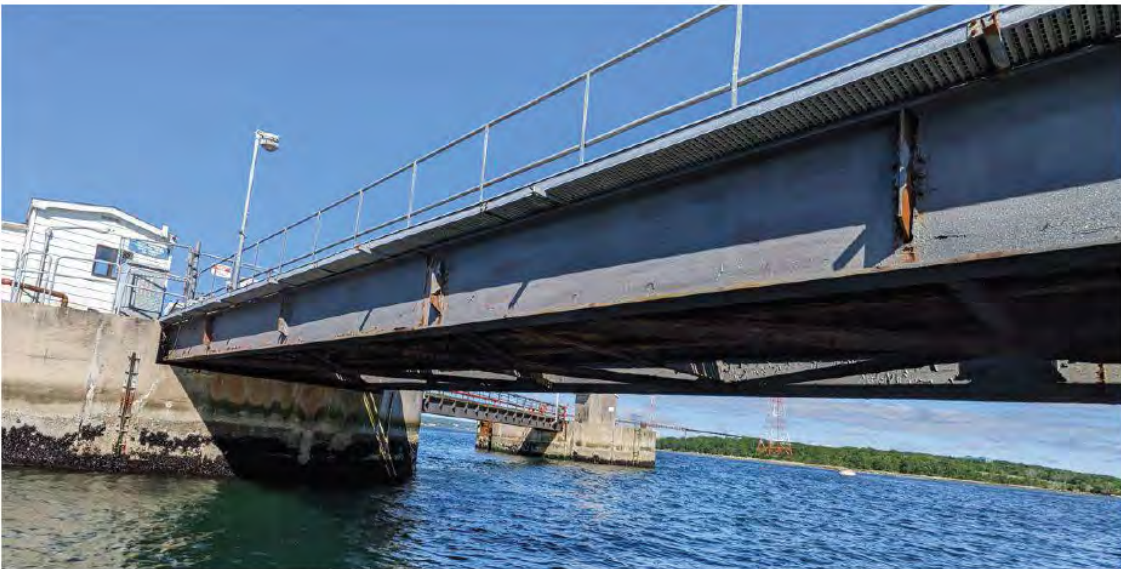
Photo 7: General photo showing the exterior of Girder 3 as identified in the Inspection Layout Sketch found in Appendix A. The coatings appear to be in good condition, with some local breakdown around the corners of the flange, and some local flaking on the webs and stiffeners. Local corrosion observed in various locations along the girder.

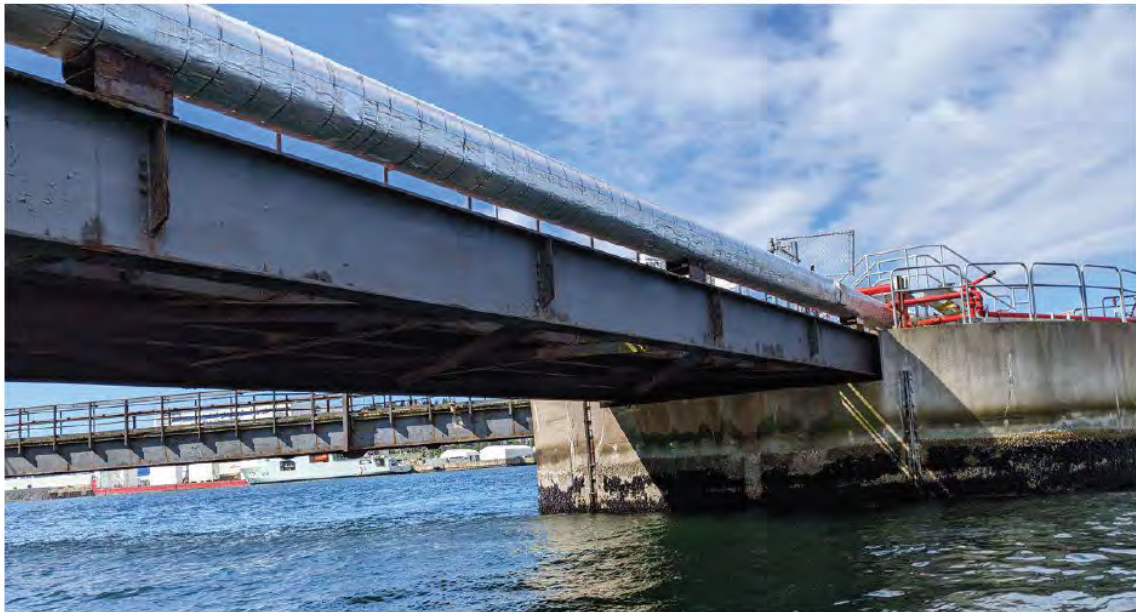
Photo 8: General photo showing the exterior of Girder 6 as identified in the Inspection Layout Sketch found in Appendix A. The coatings appear to be in good condition, with some local breakdown around the corners of the flange, and some local breakdown on the webs, flanges, and stiffeners. Local corrosion observed in various locations along the girder.

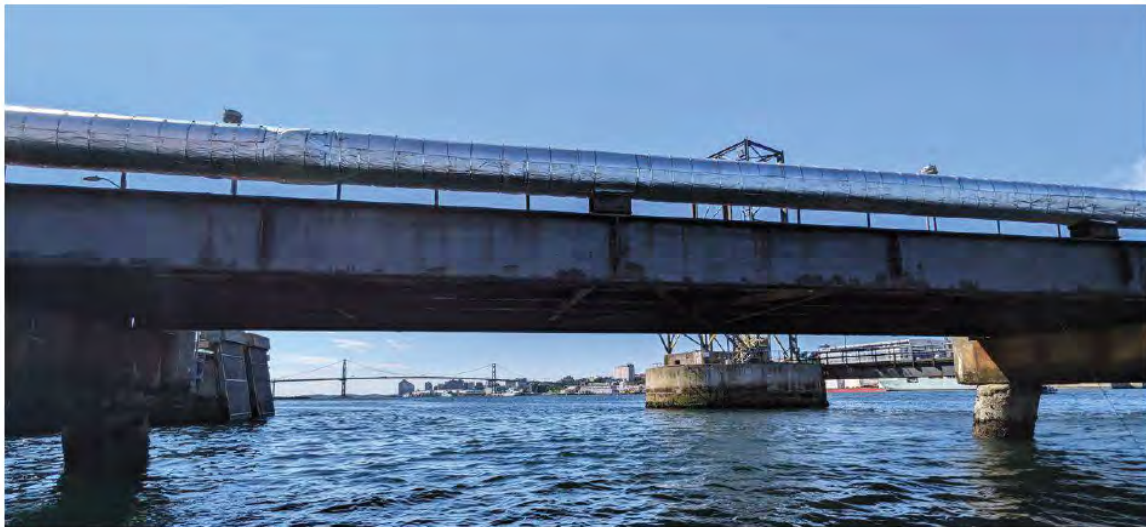
Photo 9: General photo showing the exterior of Girder 5 as identified in the Inspection Layout Sketch found in Appendix A. The coatings appear to be in good condition, with some local breakdown around the corners of the flange, and some local breakdown on the webs, flanges, and stiffeners. Local corrosion observed in various locations along the girder.

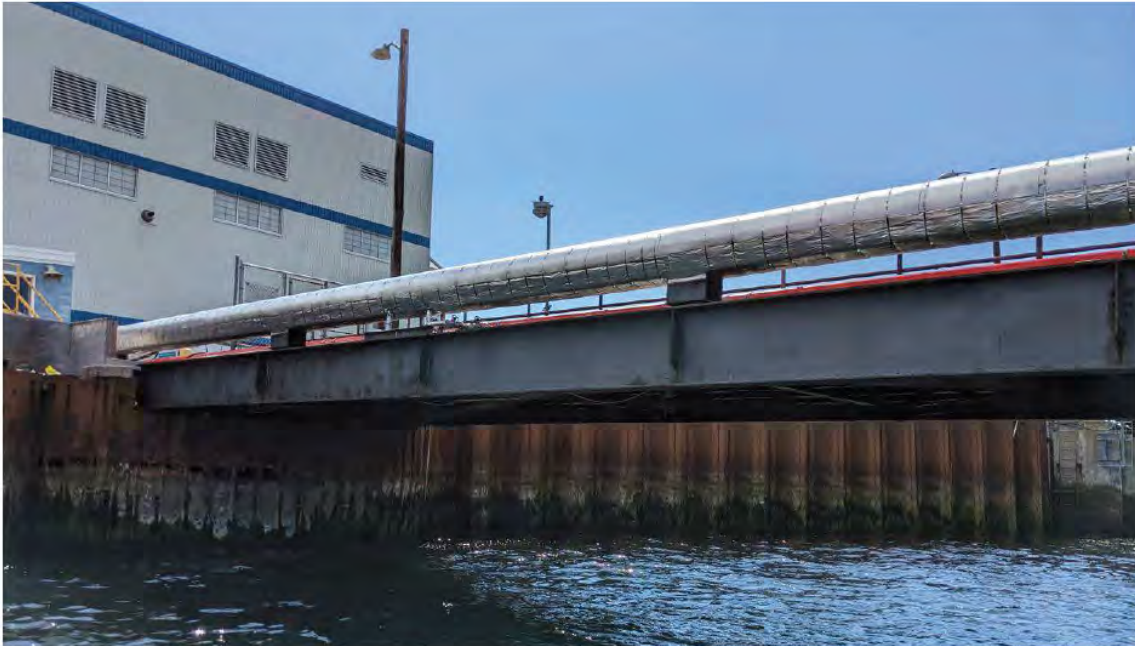
Photo 10: General photo showing the exterior of Girder 4 as identified in the Inspection Layout Sketch found in Appendix A. The coatings appear to be in good condition, with some local breakdown around the corners of the flange, and some local breakdown on the webs, flanges, and stiffeners. Local corrosion observed in various locations along the girder.

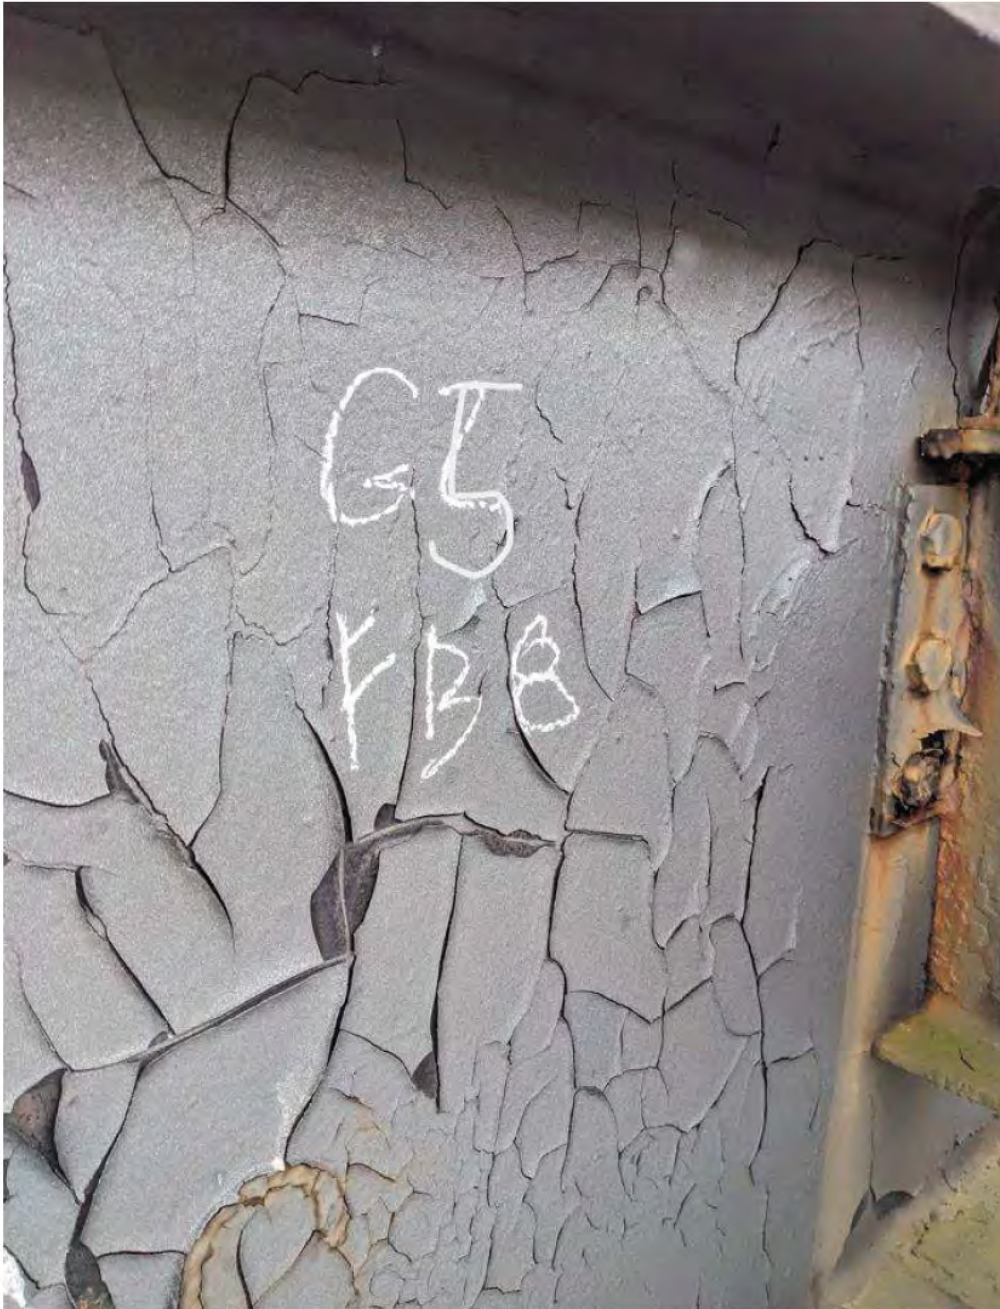
Photo 11: General photo showing the coatings breakdown along the interior side of the girder web. Localized corrosion can be observed in areas where the coatings have broken down further.

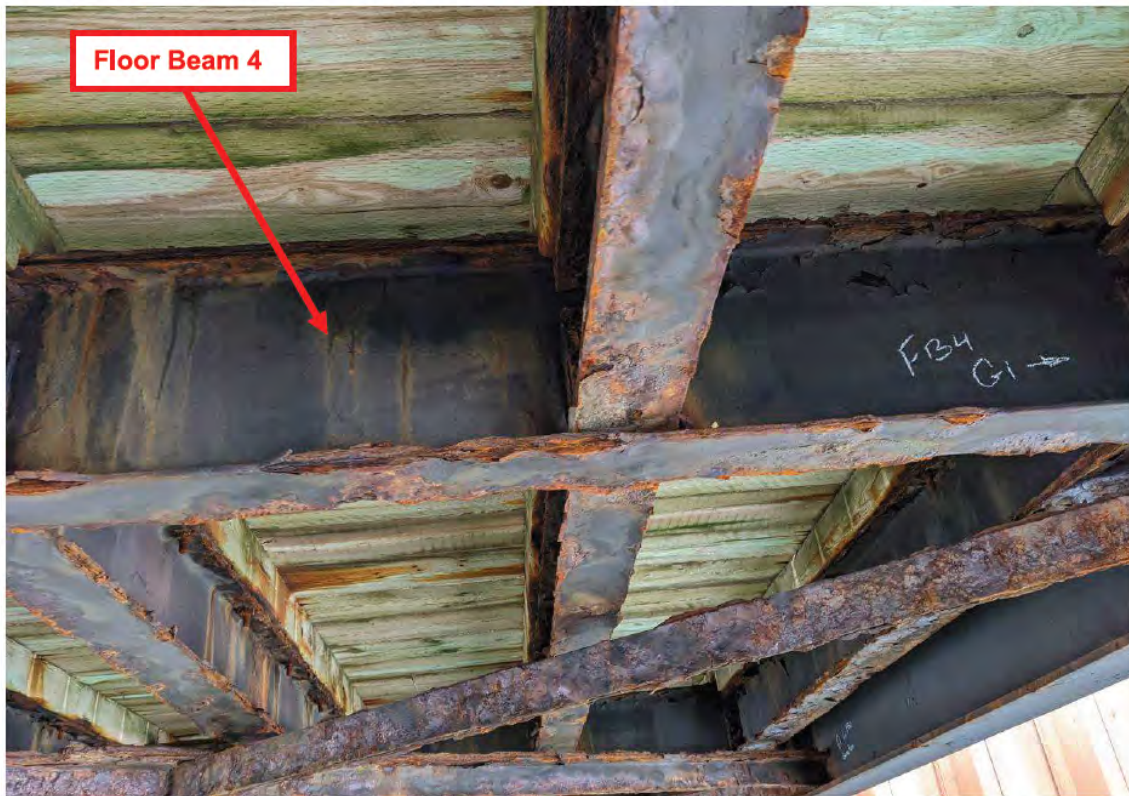
Photo 12: Photo showing the general floor beam condition. Overall conditions are similar between spans. General coatings breakdown, general corrosion observed, both flanges starting to delaminate locally in locations.

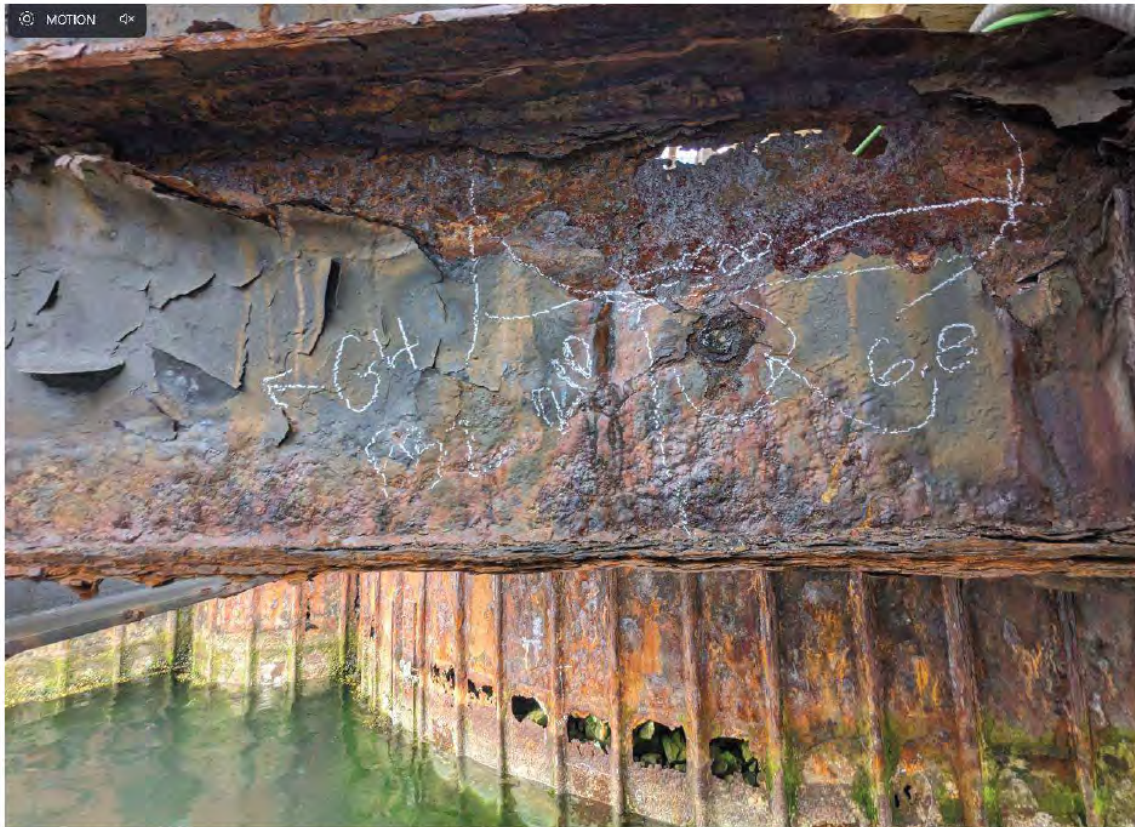
Photo 13: Photo showing the condition of Floor Beam 2. As can be seen in the photo above, a hole has developed in the web of the beam, and both the top and bottom flanges are heavily corroded.

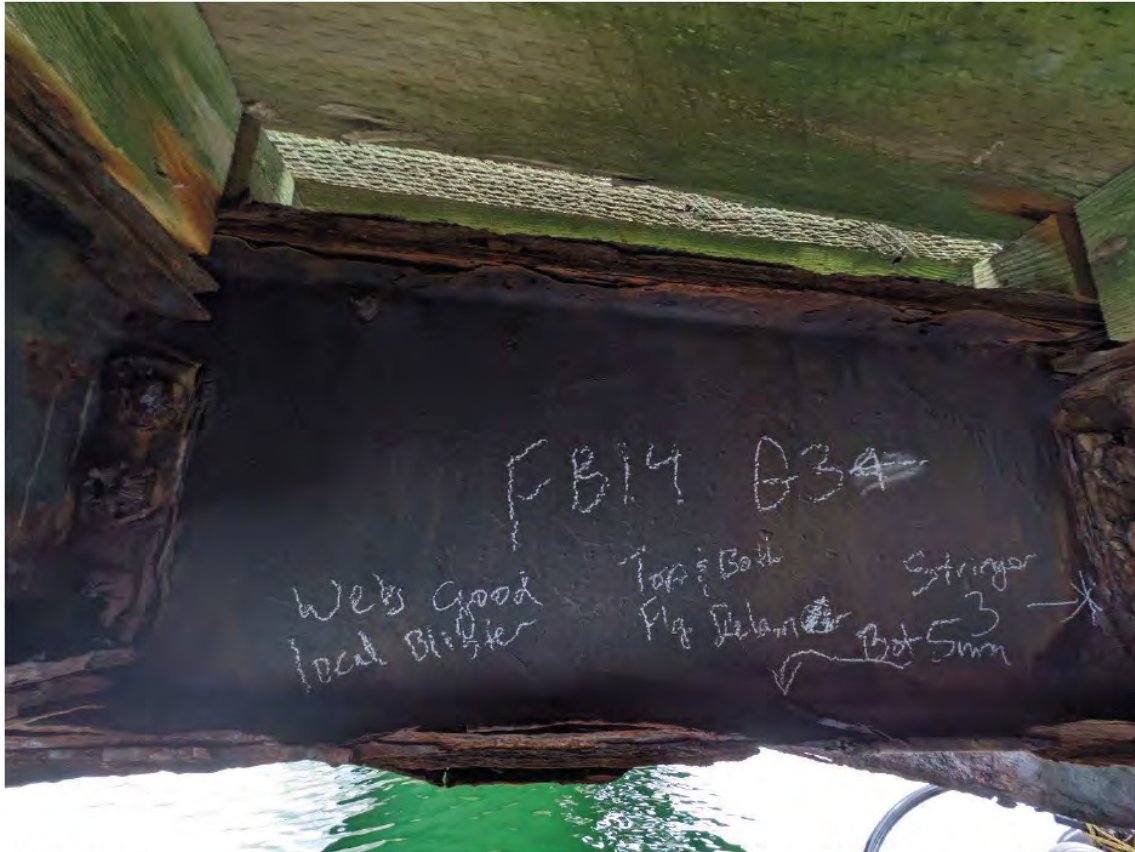
For load combination 1 and 2, which use the telehandler for offloading, floor beams 14 and 15 are unable to remain under the 85% utilization ratio for this unbraced length due to the observed deterioration. The telehandler and beams required to act as a jump bridge for the telehandler add considerable load to the structure. These floor beams would have to be repaired to support these additional loads. However, under the unbraced length of 2.5 m, all floor beams are able to achieve adequate capacity and remain under the 85% utilization for load combinations 3 and 4, which don't use the telehandler.

Photo 14: Photo showing the condition of Floor Beam 14. As can be seen in the photo, the coating along the web appears to be in fair condition. There is coating breakdown as visible corrosion, and delamination on the top and bottom flanges.

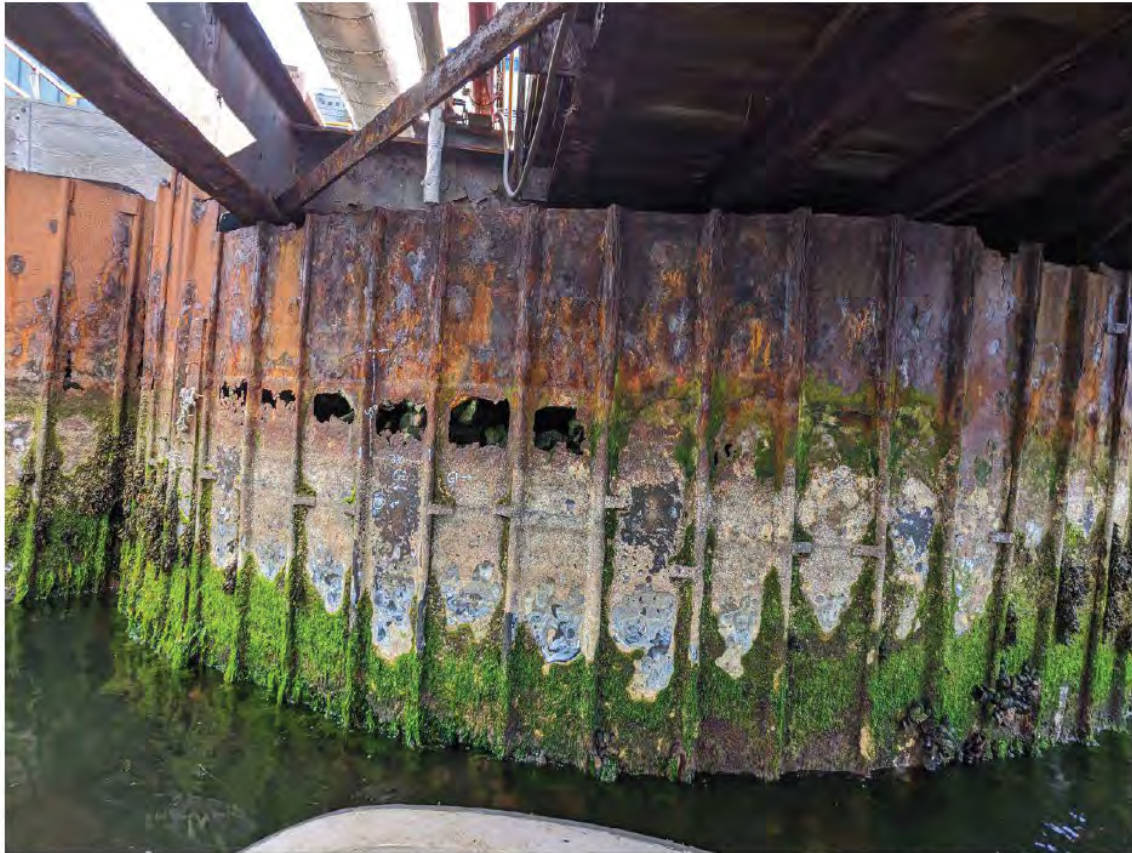
Photo 15: Photo showing the condition of Shore-side Cell. As can be seen in the photo above, there is marine growth over the wetted area of the steel sheet pile wall. There are no signs of coatings, corrosion is visible throughout, with areas of delamination in the steel sheet pile, and full section loss at locations.

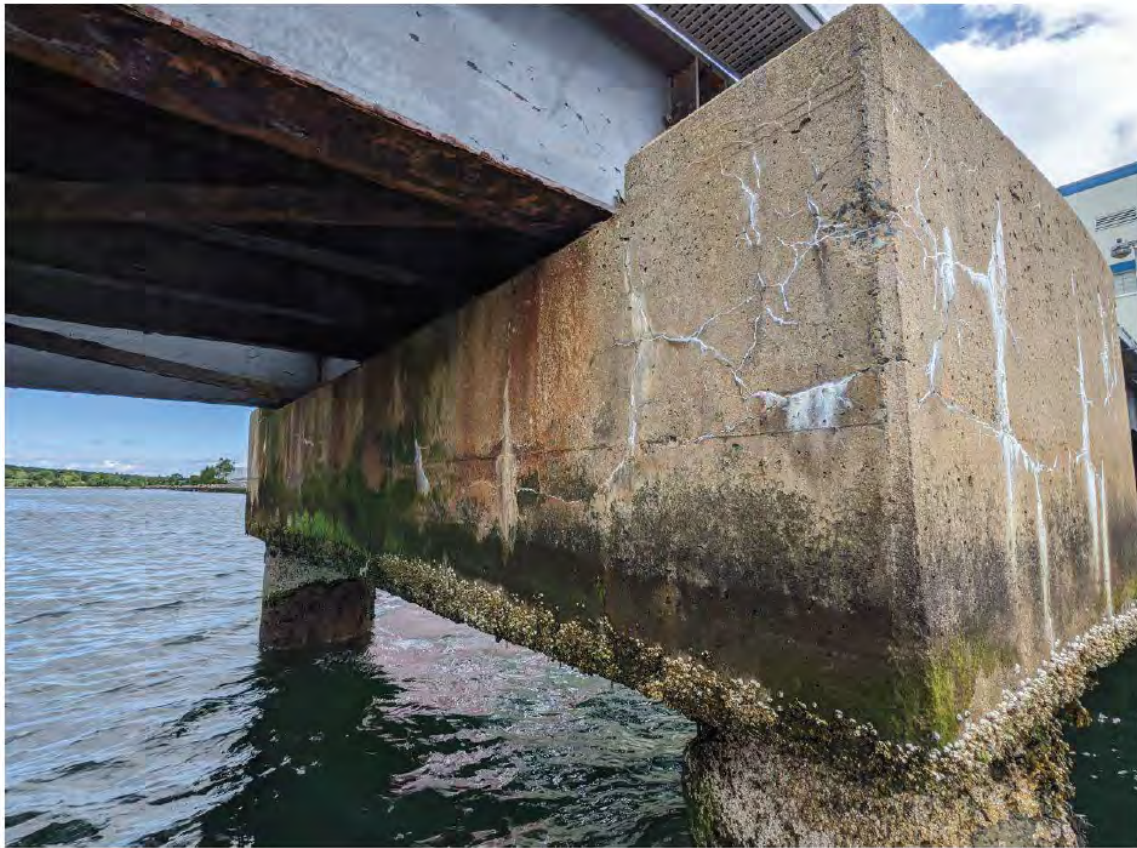
Photo 16: Photo showing the condition of pile cap at Pier 1. Visible cracking throughout the pier cap can be seen, as well as efflorescence.

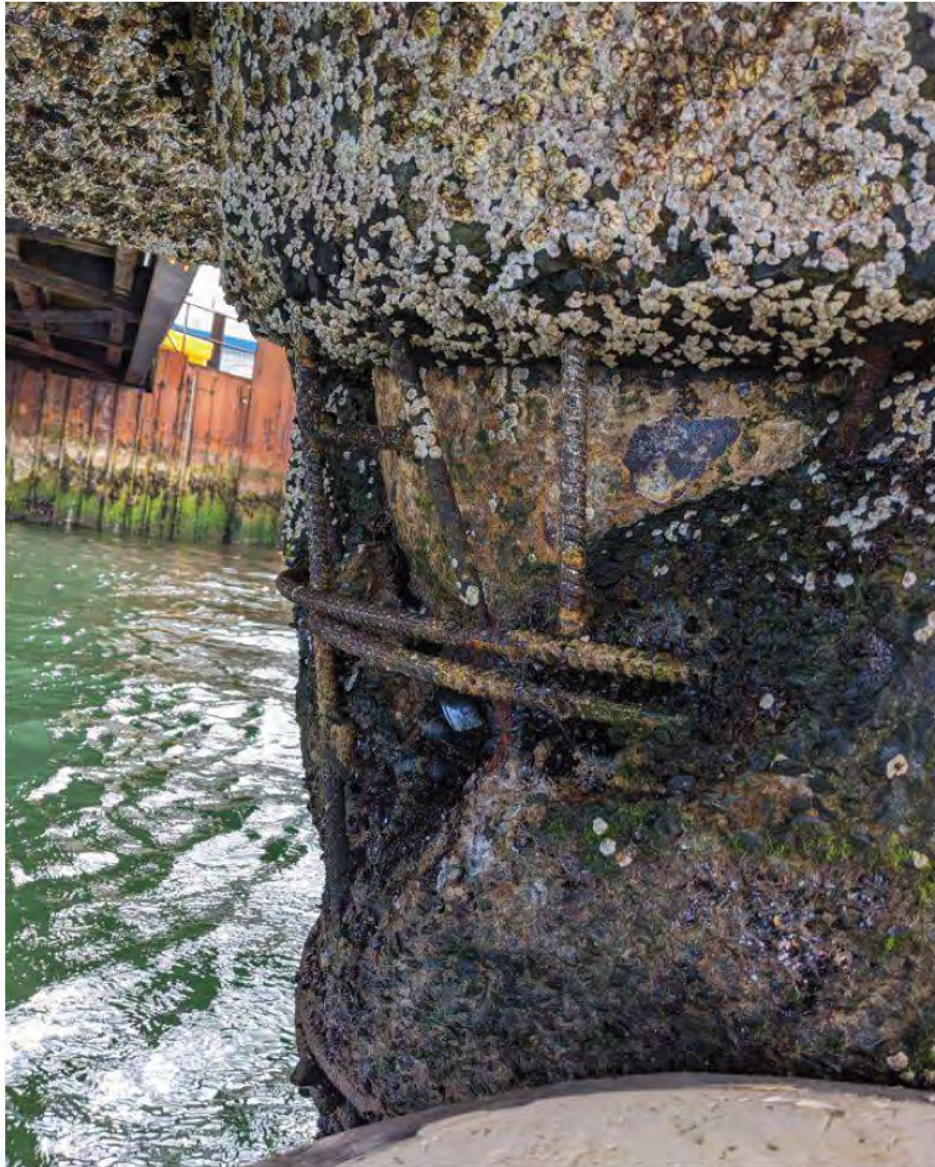
Photo 17: Photo showing the one of the piles at Pier 1. The concrete cover for the steel pile has spalled off locally and the rebar is exposed and has started to corrode.

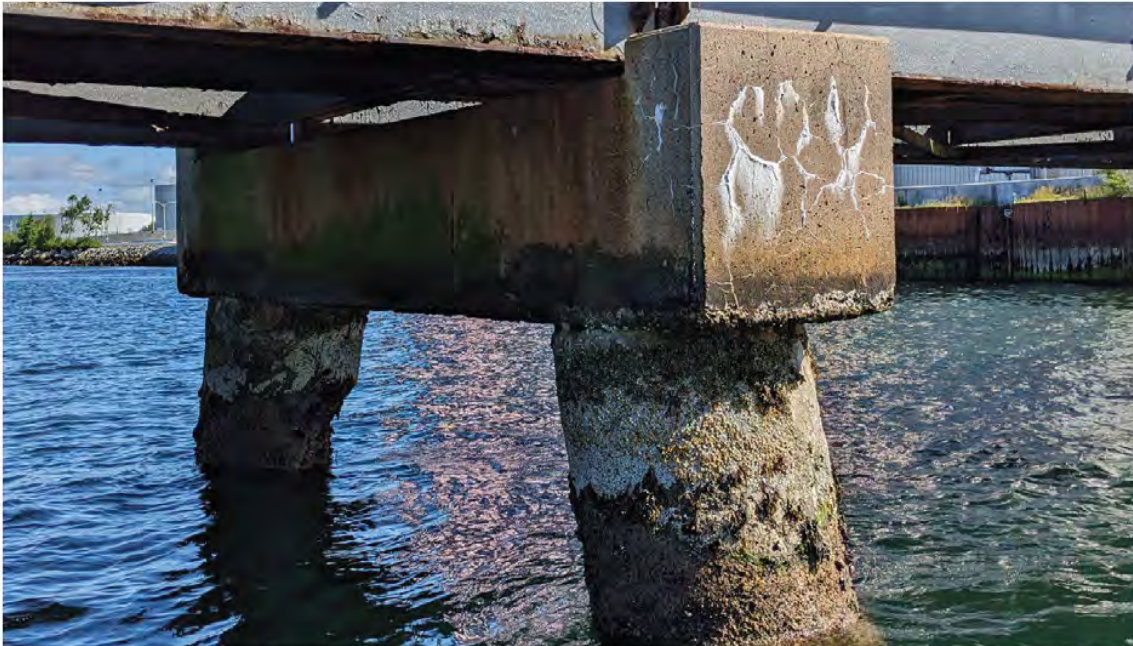
Photo 18: Photo showing the condition of pile cap at Pier 2. Visible cracking throughout the pier cap can be seen, as well as efflorescence.

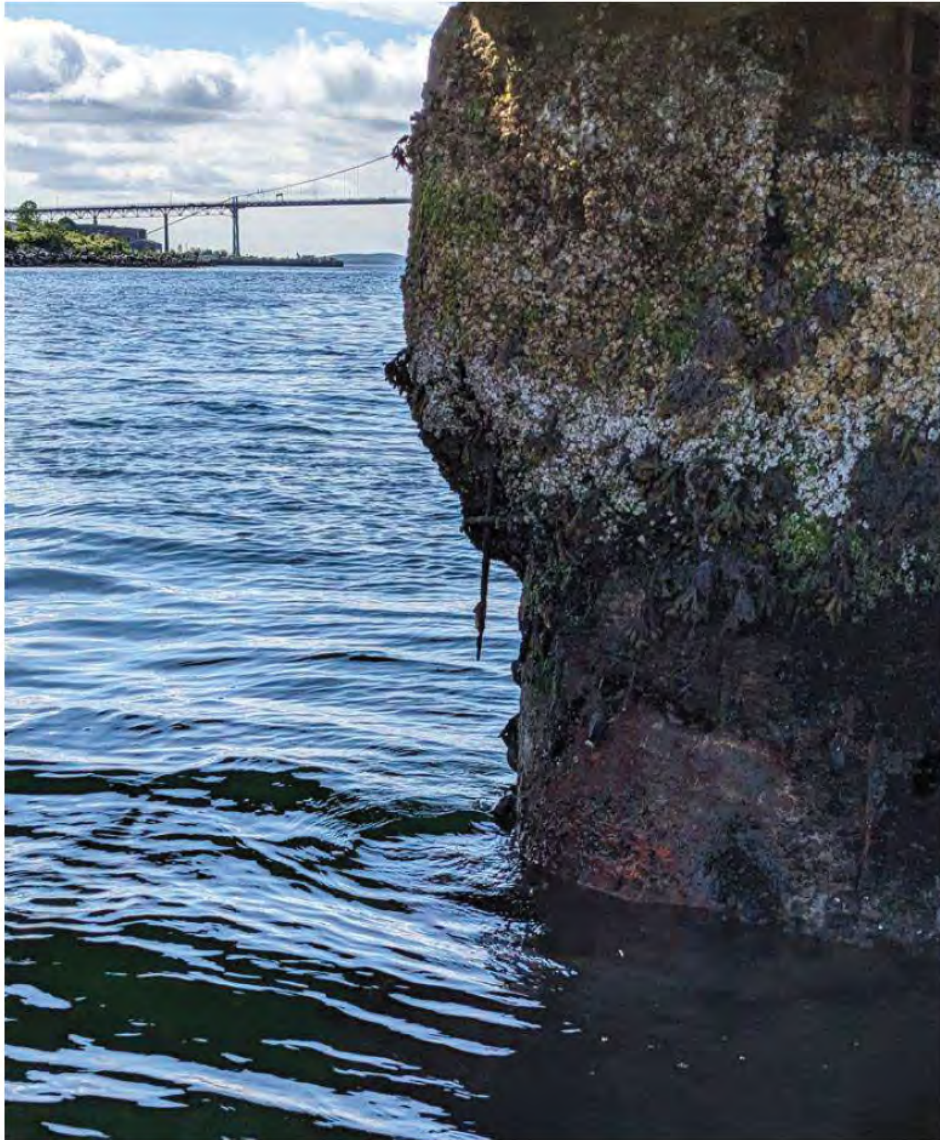
Photo 19: Photo showing the one of the piles at Pier 2. The concrete cover for the steel pile has spalled off locally and the rebar is exposed, and several bars have fully corroded through. The exposed steel pile has started to show signs of corrosion.

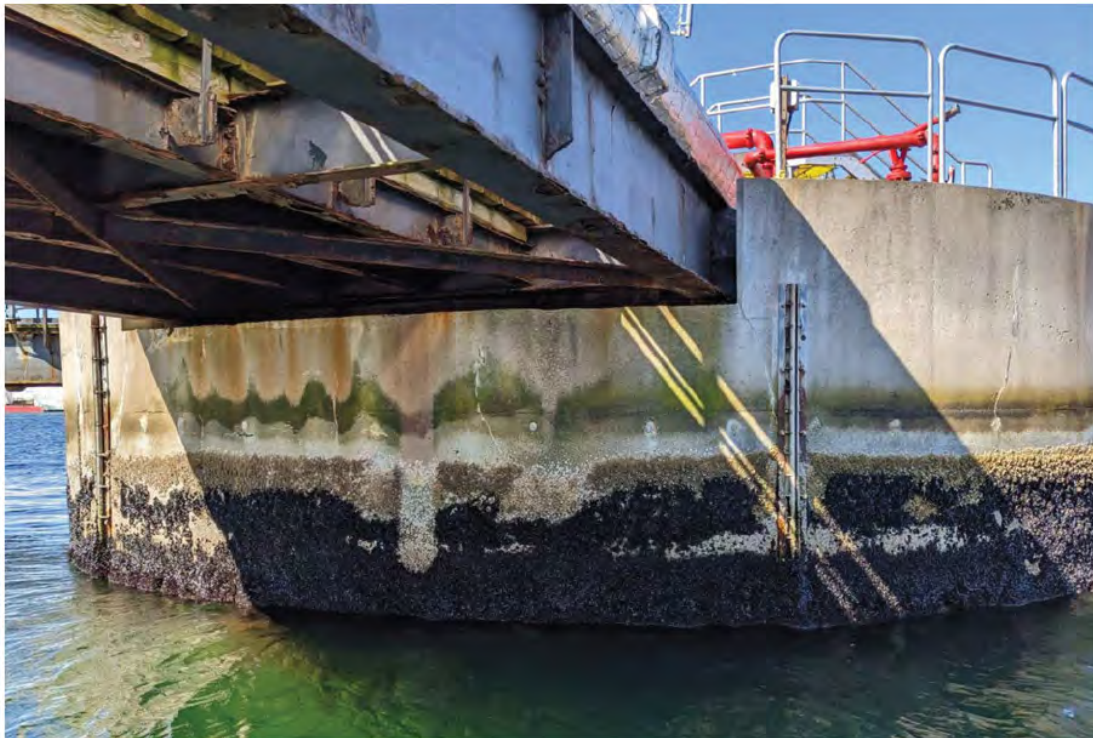
Photo 20: Photo showing the manifold cell structure. Marine growth was observed above the water level at the time of the inspection.

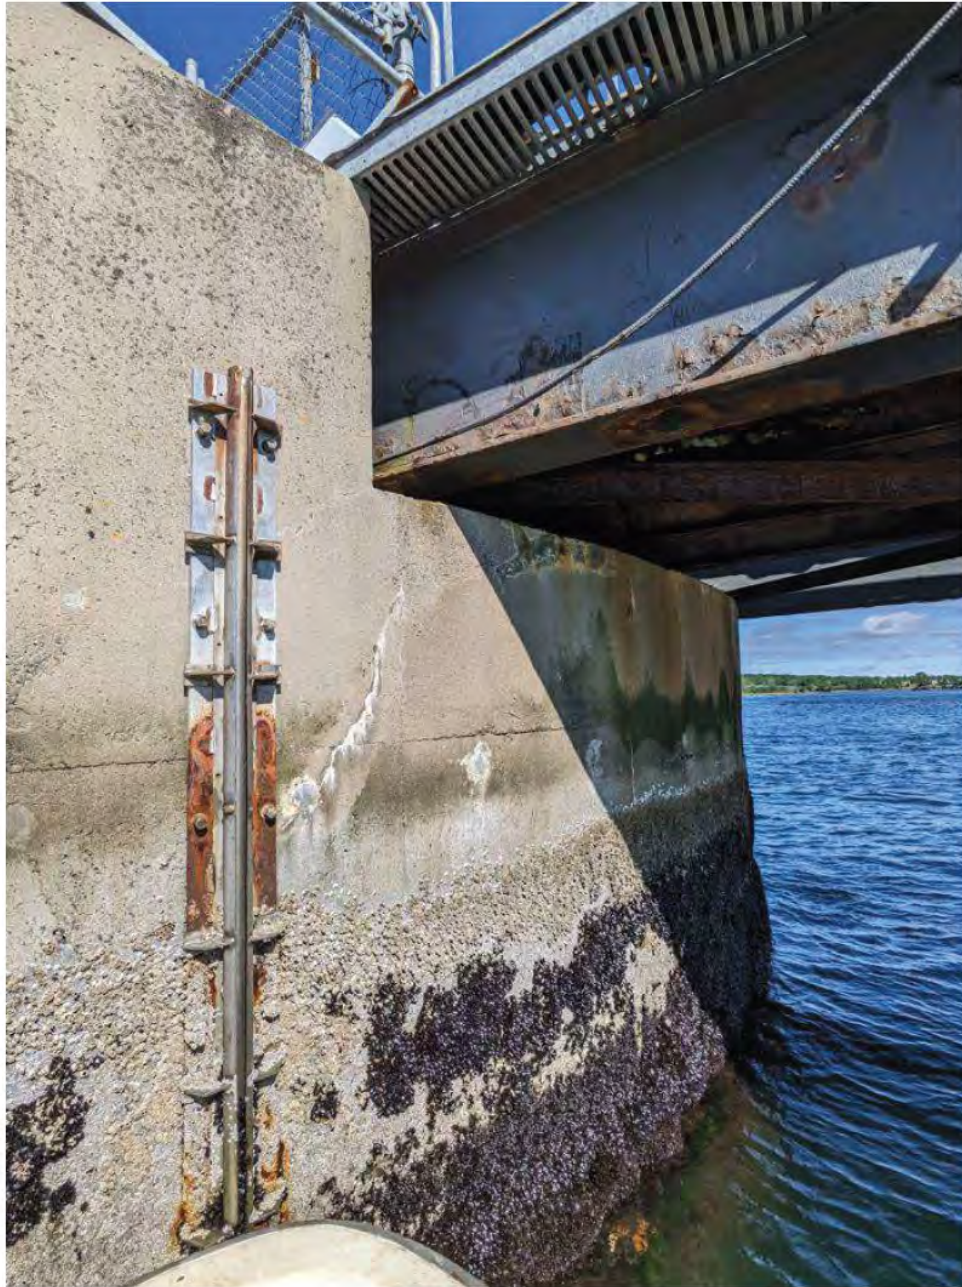
Photo 21: Photo showing the manifold cell structure. Marine growth was observed above the water level at the time of the inspection. There were local cracks and efflorescence visible along the structure.

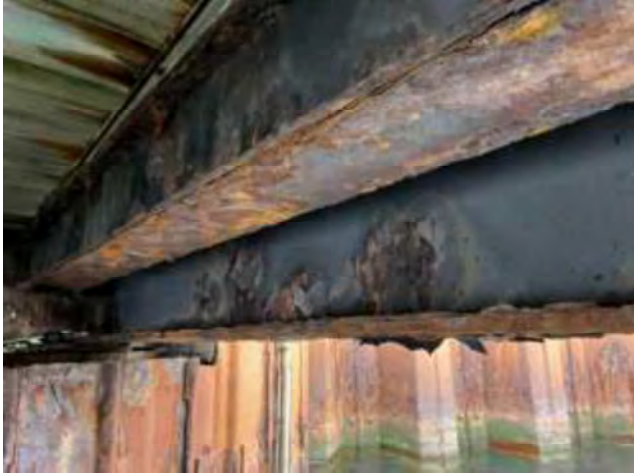
**Photo 1 - South Girder at Span A showing localized corrosion in the web.**

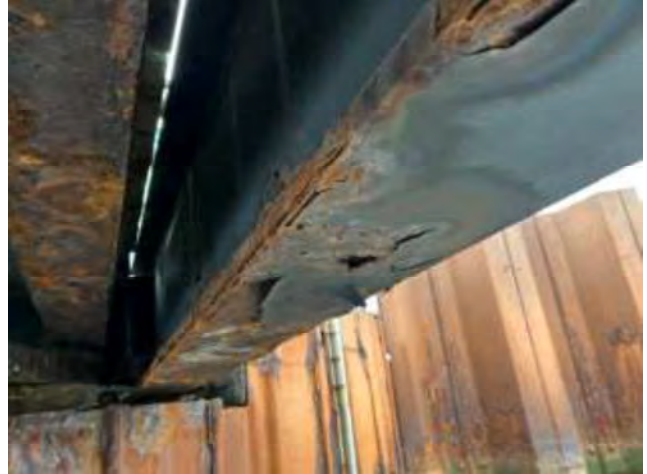
**Photo 2 - South Girder at Span A showing corrosion on the flange and coating failure.**

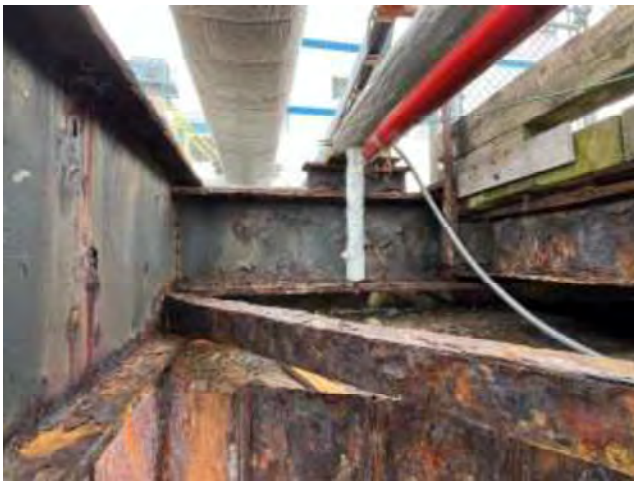
**Photo 3 - North Girder at Span A showing corrosion on the flange and web with coating failure.**
