**CI C0067183**

**TUC Wharf Access Bridge Replacement**

**August 5, 2025**

**NSEB APPROVAL SHEET**

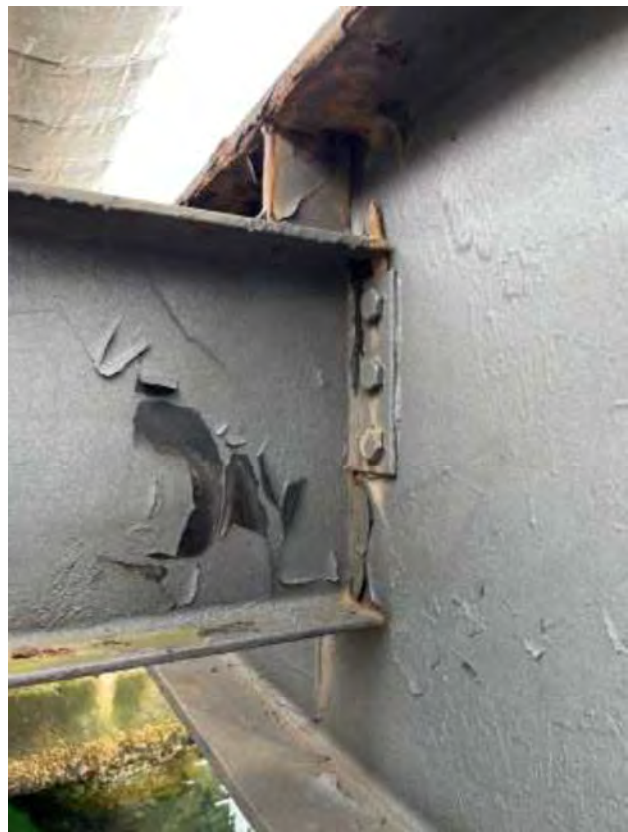
**Photo 4 - North Girder at Span A and typical bolted beam to girder connection.**

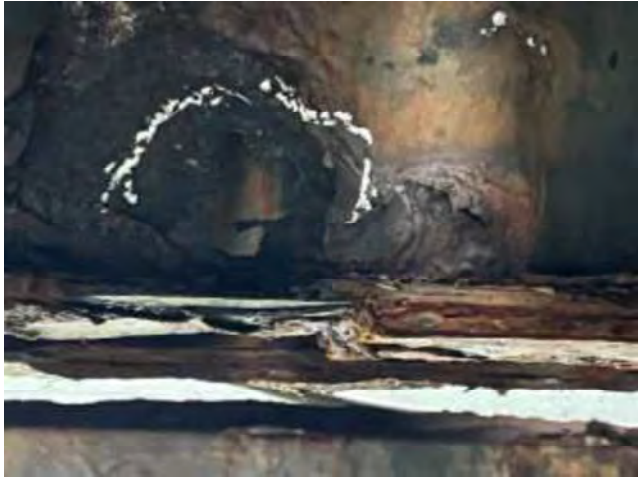
**Photo 5 - Full section loss of through the web of joists.**

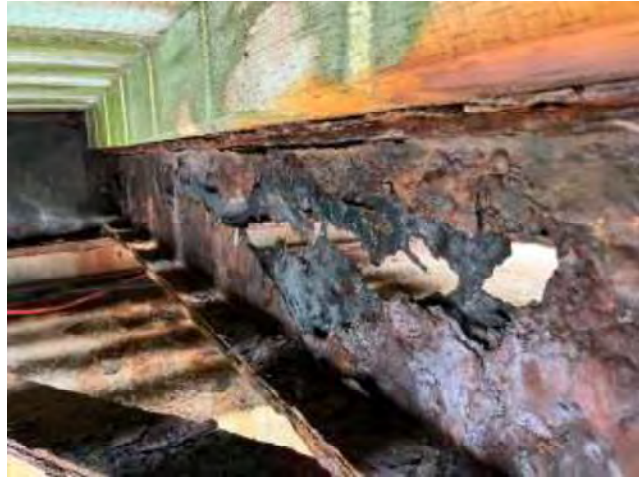
**Photo 6 - 2 full section loss through web of joists measuring 18" in total length.**

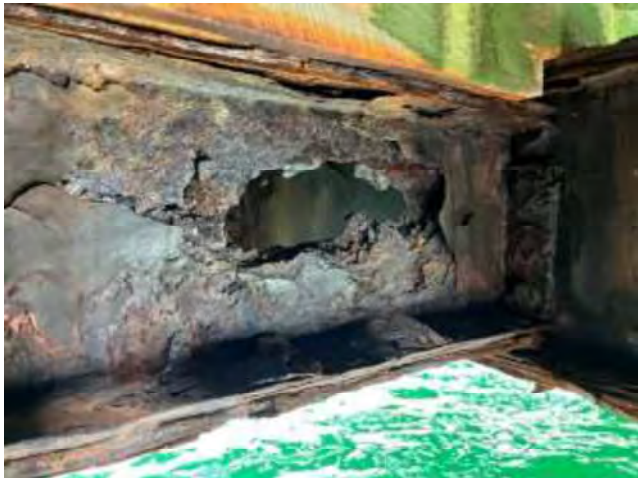
**Photo 7 - Full section loss at web of joist measuring 6" long.**

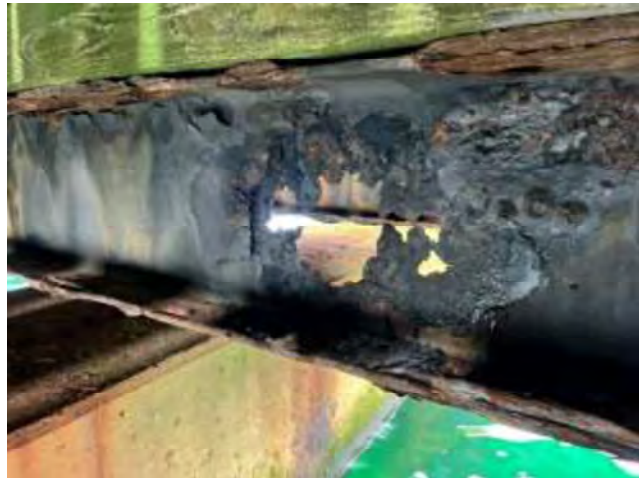
**Photo 8 - Full section loss at web of joist extend through the full height of the web and significant section loss in flange.**

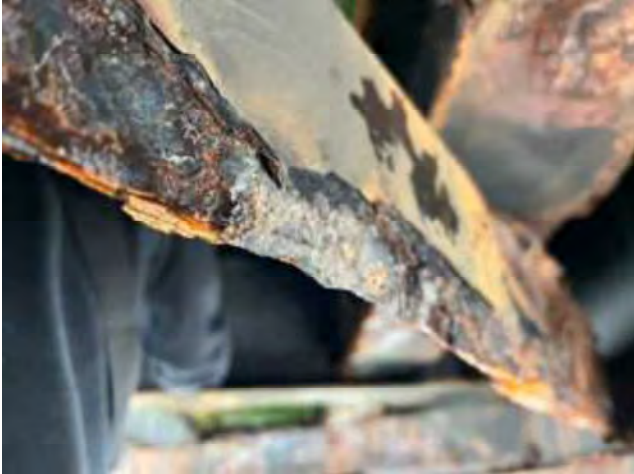
**Photo 9 - Braces with severe corrosion damage.**

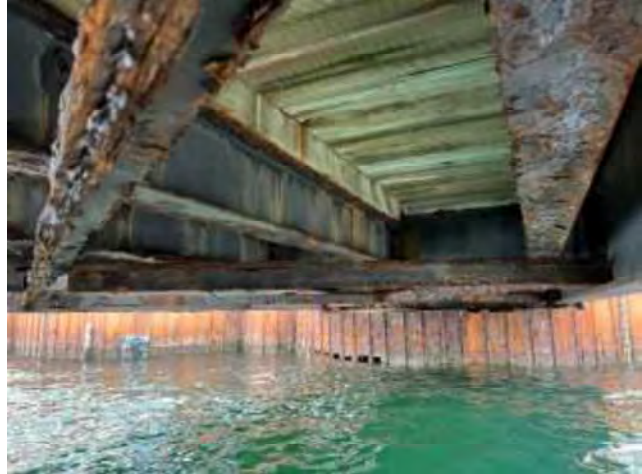
**Photo 10 - Braces with severe corrosion damage prior to corroded area being removed.**

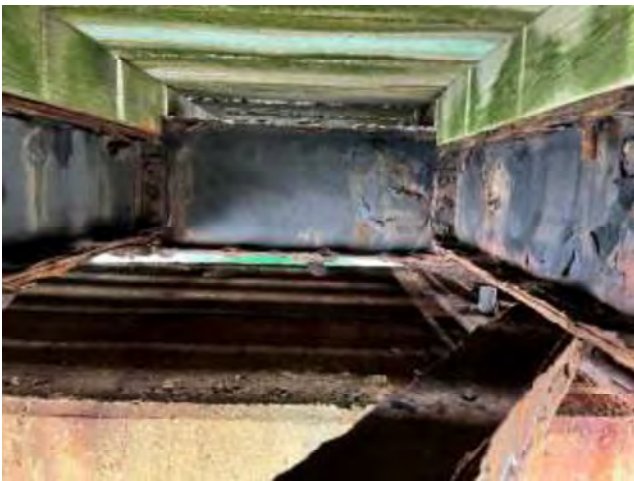
**Photo 11 - Beam with corrosion damage.**

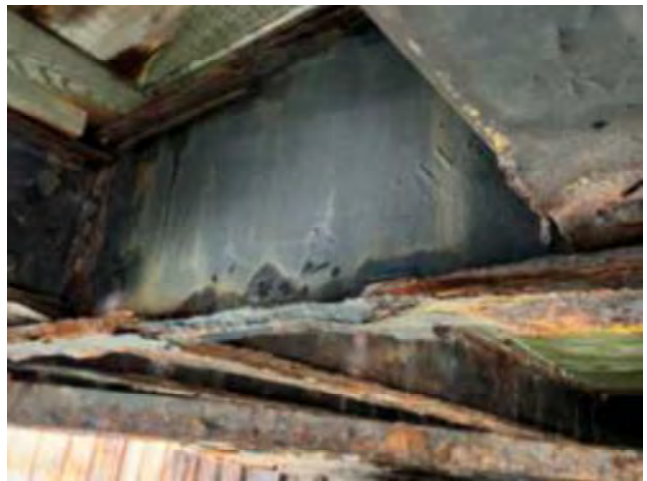
**Photo 12 - Beam with full section loss through the flange between the joists.**

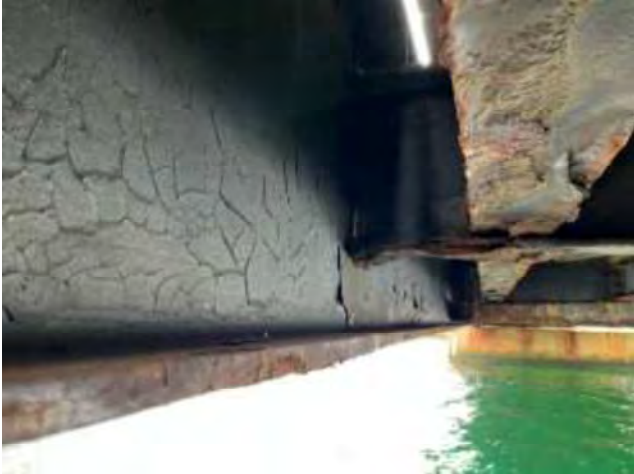
**Photo 13 - Coating on girder alligatoring (South girder).**

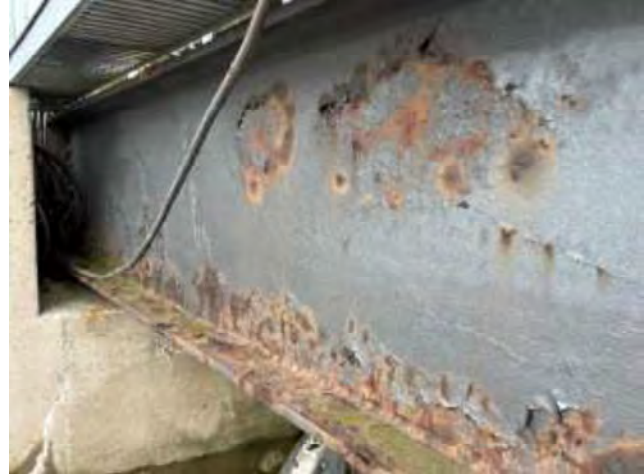
**Photo 14 - Coating of girder cracking and rusting (North girder).**

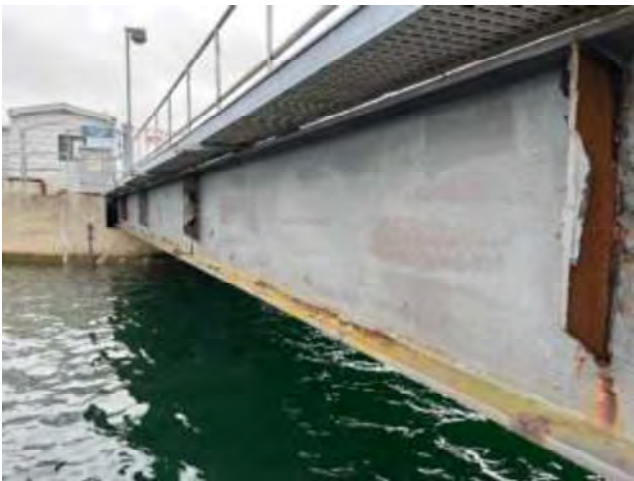
**Photo 15 - South Girder at Span C in fair condition.**

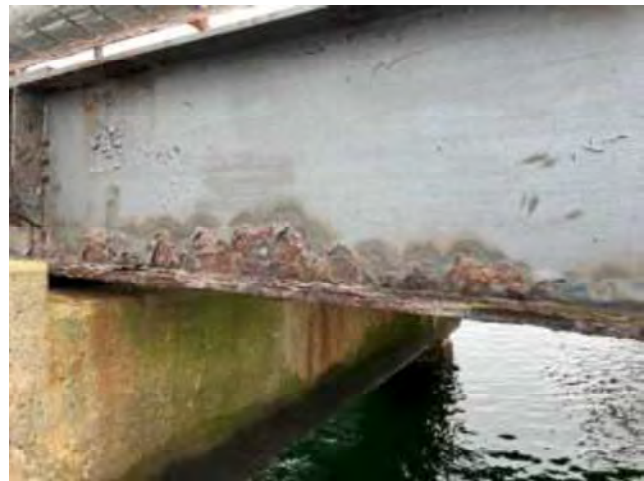
**Photo 16 - South Girder at Span B in fair condition.**

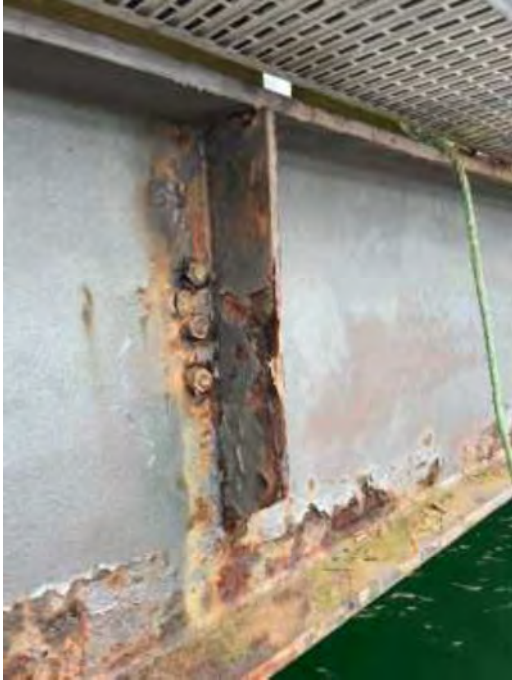
**Photo 17 - North Girder at Span C in fair condition with minimal section loss due to corrosion.**

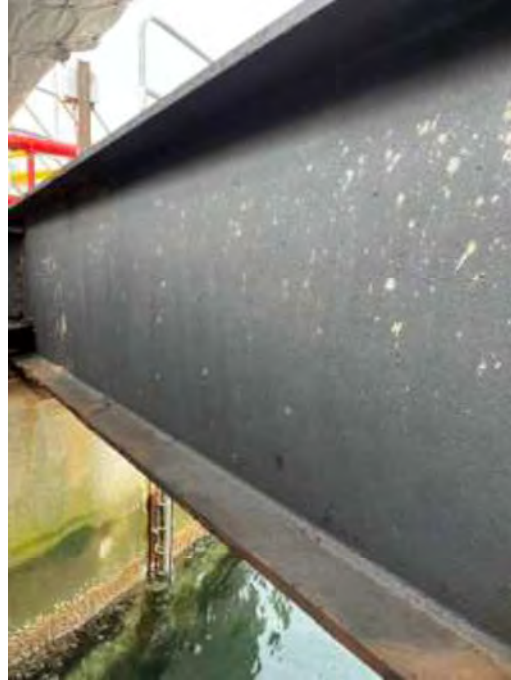
**Photo 18 - North Girder (South side) at Span C in fair condition.**

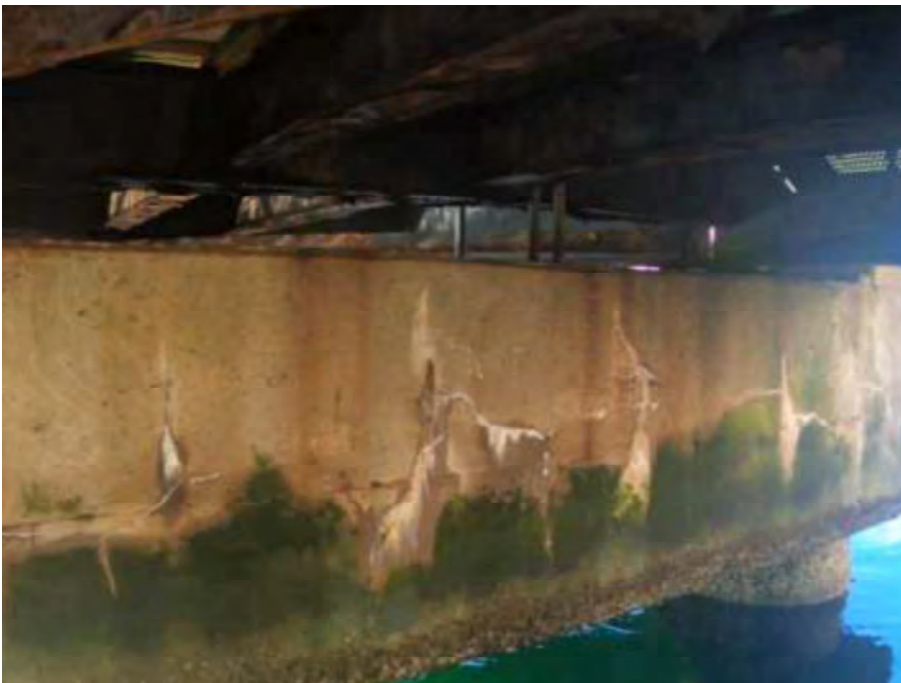
**Photo 19 - Presence of efflorescence of observed in pile caps.**

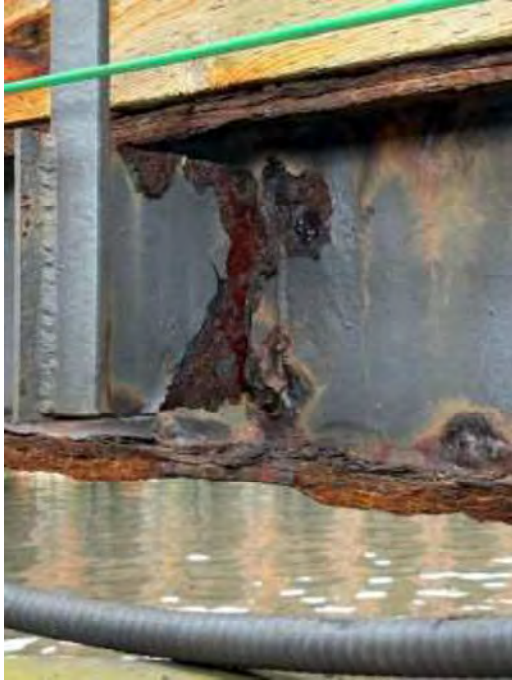
**Photo 20 - Full section loss of North handrail to the structure.**

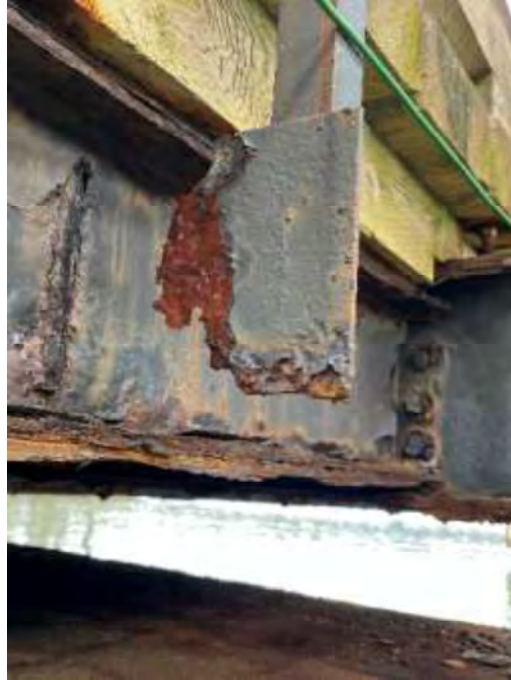
**Photo 21 - Full section loss of North handrail to the structure.**

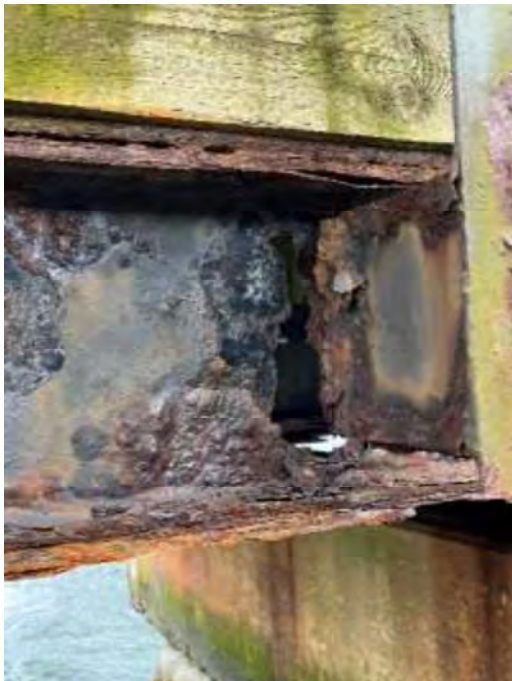
**Photo 22 - Full section loss of North handrail to the structure.**

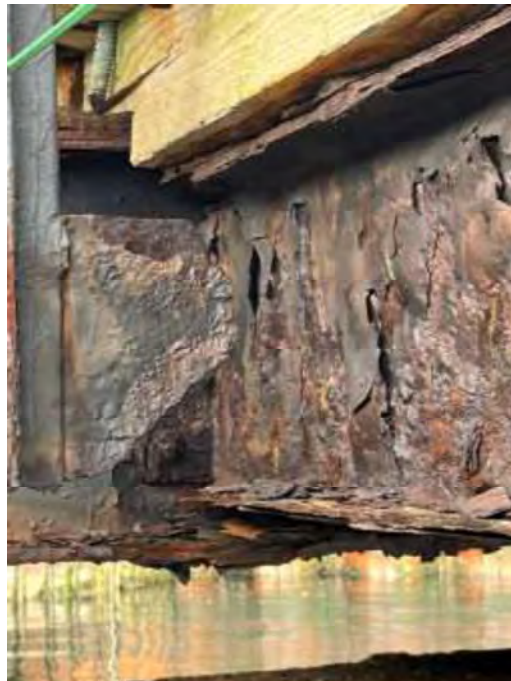
**Photo 23 - Full section loss of North handrail to the structure.**

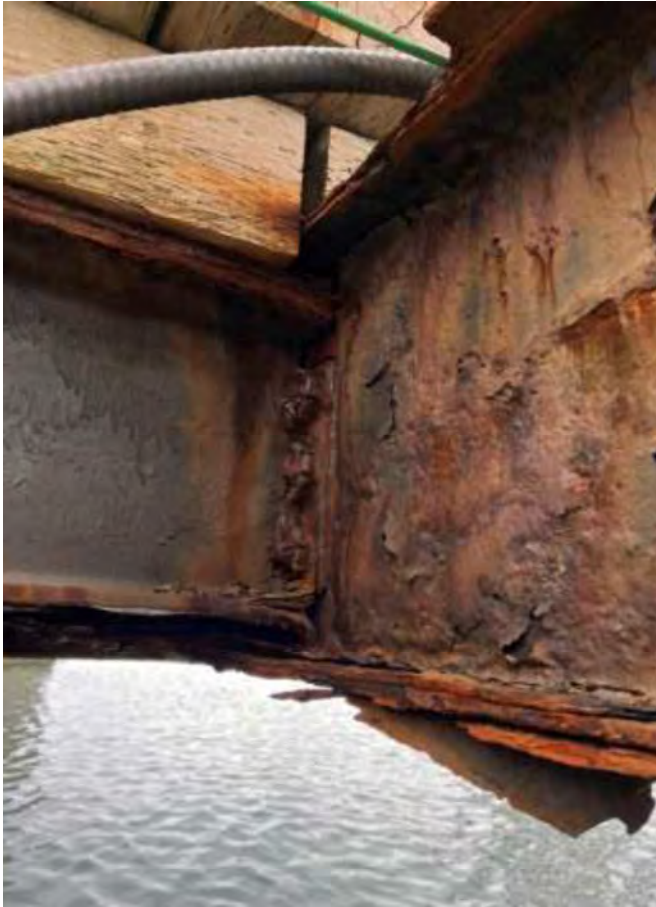
**Photo 24 - Poor condition observed in connection at multiple locations.**

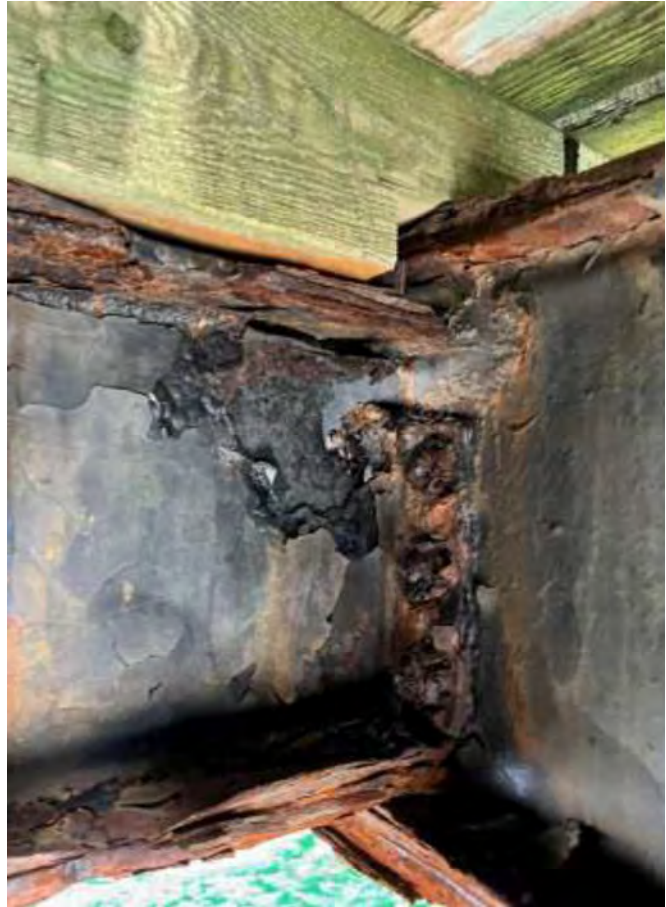
**Photo 25 - Poor condition observed in connection at joist to beam connection.**

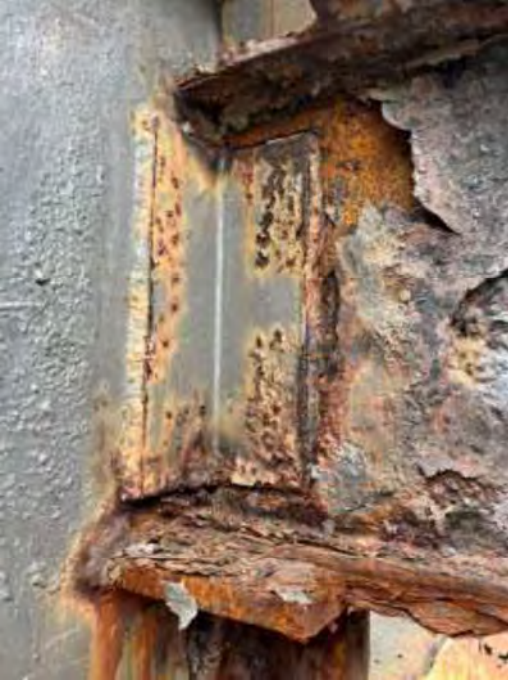
**Photo 26 - Connection different from the rest of the structure (South side of North girder on Span A).**

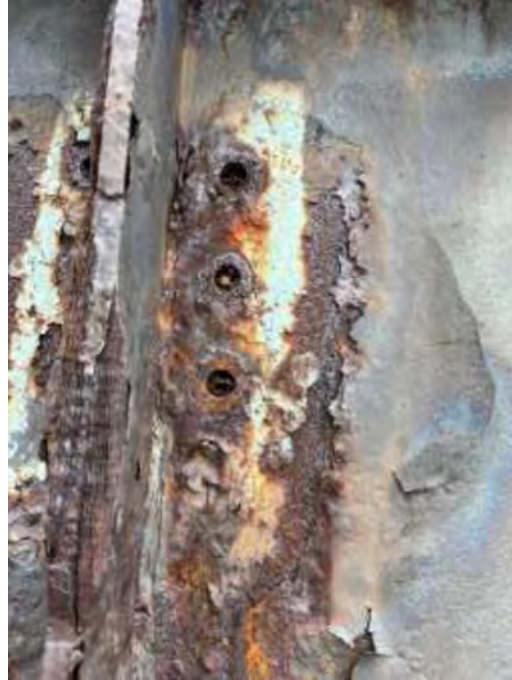
**Photo 27 - Connection different from the rest of the structure (North side of North girder on Span A).**

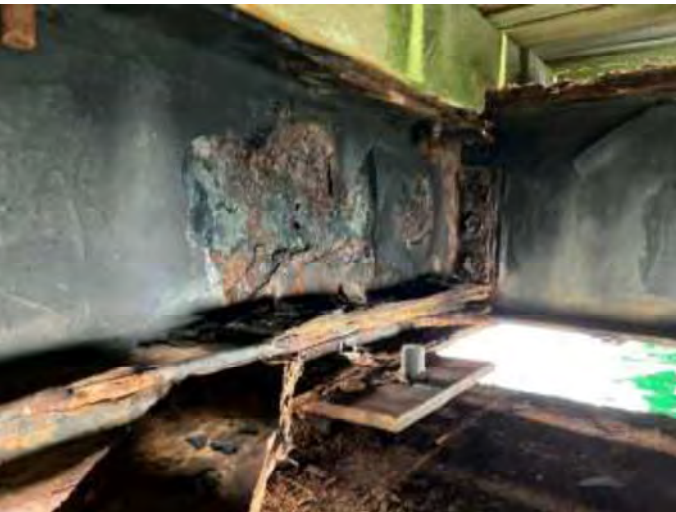
**Photo 28 - Bearing plate and anchorage to pile caps observed to be in fair condition.**

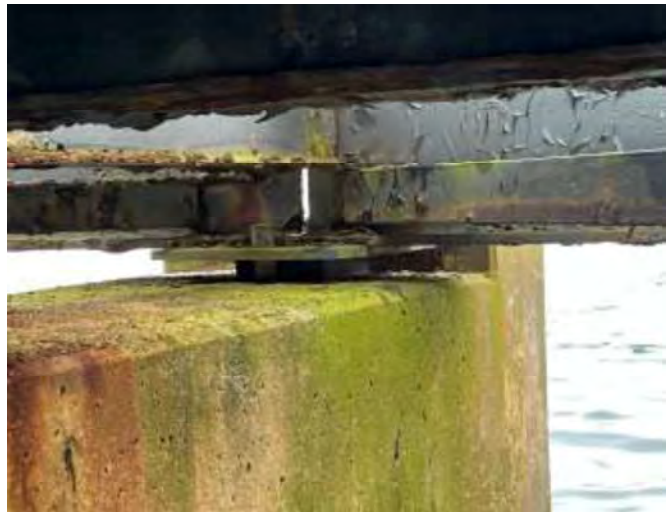
**Photo 29 - Bearing plate and anchorage to pile caps observed to be in fair condition.**

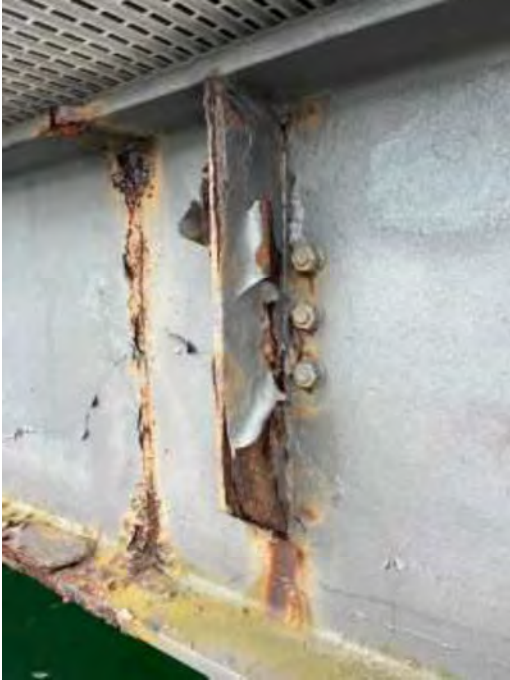
**Photo 30 - Coating failure and superficial corrosion observed at the welds at splice location in the girders and the girder bearing plate.**

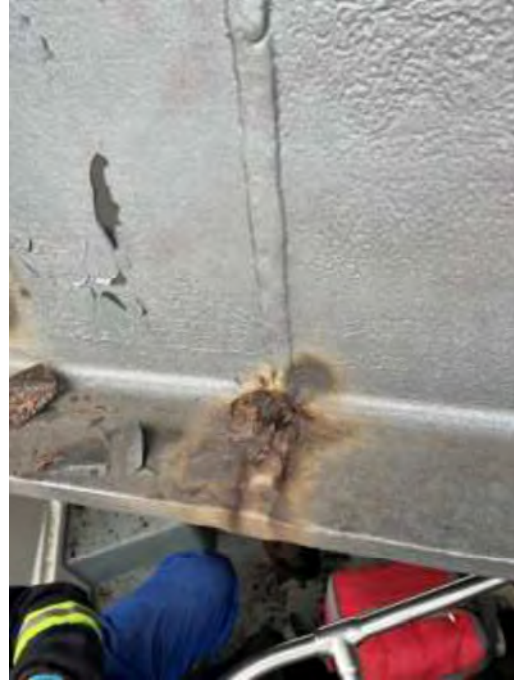
**Photo 31 - Coating failure and superficial corrosion observed at the welds at splice location in the girders.**

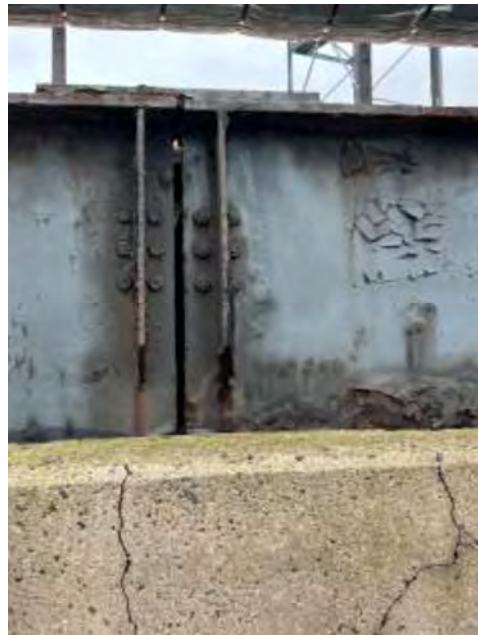
**Photo 33 - Girders connection at pile caps.**
