**Request IR-1:**

**In the “DESCRIPTION” of NS Power’s application, NS Power notes that “This project is for the refurbishment of Upper Lake Falls Unit 2. The scope includes refurbishment of the turbine, headcover, turbine shaft, turbine bearings and housing, as well as all wear items. A re-alignment of the unit is required to ensure the unit will continue to operate reliably.”**

**Response IR-1:**

PLANT UPPER LAKE FALLS  
UNIT # 2

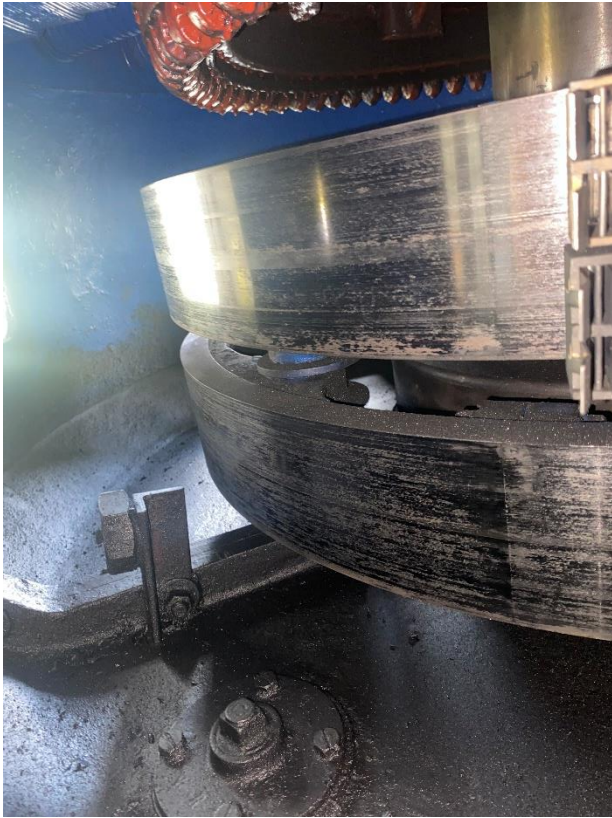
Photo 1: Exciter Slip Rings

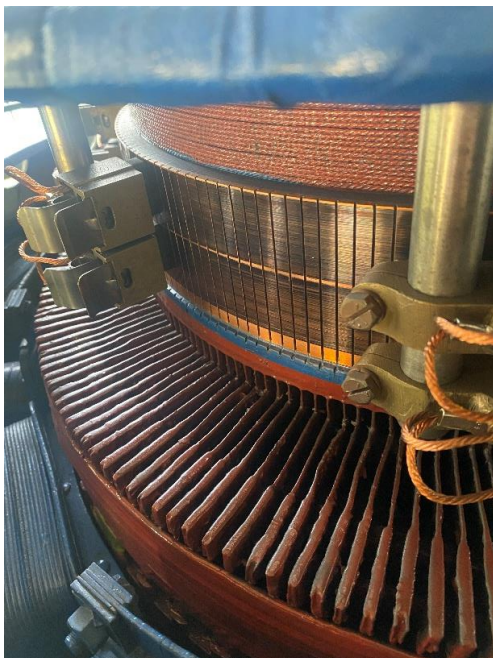
Photo 2: Exciter Commutator

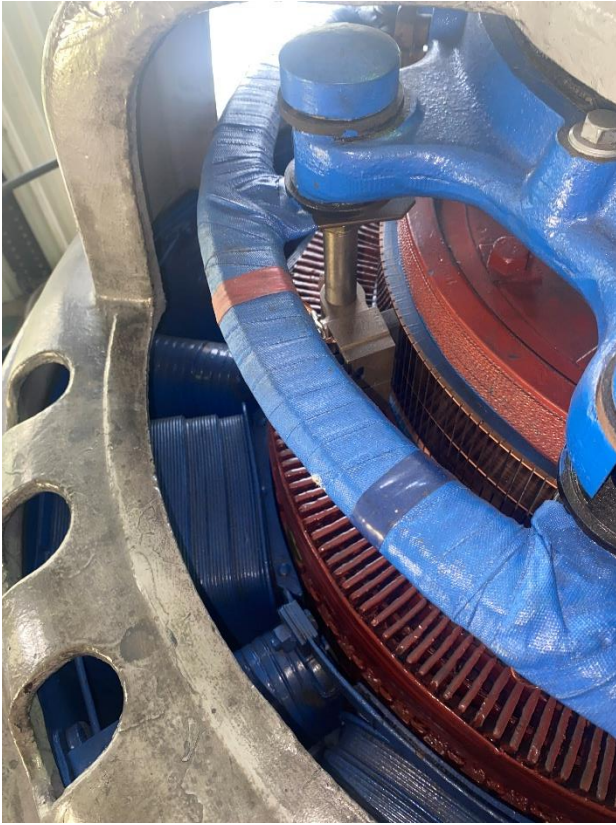
Photo 3: Exciter Poles

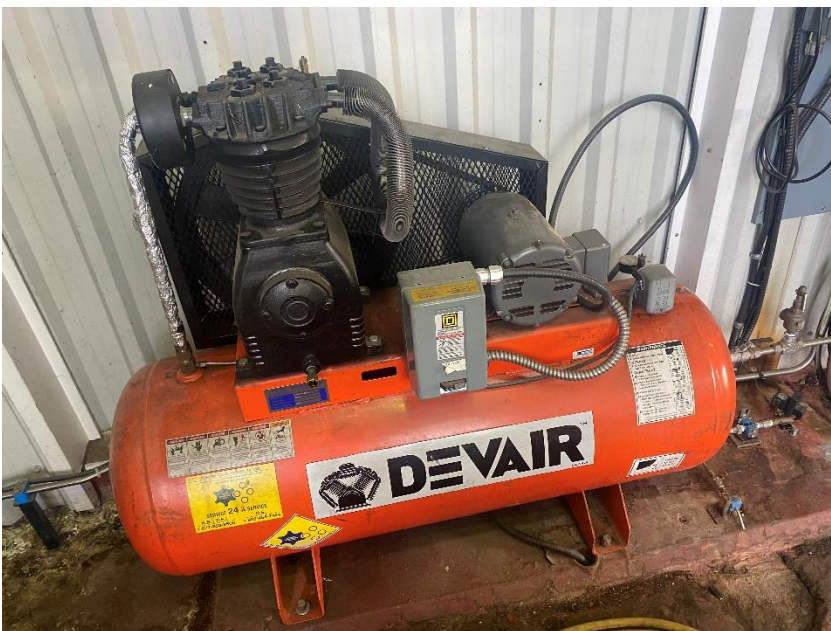
Photo 4: Upper Lake Compressor

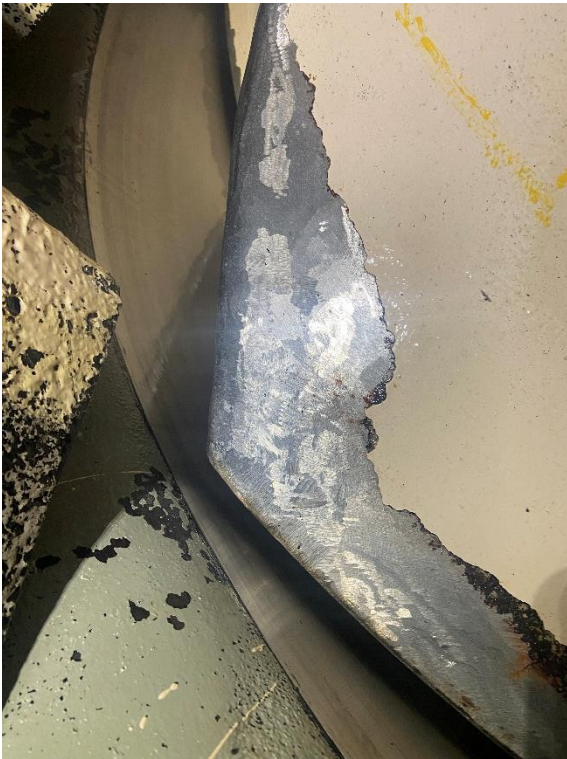
Photo 5: Turbine Runner Blade tip

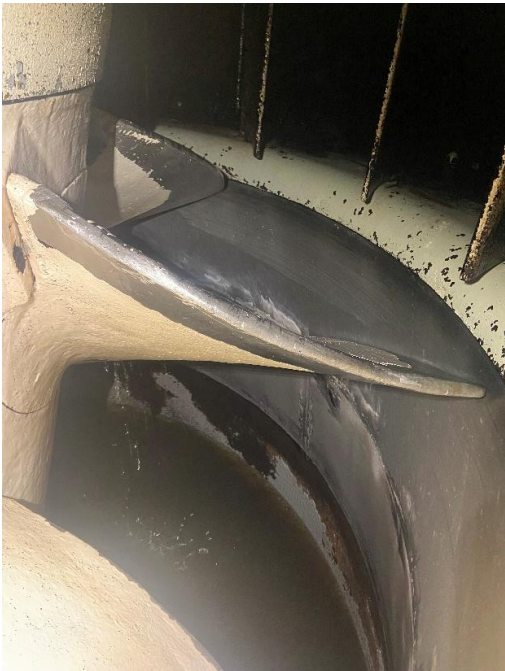
Photo 6: Turbine runner cladding and blades

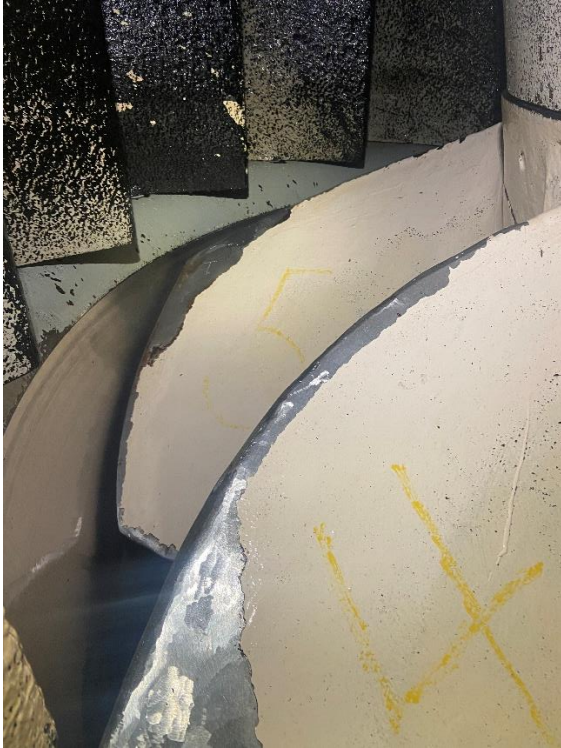
Photo 7: Turbine runner blades

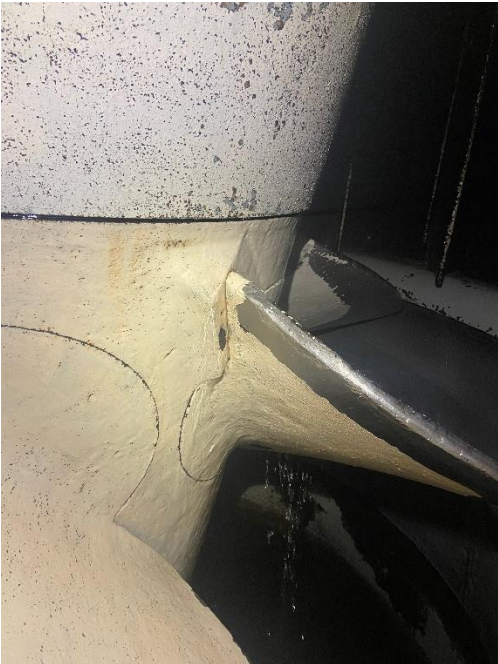
Photo 8: Turbine runner hub

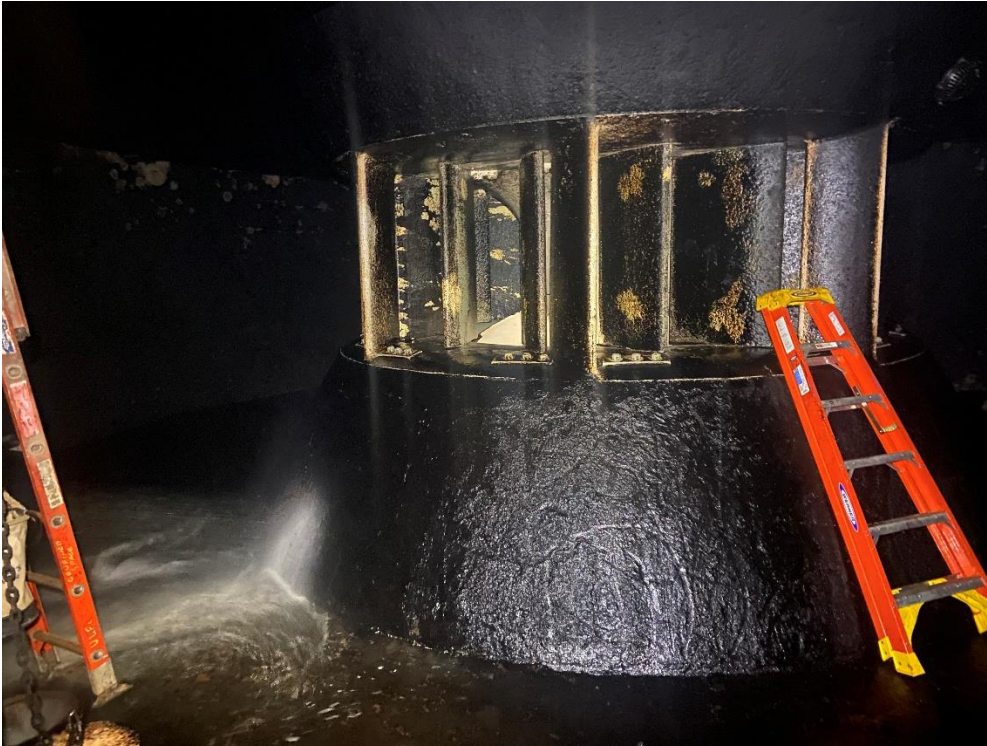
Photo 9: Scroll case looking DS

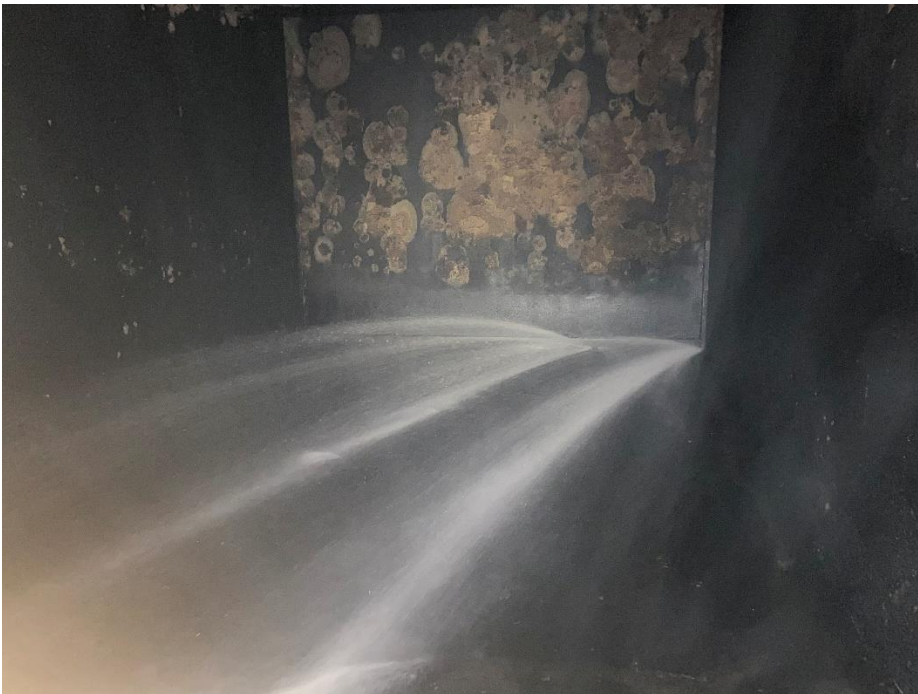
Photo 10: Scroll case looking US at headgates

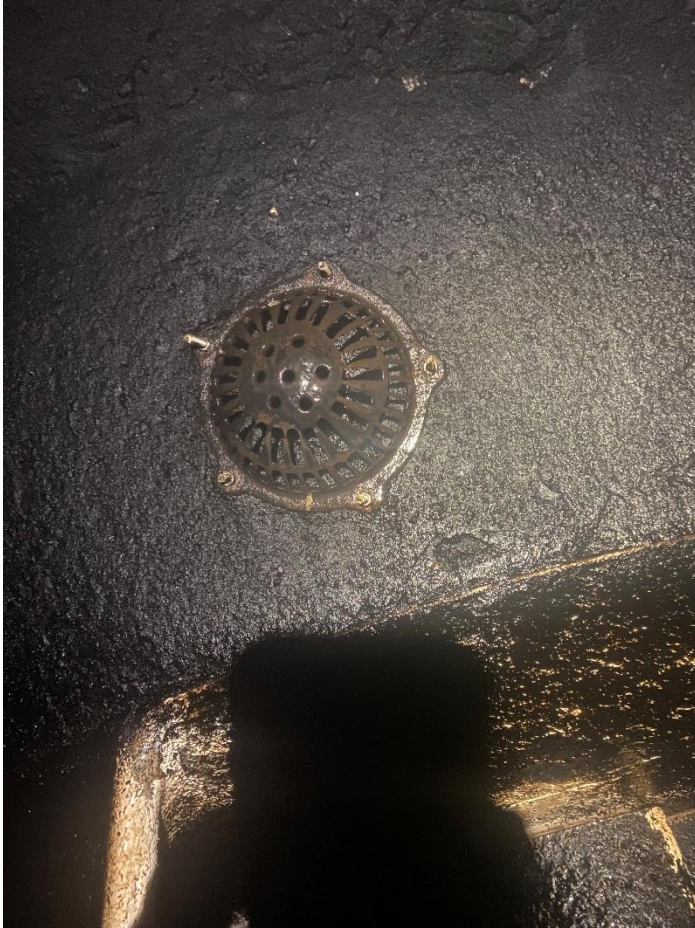
**Photo 11:** Cooling water screen
