**CI C0080112**

**HYD Big Falls Unit 6 Rotor Re-Insulation**

## TESTING

NorthPoint Job Number 57638

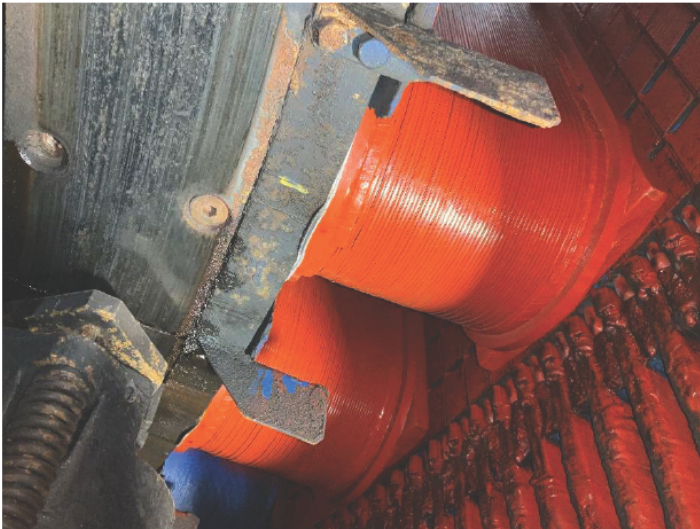
POLE 1 AND 44 WHICH WERE  
REFURBISHED IN 2023 AT DELSTAR  
ENERGY

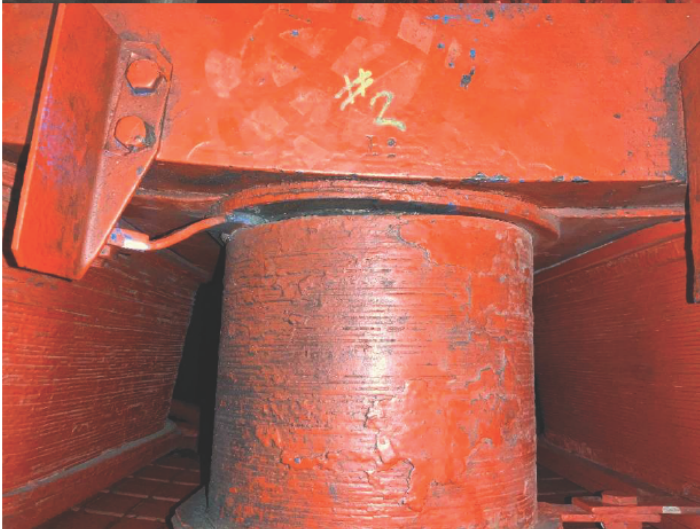
POLE 2: SECTION OF THE COLLAR  
MISSING.

REMOVED DUE TO VISUAL CONDITION NOT NOTED ABOVE: 2, 6, 19, 38, 41

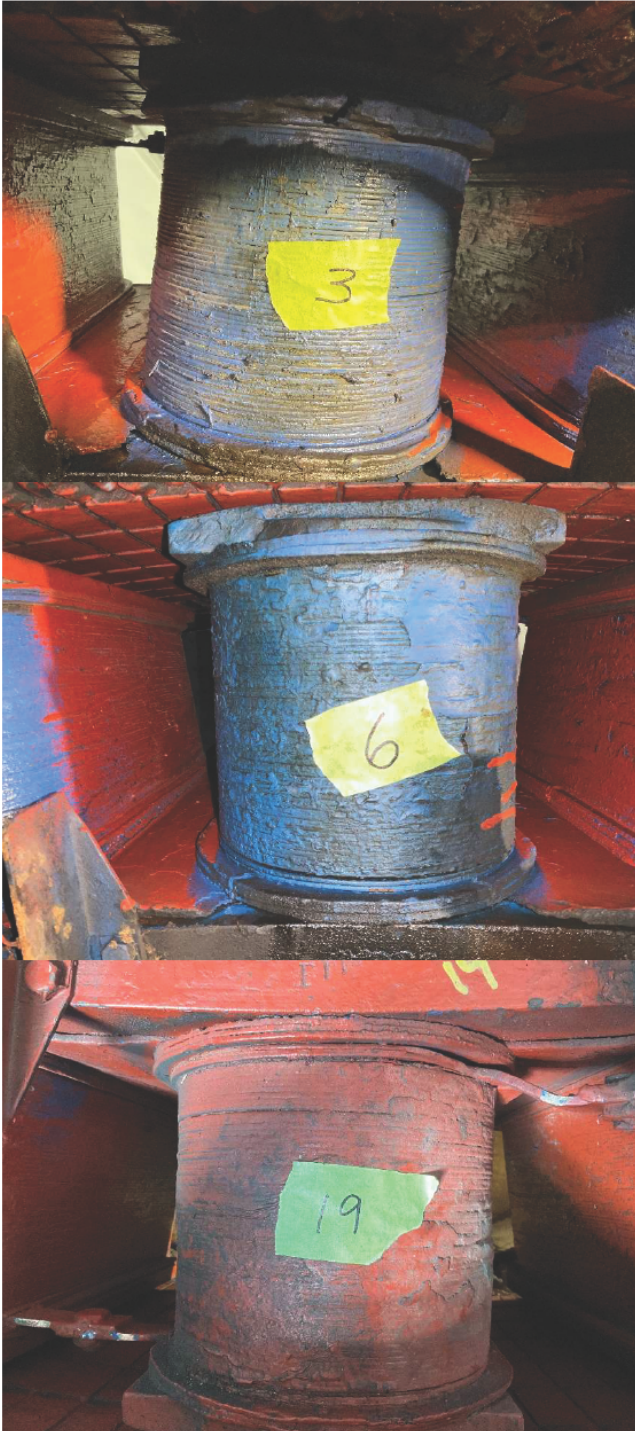
POLE 3 WITH LARGE CRACK IN OUTER WASHER, THIS CAN ALLOW MOVEMENT OF THE COIL DURING OPERATION. COULD POSSIBLY ALSO PUT STRESS ON CONNECTION TO POLES 2 AND 4 IF THEY ARE SECURE IN PLACE.

POLE 6 INNER COLLAR CRACKED IN TWO LOCATIONS, A PIECE OF THE COLLAR COULD POTENTIALLY COME LOOSE FROM THE POLE DURING OPERATION. NOTE POLE 7 IS SHOWING HIGH DC DROP WHICH COULD INDICATE COPPER FATIGUE

POLE 19 APPEARS TO HAVE GAP BETWEEN FIRST INNER TURN AND LEAD. THIS POLE MAY HAVE BEEN REPAIRED AT SOME TIME.

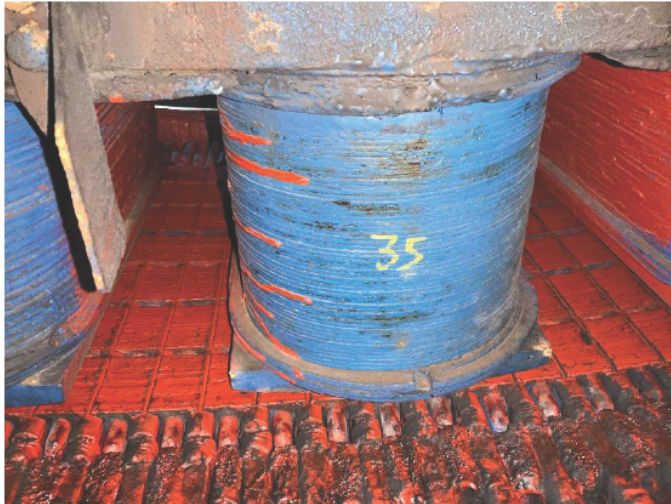
POLE 35 HAS A LARGE CRACK IN THE  
OUTER COLLAR.

DC DROP TEST MUST BE REMOVED: 3, 7, 14, 25, 26, 29, 33, 35, 36, 37

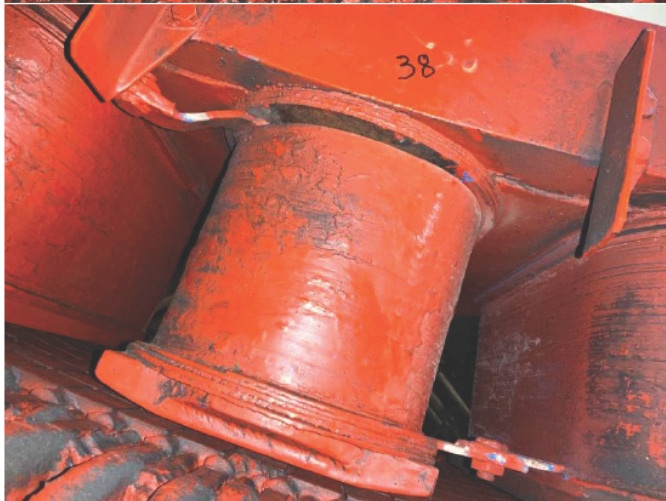
POLE 38 HAS A LARGE SECTION OF THE  
INNER POLE MISSING AND MUST BE  
REPAIRED.

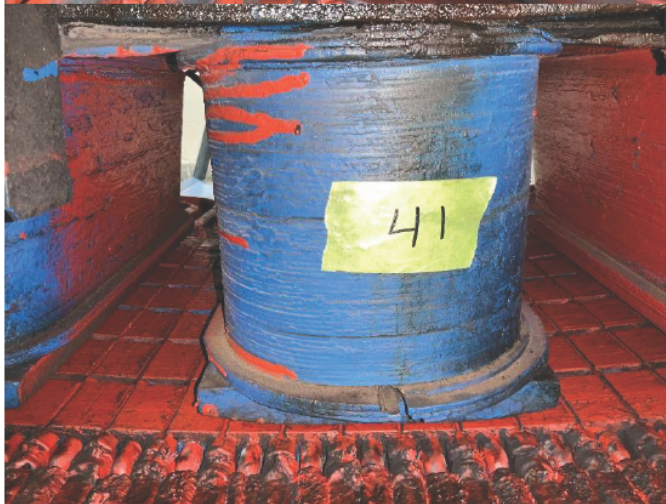
POLE 41 HAS A LARGE CRACK IN THE  
OUTER COLLAR WHICH COULD ALLOW  
MOVEMENT OR FAIL DURING  
OPERATION.

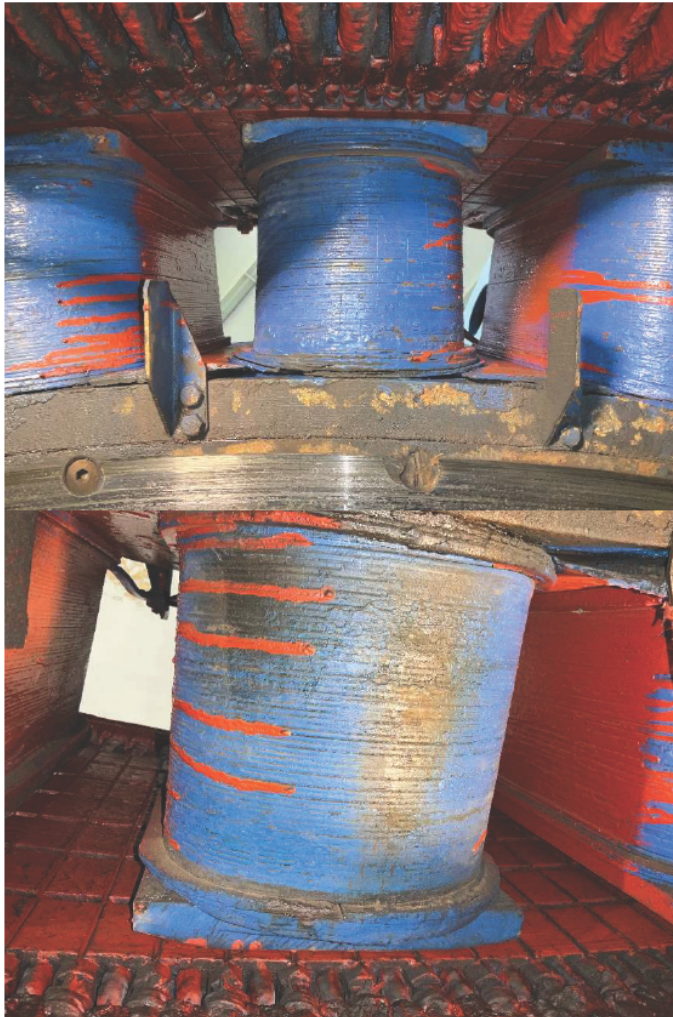
ALTHOUGH NOT A FULLY CTRACKED POLE THE PICTURE TO THE LEFT INDICATES AND EXAMPLE OF WHAT NTS HAD DOCUMENTED IN THE POLE DROP TABLE AS POOR.

THE POLE TO THE LEFT HAS MINOR CRACK IN THE OUTER COLLAR, THIS WOULD BE AN EXAMPLE OF A POLE WHICH WOULD HAVE BEEN IDENTIFIED IN NTS POLE DROP TABLE AS HAVE BEEN REPAIRED AT SOME TIME.
