## CONDITION ASSESSMENT and COSTED OPTION ANALYSIS: Factorydale Turbine Project – Berwick Electric Commission

| <b>Document Number (Hysovent)</b> | HSV-2024-043-CA01 |
| <b>Title</b> | Condition Assessment and costed option analysis:<br>Factorydale turbine project |
| <b>Customer</b> | Town of Berwick – Berwick Electric Commission |

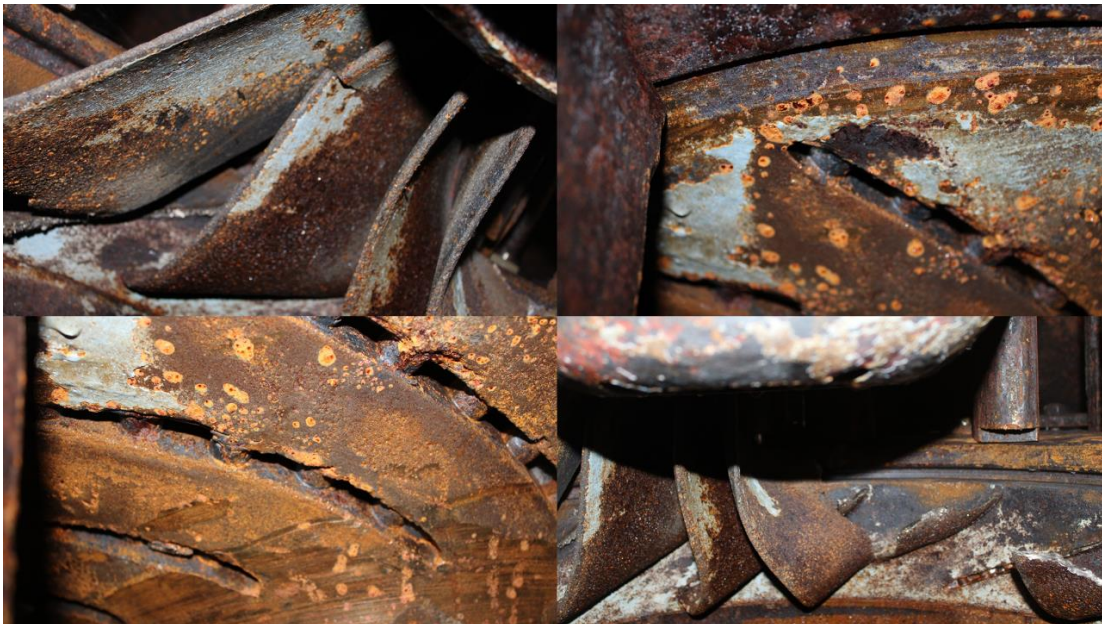
*Figure 3: Runner Damage*

In short, the runner is destroyed beyond repair.

On the Root Cause Analysis of the failure of the machine we will elaborate a little bit more about the runner destruction.

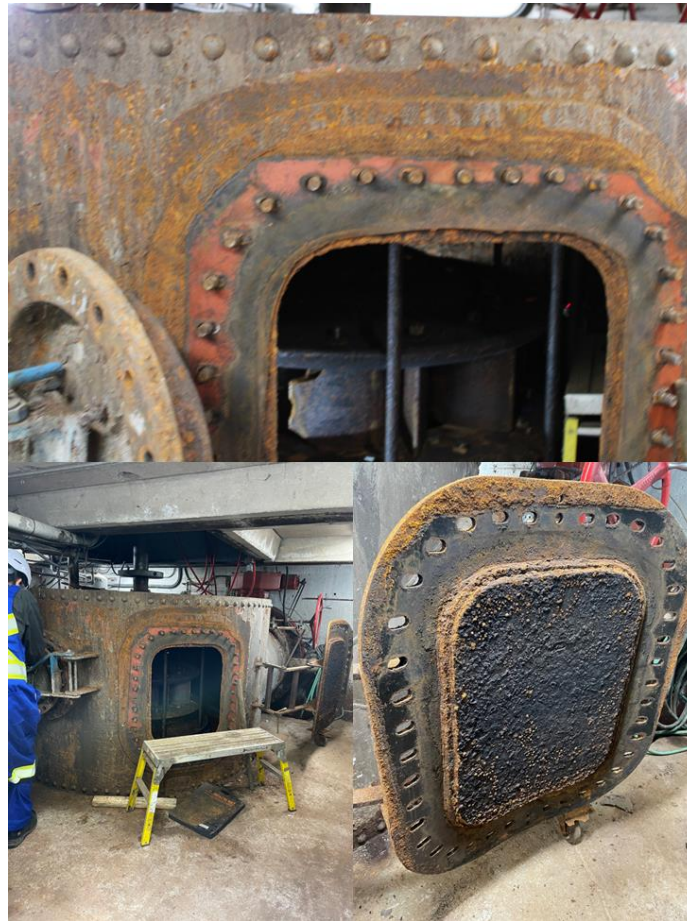
*Figure 6: More details about the scroll case*

The presence of corrosion is evident, inside and outside. The steel doesn't seem to be fractured though, and no leaks through it had been reported. But the headcover unions are where the leaks are present. There is no good seal between the headcover and the structure of the case, and water is always present during normal operations. The headcover is heavily corroded as well. No coating is left outside, and no epoxy coating was noticed inside either.

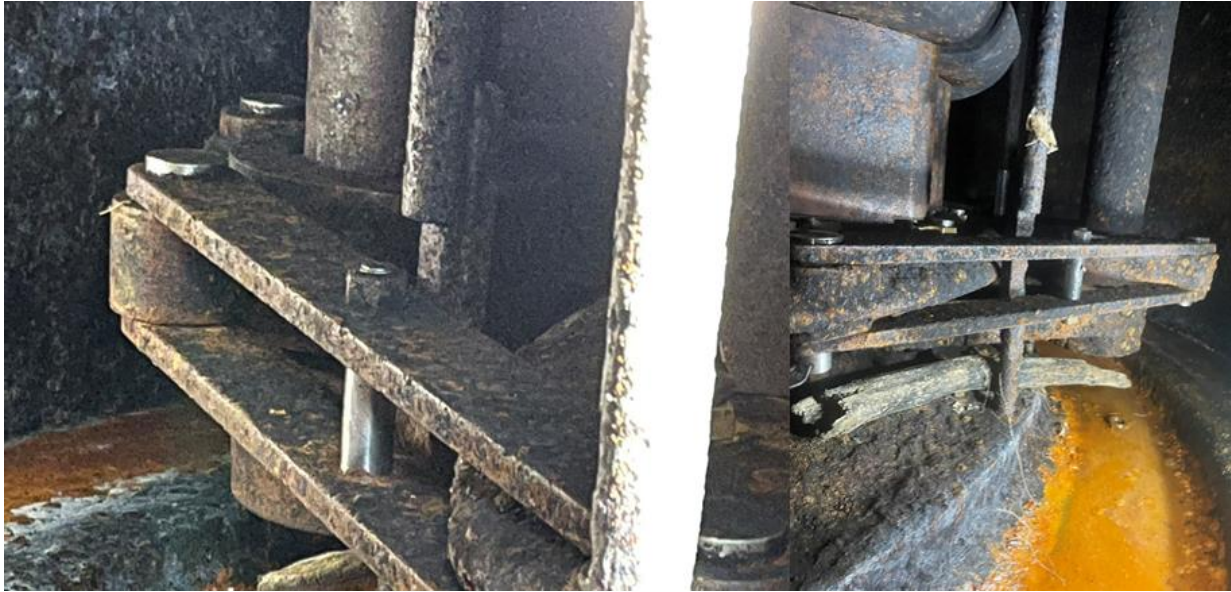
Now, a wooden branch approximately 2 ½" in Diameter and 14" long was found inside the scroll case.

While this is not likely the initiator of the destruction of the wicket gates and the runner, it indicates that large objects can get into the scroll case.

*Figure 9: Wicket Gate Mechanism Arms - left and right arms. Notice the wood log on the right picture.*

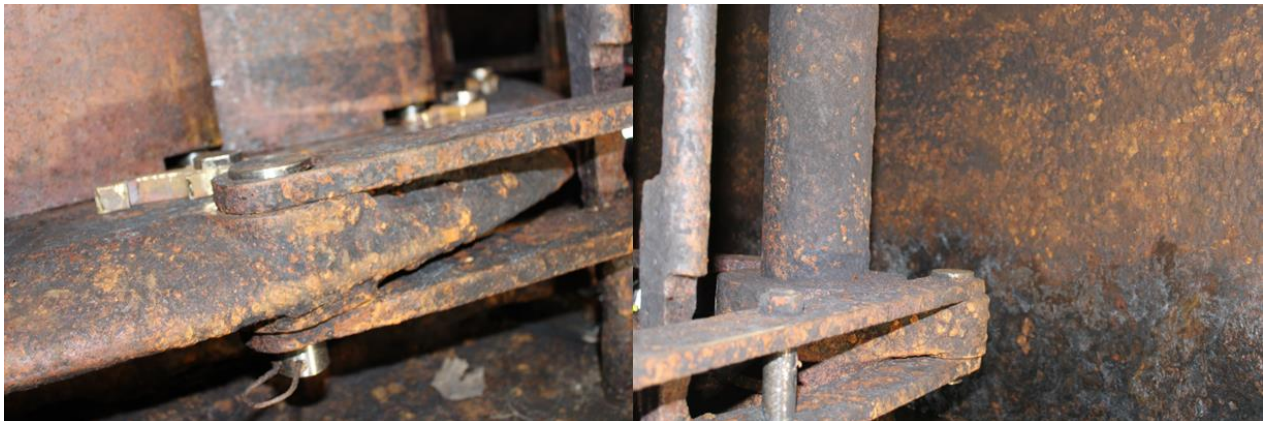
Same comment than the rest of the turbine components. The corrosion is evident. In this case, interesting though, the pins that connect the operating arms with the operating ring, and the pivot, are in fact in good condition. But they have been changed in the past, after failures, as there was the presence of damaged pins on the shop table. No signs of bending, or deformation on the arms, pivot, or shaft.

*Figure 10: Wicket Gate Mechanism Arms, details*

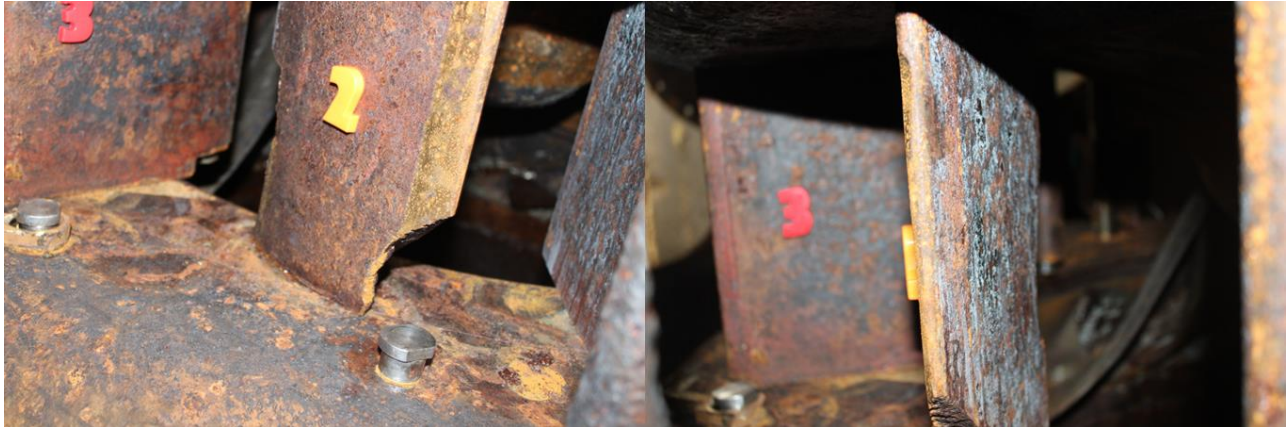
*Figure 12: Wicket Gate 02*

Both ends of the wicket gate are damaged, missing over 10% of its mass. The control pin and the control link are missing.

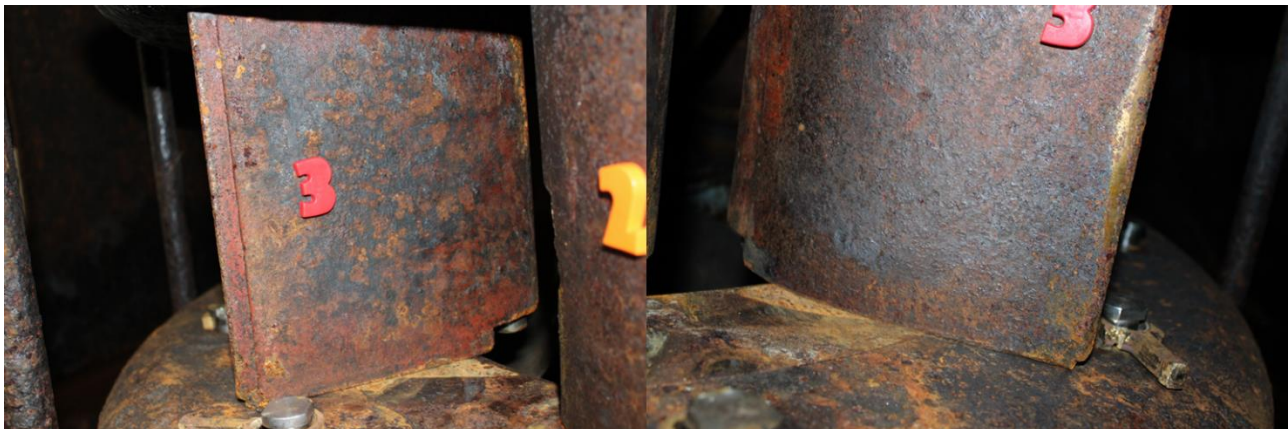
*Figure 13: Wicket Gate 03*

The control link of Wicket Gate 03 was found broken, and the wicket gate rotated 180 degrees. This was the position it was found, which proves that the wicket gate could have been rotating freely during the failure event. No major damage, other than small amount (1% or less) of missing material on the lower tip of the gate.

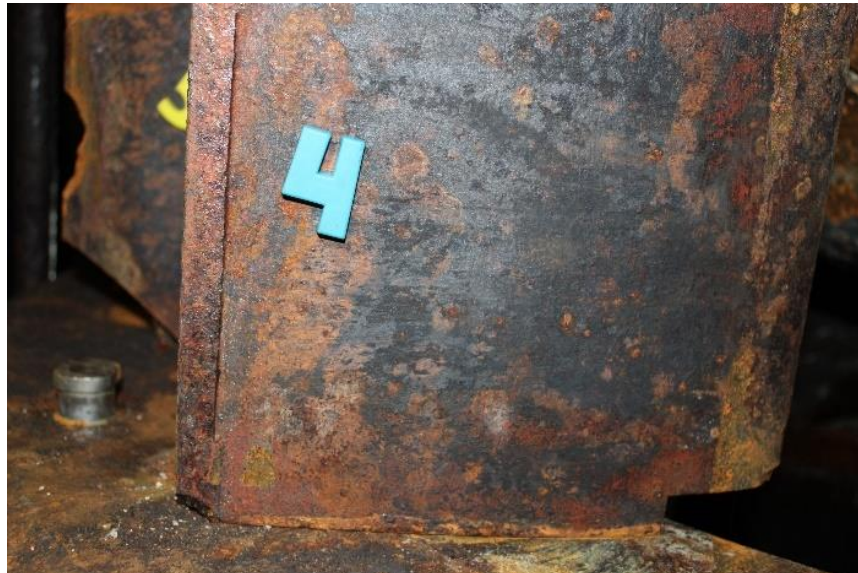
*Figure 14: Wicket Gate 04*

Missing control link and 180 degrees rotated was how we found Wicket Gate 04. No major damage, other than small amount (1% or less) of missing material on the lower tip of the gate. The link pin on the gate is missed as well.

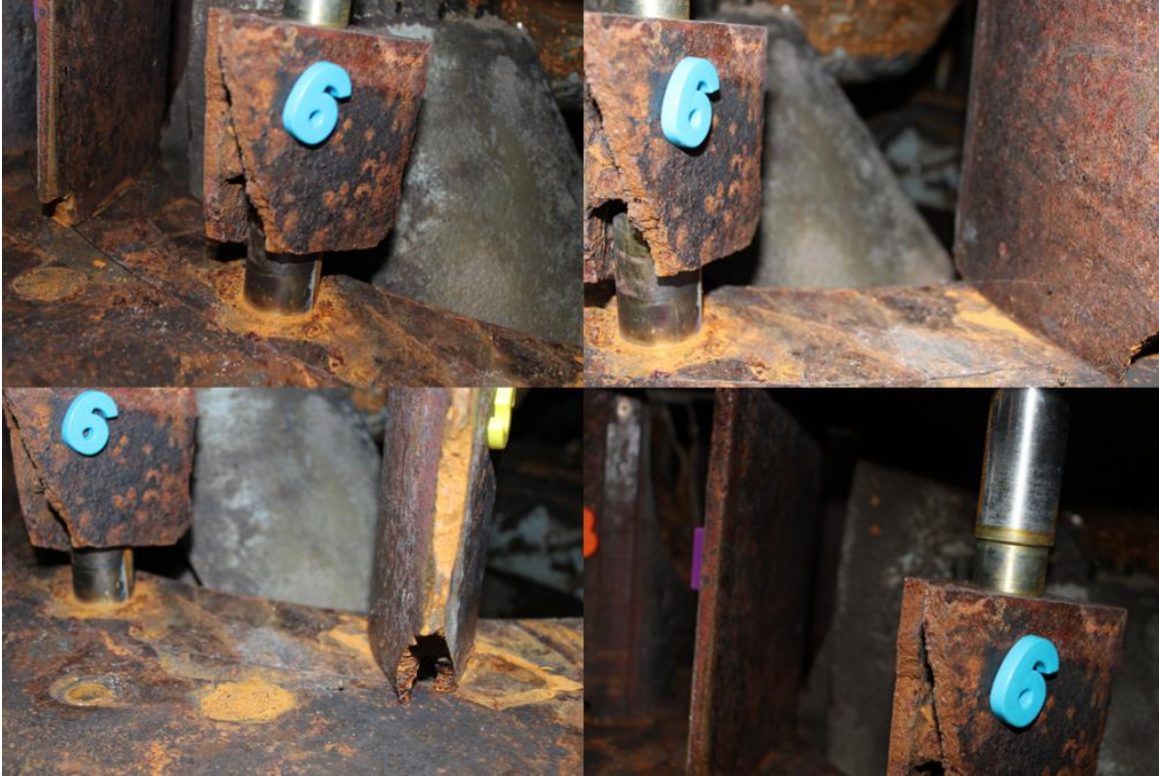
*Figure 16: Wicket Gate 06*

This is one of the most damaged ones. Only around 20% of the entire mass of the wicket gate remains. No signs of the rest.

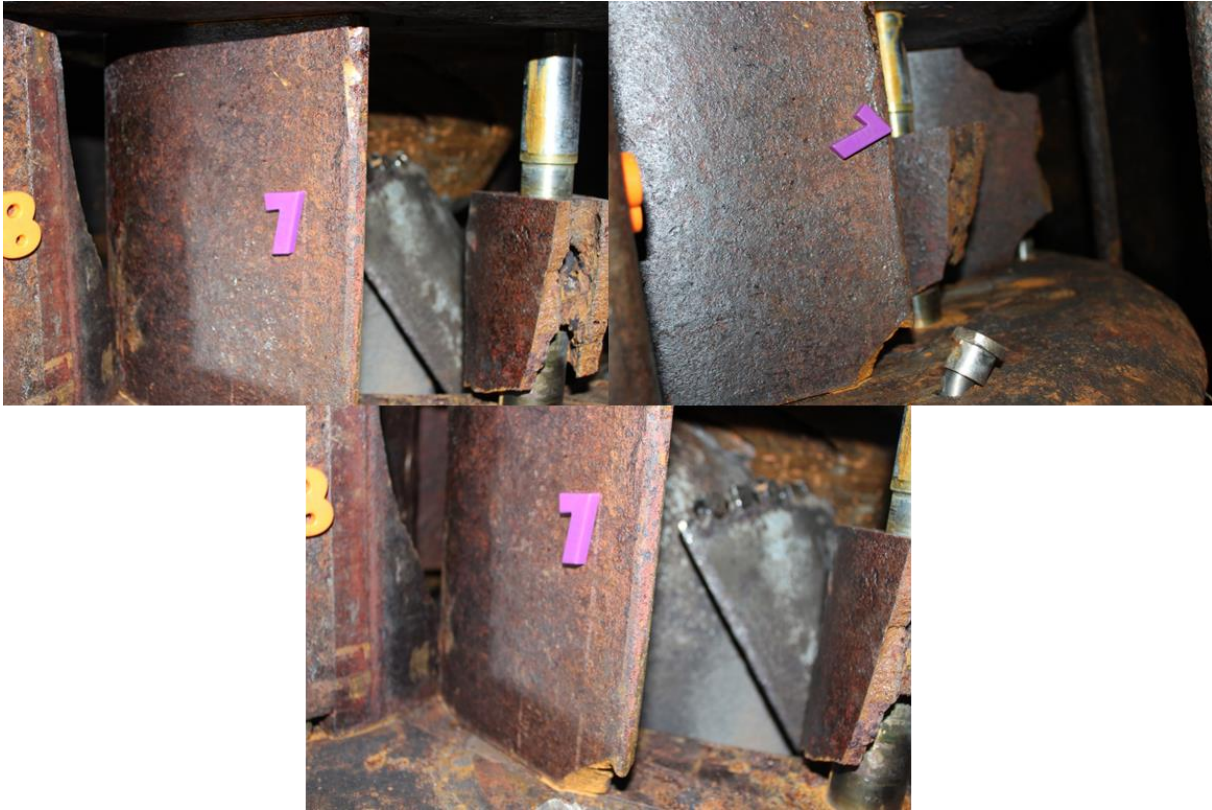
*Figure 17: Wicket gate 07*

This wicket gate only suffered damage on the lower tip of the edge. Most definitively caused by impact. Was found rotated over 180 degrees of its expected position. Control link completely destroyed.

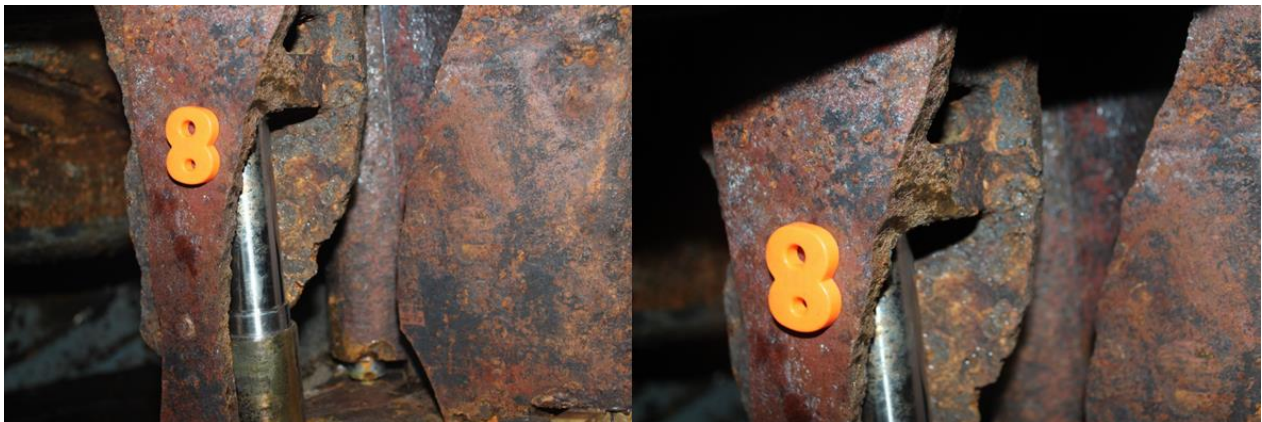
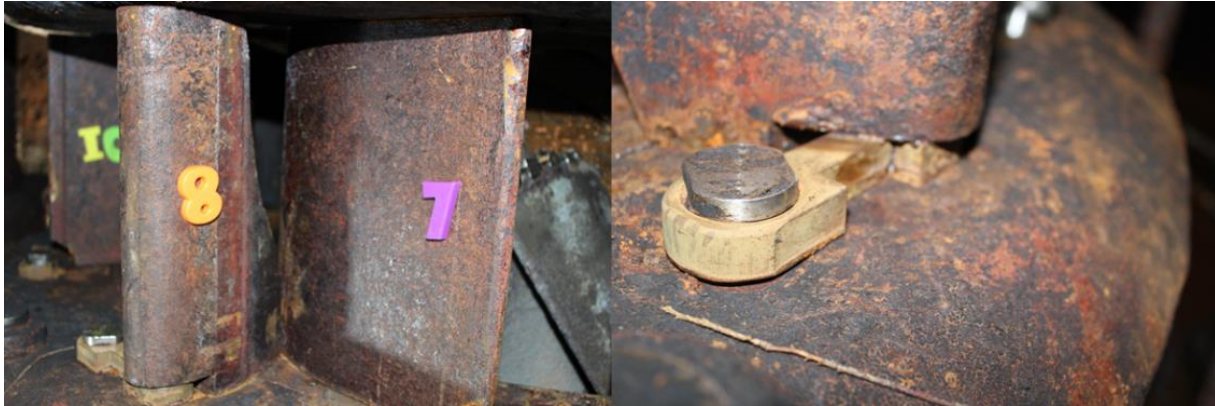
*Figure 18: Wicket gate 08, half attached to the pivot shaft*

*Figure 19: Wicket gate 8, half attached to the control link*

Of all the Wicket Gates, this one, and the missed number 14, are key to understanding one of the causes of the incident. The wicket gate was broken in two pieces, and the control link remained intact, and stuck in place, impossible to move. Let's remember that the link is made of bronze, way less resistant than the casting of the wicket gate, and it is designed to fail, as a “mechanical fuse”.

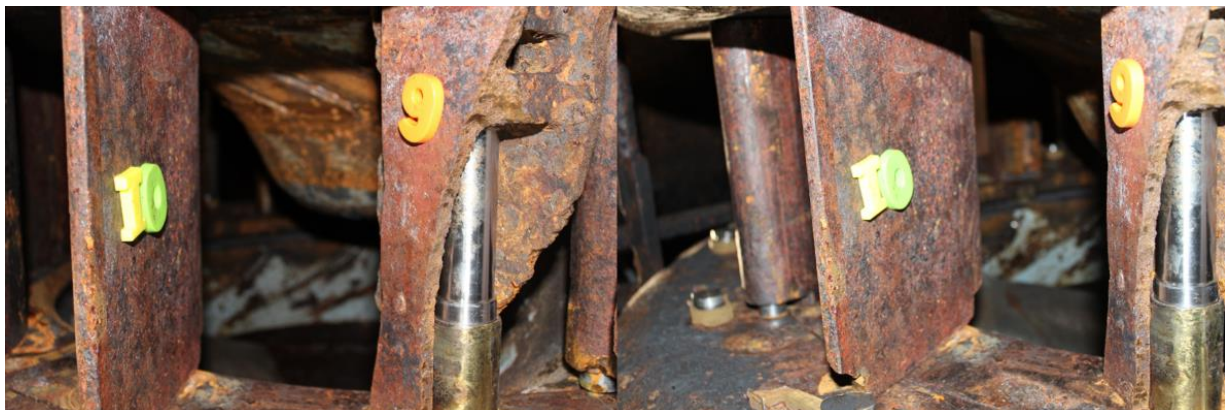
*Figure 20: Wicket gate 09 - In the picture is marked as Wicket gate 10*

We marked Wicket Gate 09 as 10 by confusion during our inspection. This wicket gate only suffered damage on the lower tip of the edge. Most definitively caused by impact. Was found

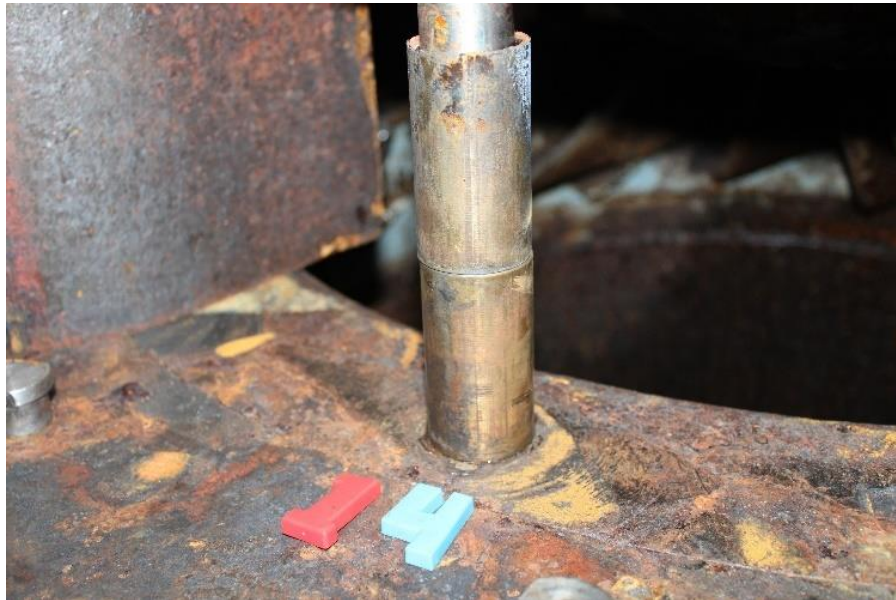
*Figure 25: Wicket Gate 14 shaft, the only remain*

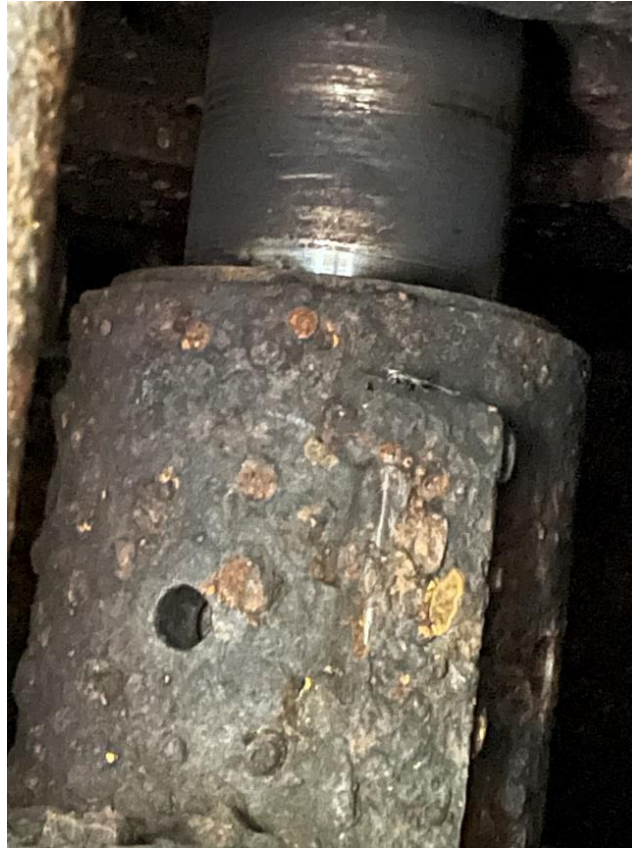
We didn't have access to the bearings because that would require a disassembly of the unit, but we saw the condition of the shaft on the area closer to the guide bearing.

*Figure 26: Runner shaft scoring*

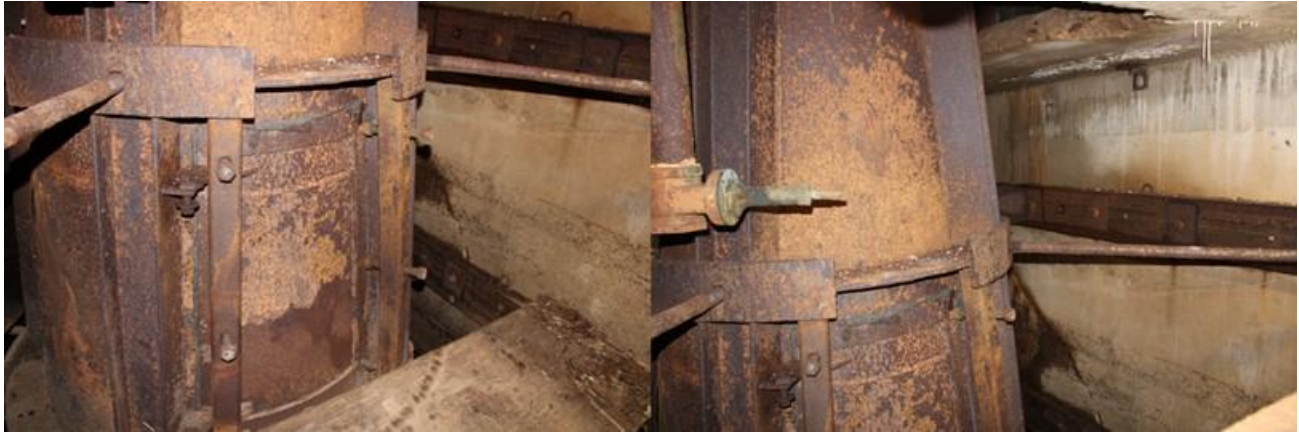
*Figure 27: Draft tube exterior, corrosion present, but expected, no damage noticed*

There are signs of corrosion outside the draft tube, we may assume that the inside, if it is not coated, is in similar condition. Proper NDE is recommended in this case to evaluate the structure of the draft tube. Replacement of the adjustment rods is required as well (the 8 rods, 4 at the top, 4 at the bottom, that adjust the vertical position of the draft tube).

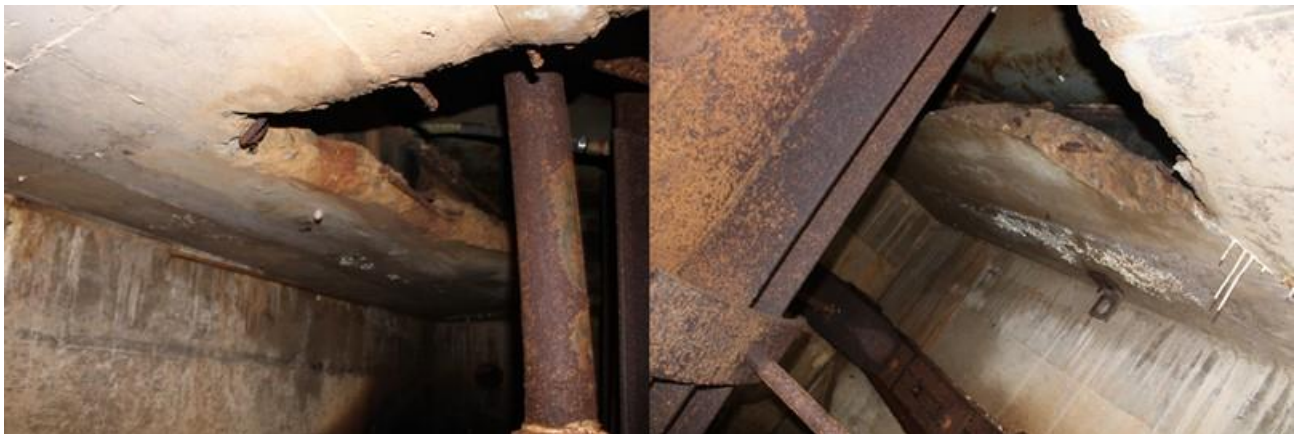
*Figure 28: Areas with concrete and rebar exposed*

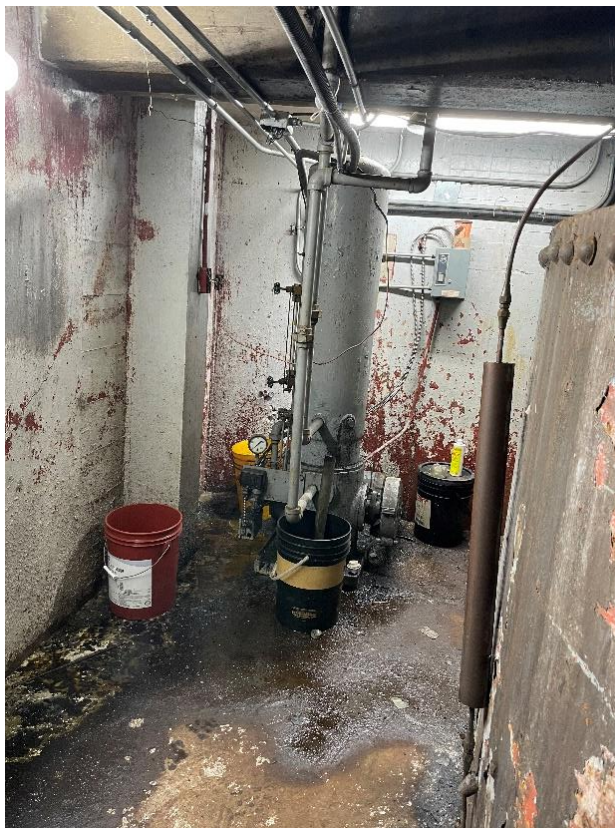
The governor had been through several modifications and repairs for the last 60 years, that is evident, but not all of them have been properly documented. It is not clean outside, and there are signs of oil leaks, something that as well was visible on the oil tank located on the turbine level.

*Figure 33: Governor Oil tank, turbine level*

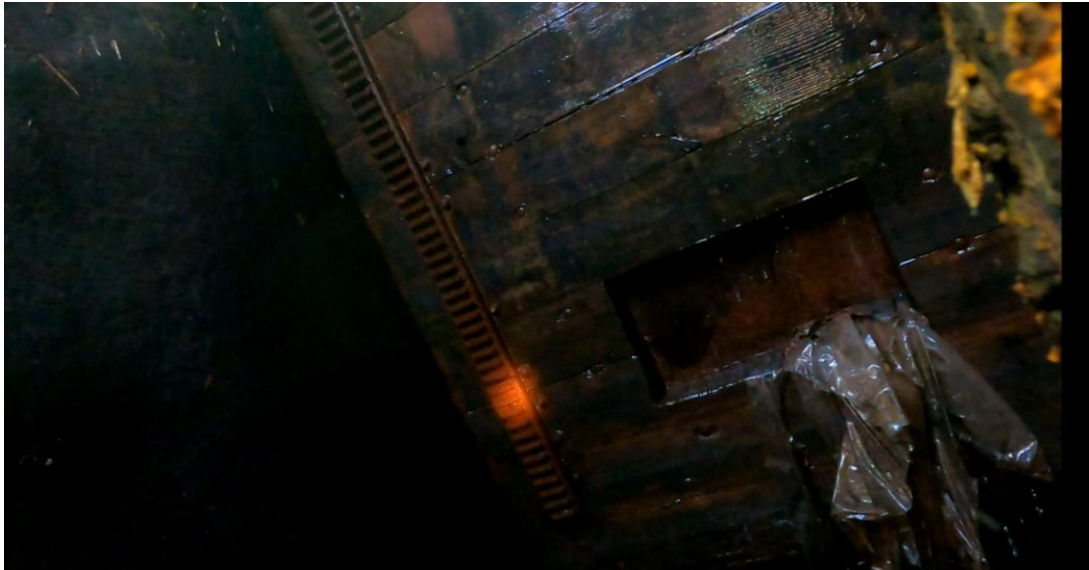
Wooden intake gate, manually operated, in good condition in general.

*Figure 38: Intake Gate*

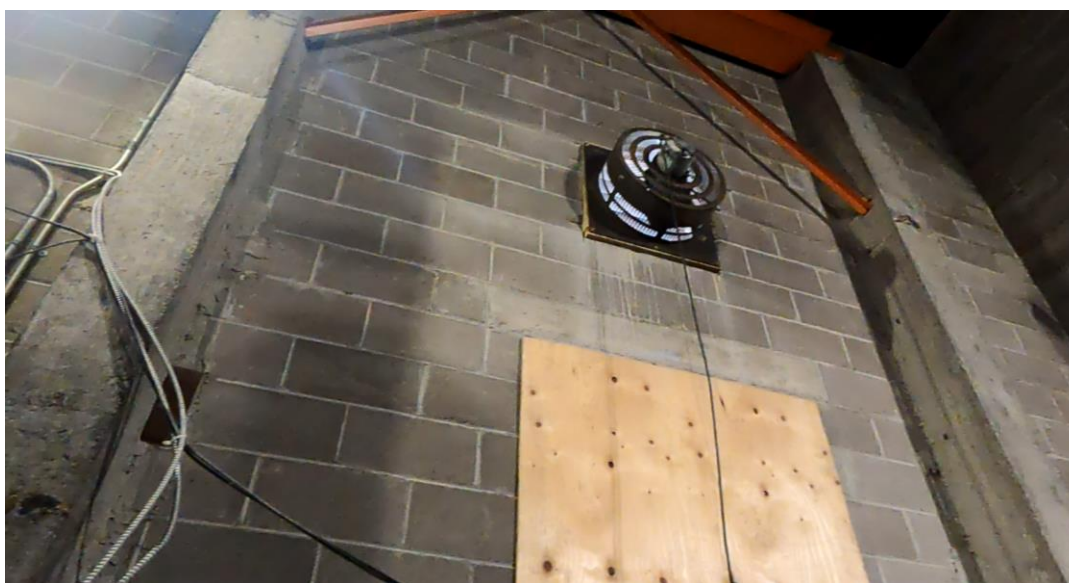
Figure 39: Columns, west side, in very good shape

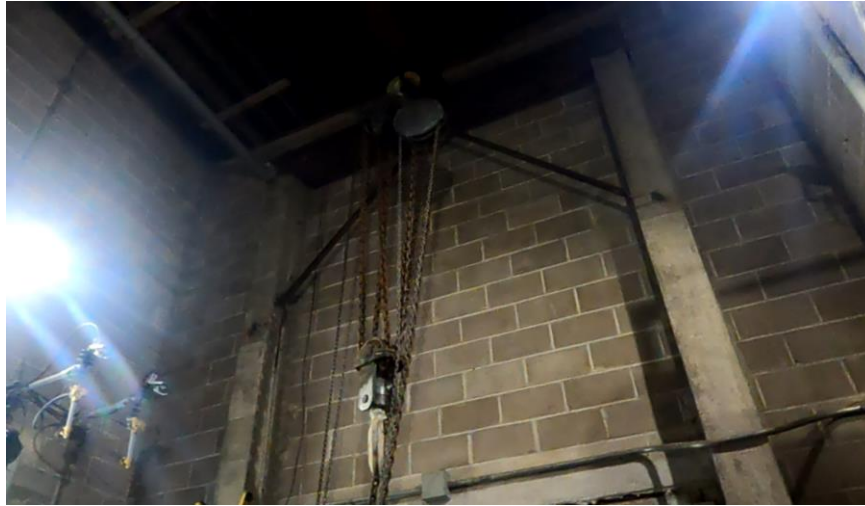
*Figure 40: Columns and crane, east side, very good condition*

We didn't notice any cracks or damage to the columns on this level.

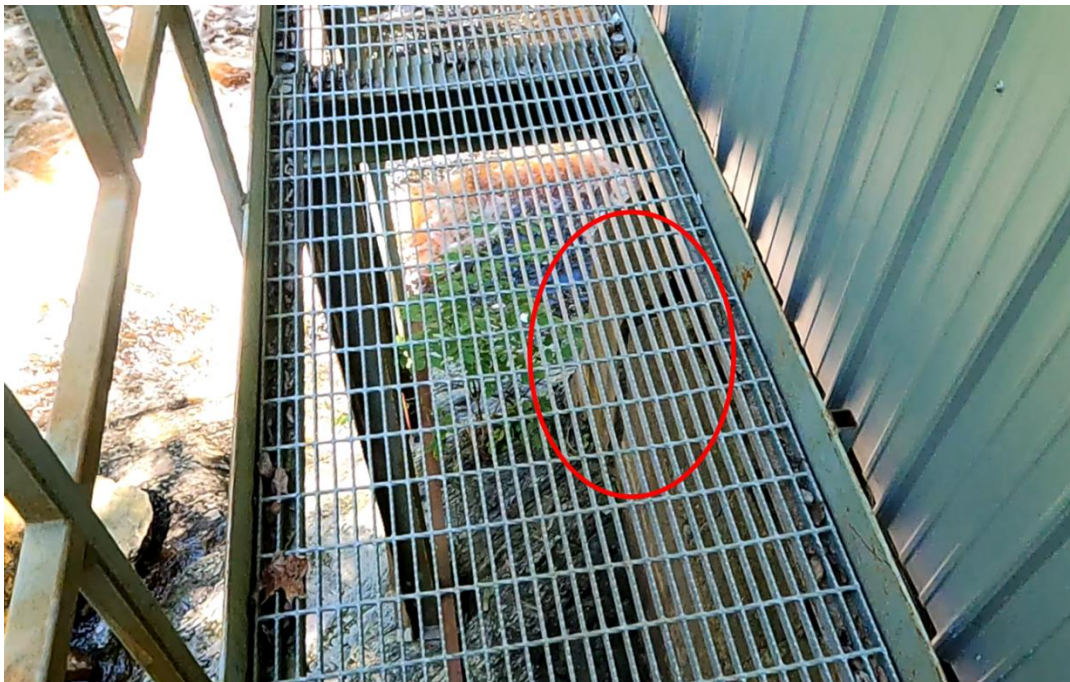
Just below the building annex, a retaining wall is present, which looks like is original from the plant. The only drawing that we had access to does not shown this wall. It has a crack, that has been growing over the years apparently, and basically separated the wall in two.

*Figure 44: Crack on the retainer wall*

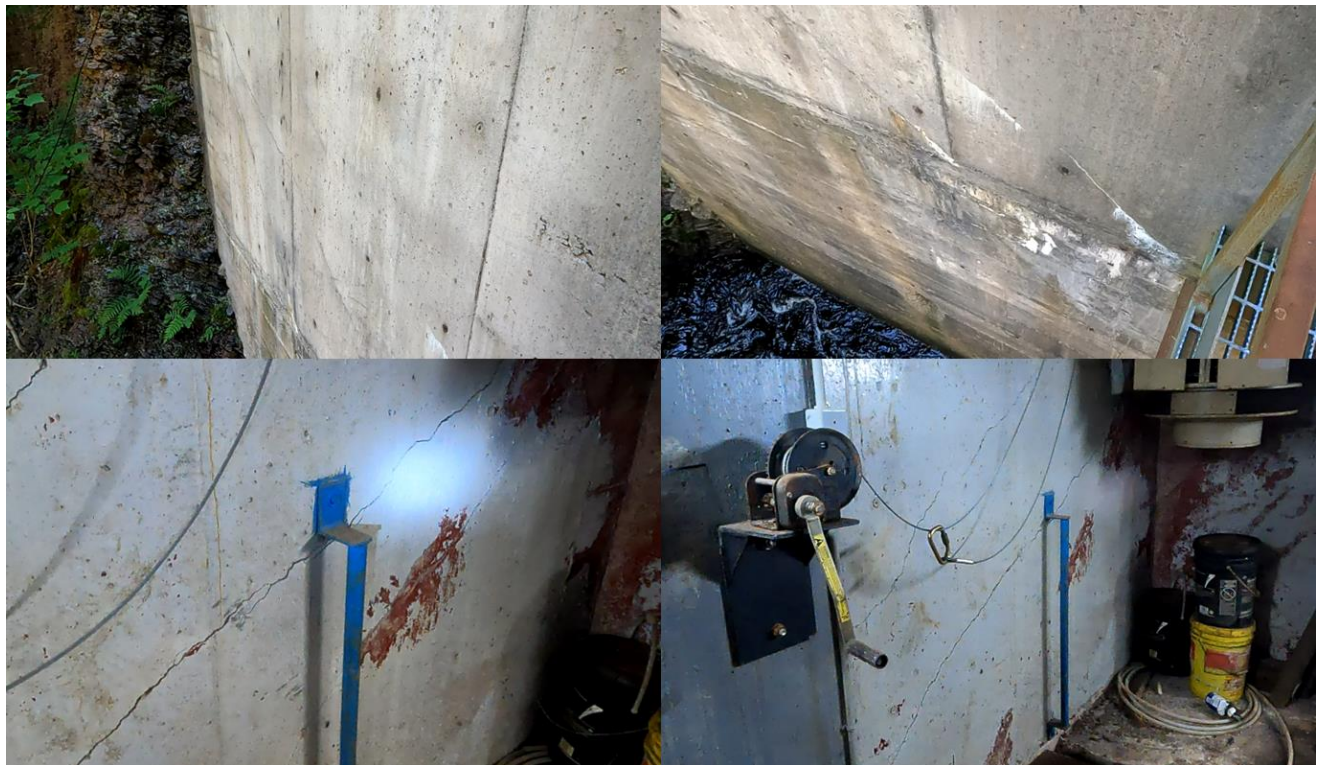
*Figure 45: North wall crack*

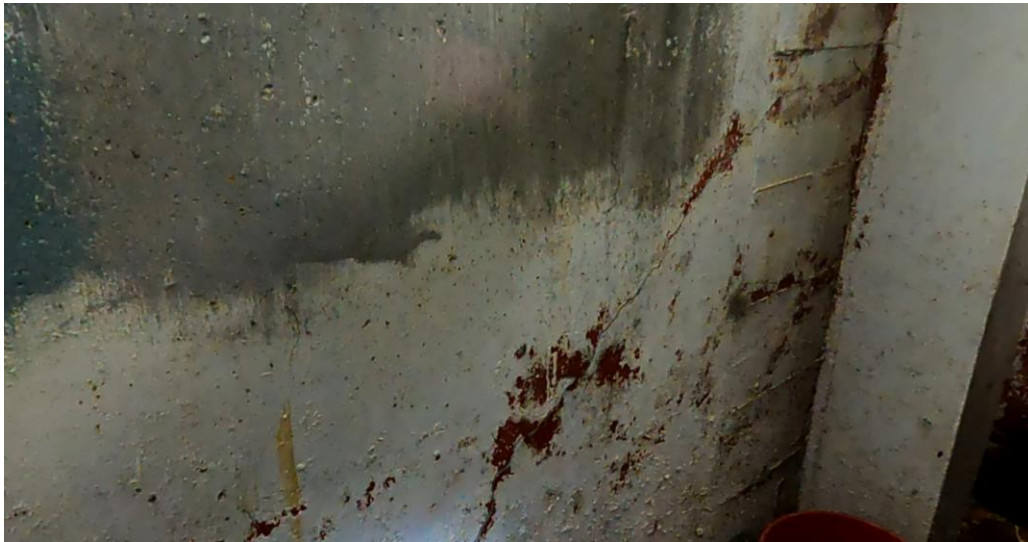
*Figure 46: East wall crack*

This wall is fully below-grade, we cannot see the other side of the wall to evaluate if goes through the entire section, so we will assume that it goes through. What took our attention is that there is another crack at the upper section on the wall that continues to the south-east column.

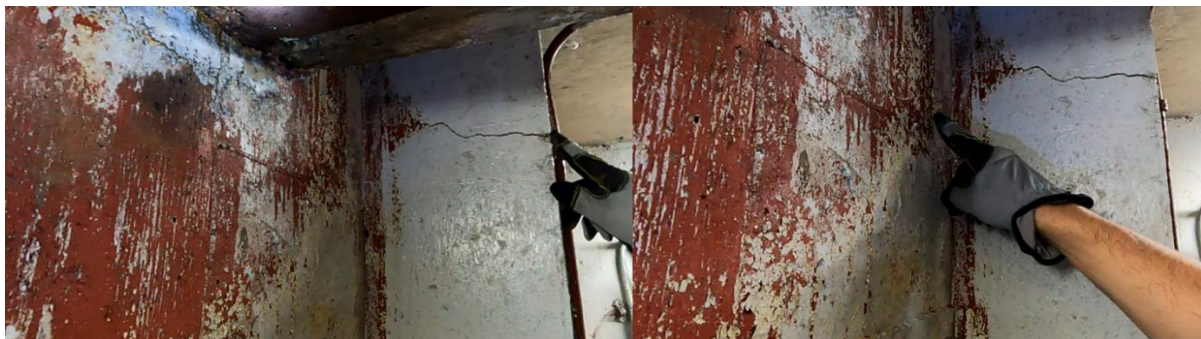
*Figure 47: Crack on the east wall, that goes through the south-east column*

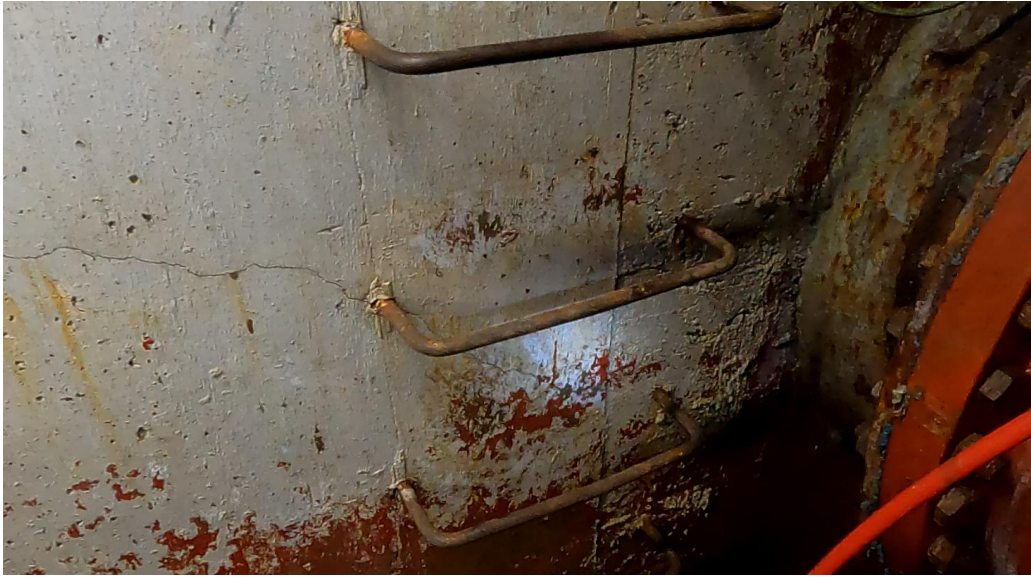
This is another crack in a wall that is fully below grade. We cannot see the other side of the wall so we will assume that it goes through the entire section of the wall.

*Figure 48: Crack on the South wall*

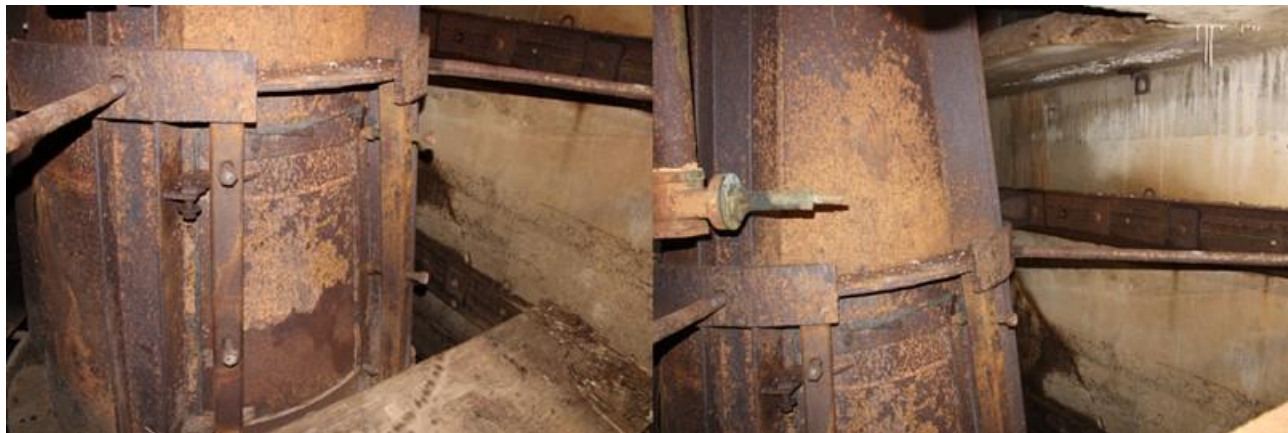
*Figure 50: Draft tube exterior, corrosion present, but expected, no damage noticed*

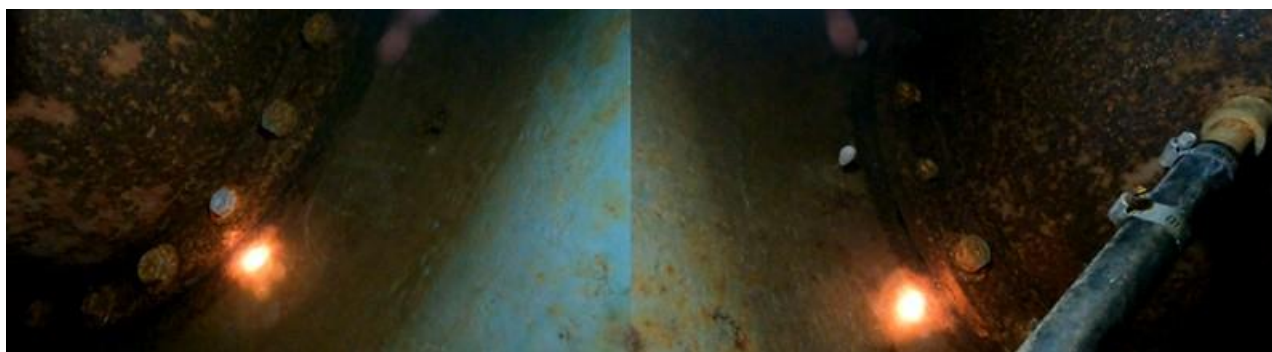
*Figure 51: Bolts that attach the curb plate/scroll case to the draft tube, nothing out of normal*

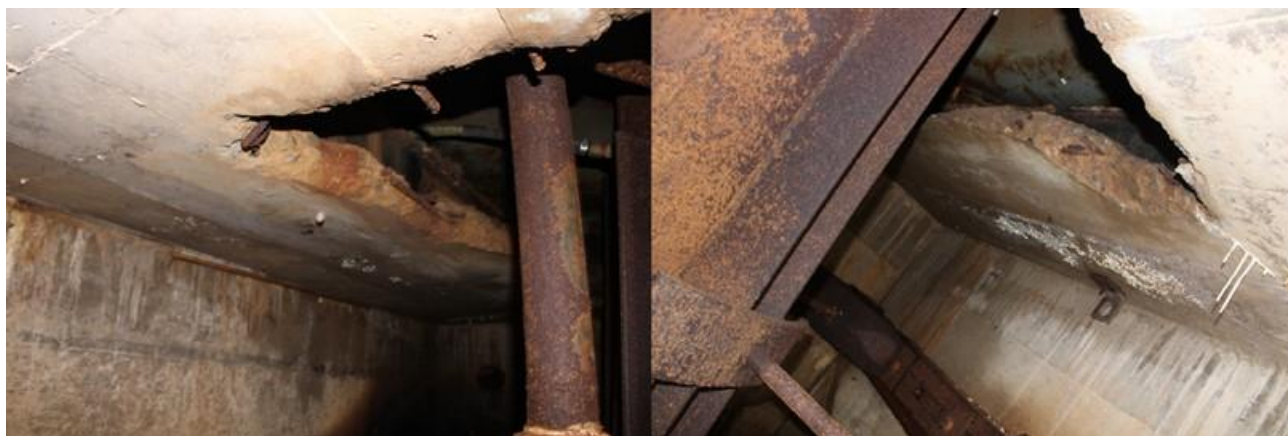
*Figure 52: Areas with concrete and rebar exposed*

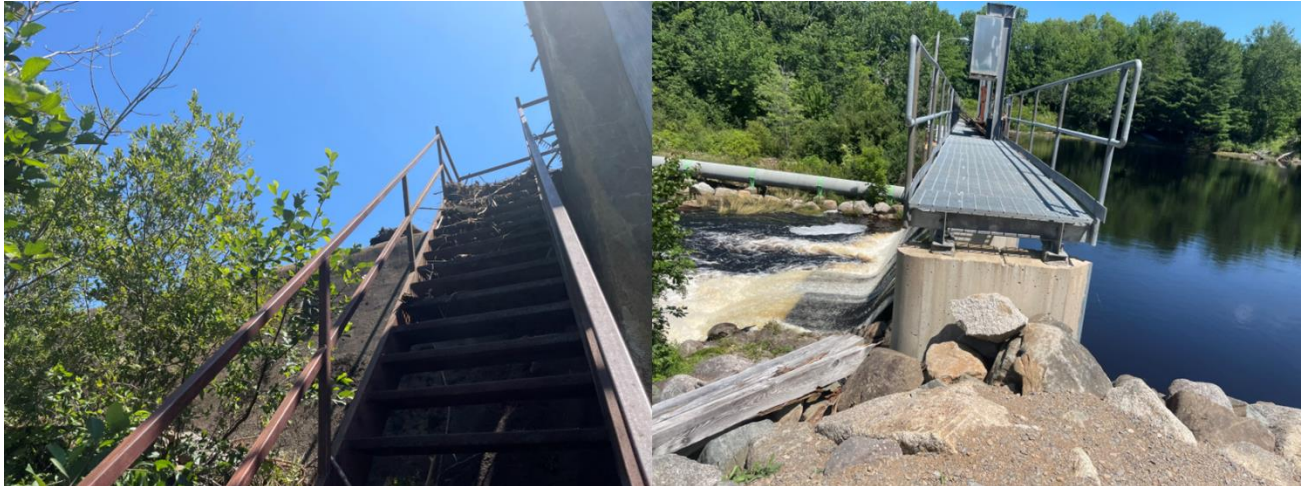
*Figure 56: Dam Access points are unsafe*

The first observation is that it is not very safe to access the dam itself. From the west side, the stairs are full of debris. And there are a lot of plants and trees that must be cleared to guarantee a proper way to access the area. On the east side, even though the catwalk looks very new, the design forgot to put a step to safely access the crest of the dam. Currently is relatively difficult and increases the chances of slip, trips and falls to access it.

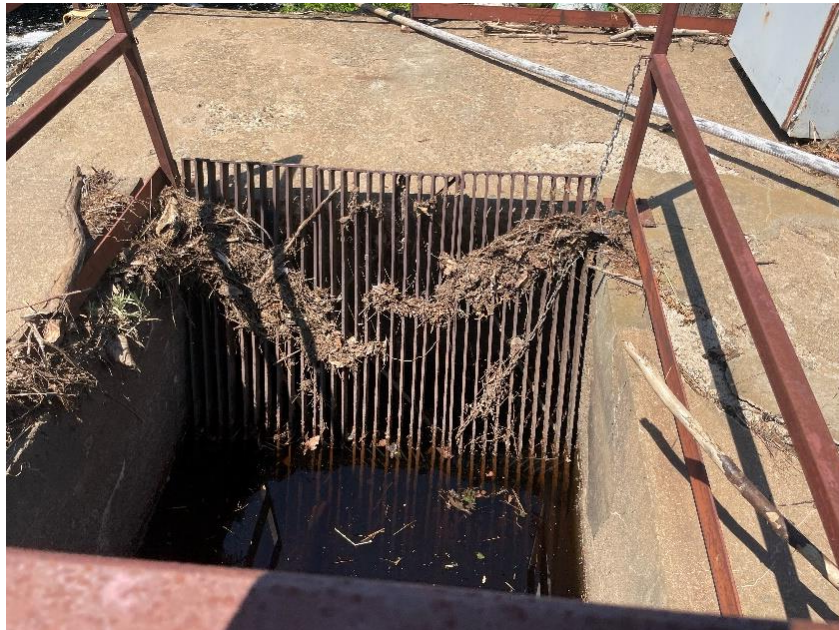
*Figure 57: Trash rack*

The trash rack is very dirty, and full of debris. Requires cleaning. In a future stage, we would recommend substituting it for a newer non metallic trash rack.

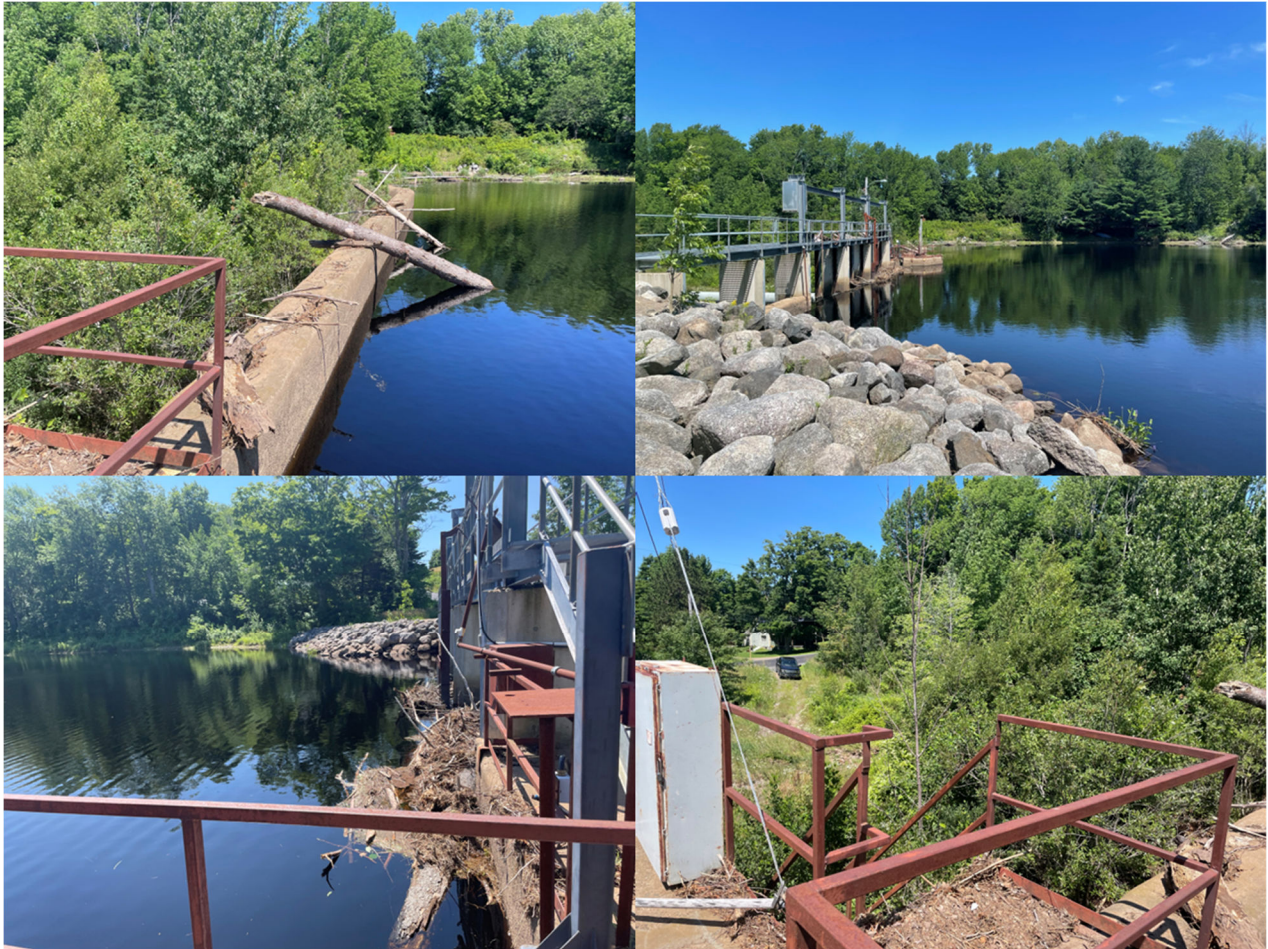
*Figure 58: Debris across the dam*

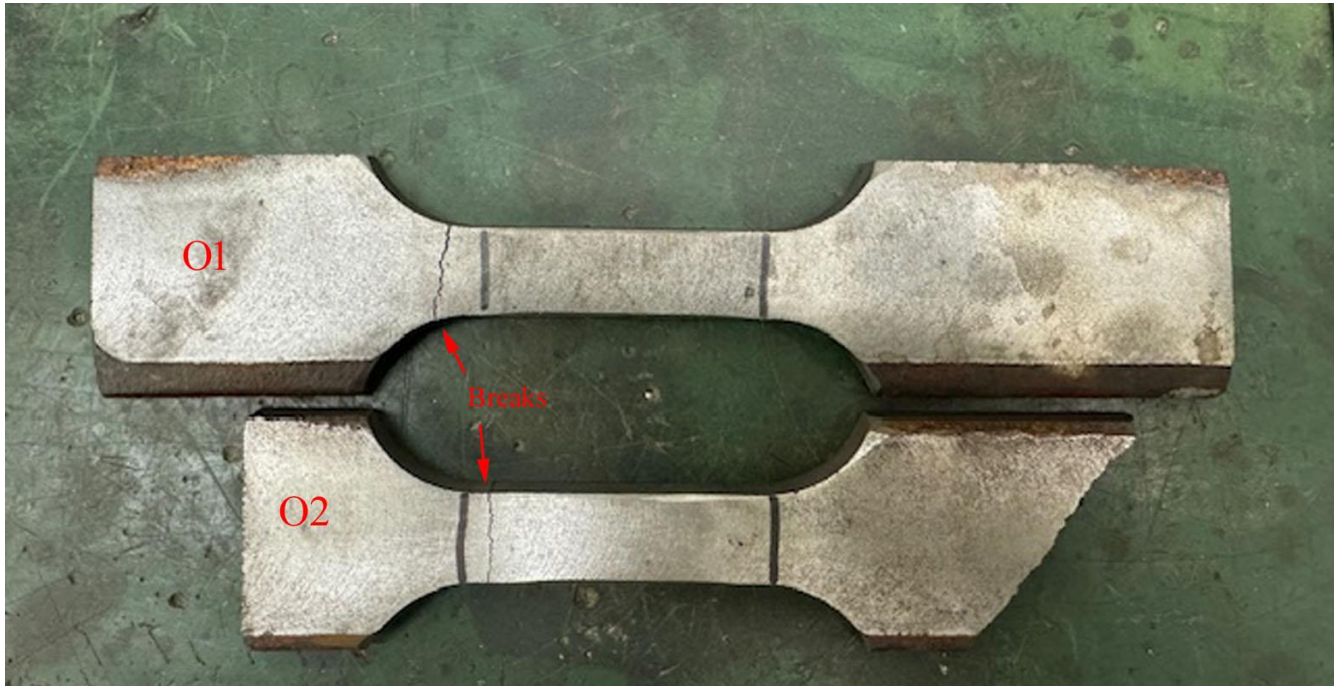
The strength of the O2 casting (62.24 MPa, 9,027 psi) was considerably less than that of the O1 casting (74.21 MPa, 10,763 psi). The 10,763 psi strength value for the O1 casting fractured in the shoulder area of the tensile sample as shown in the Figure 1 image. There was no defect or flaw in the casting noted visually, but the microstructure may have been weaker in this area.

It broke on the shoulder of the reduced section indicating it may have had a defect in that area.
