## CONDITION ASSESSMENT and COSTED OPTION ANALYSIS: Factorydale Turbine Project – Berwick Electric Commission

| <b>Document Number (Hysovent)</b> | HSV-2024-043-CA01 |
| <b>Title</b> | Condition Assessment and costed option analysis:<br>Factorydale turbine project |
| <b>Customer</b> | Town of Berwick – Berwick Electric Commission |

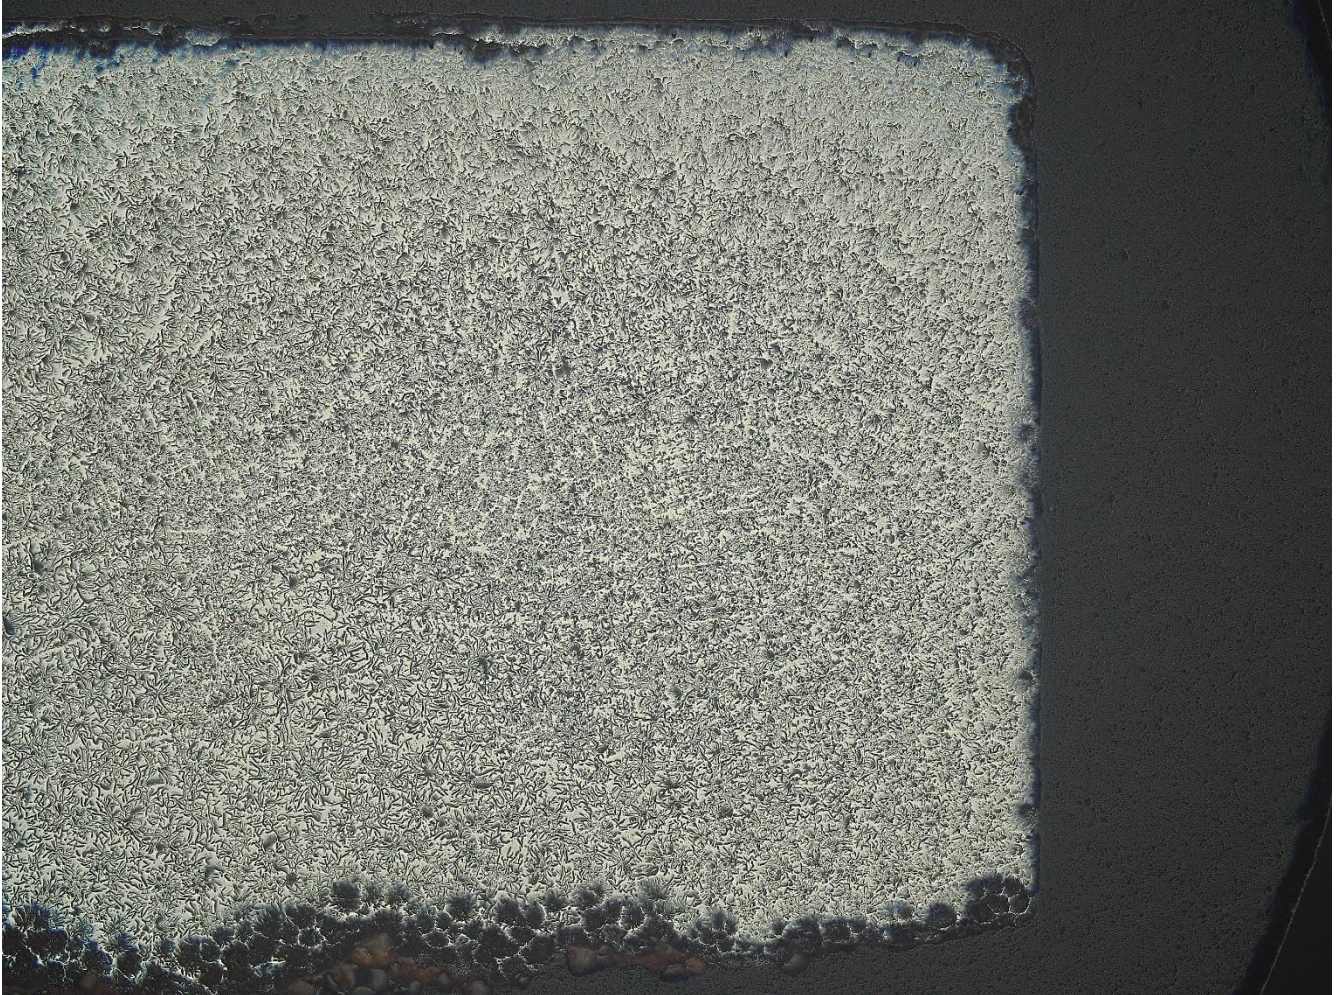
The microstructure was graphite flakes as expected for gray cast iron but there were undesirable rosette formations and the graphite flake size was larger than desired. The polished cross sections are shown in the unetched condition in figures 1 and 2.

*Figure 1 O1 L Unetched microstructure showing dendritic center 20x*

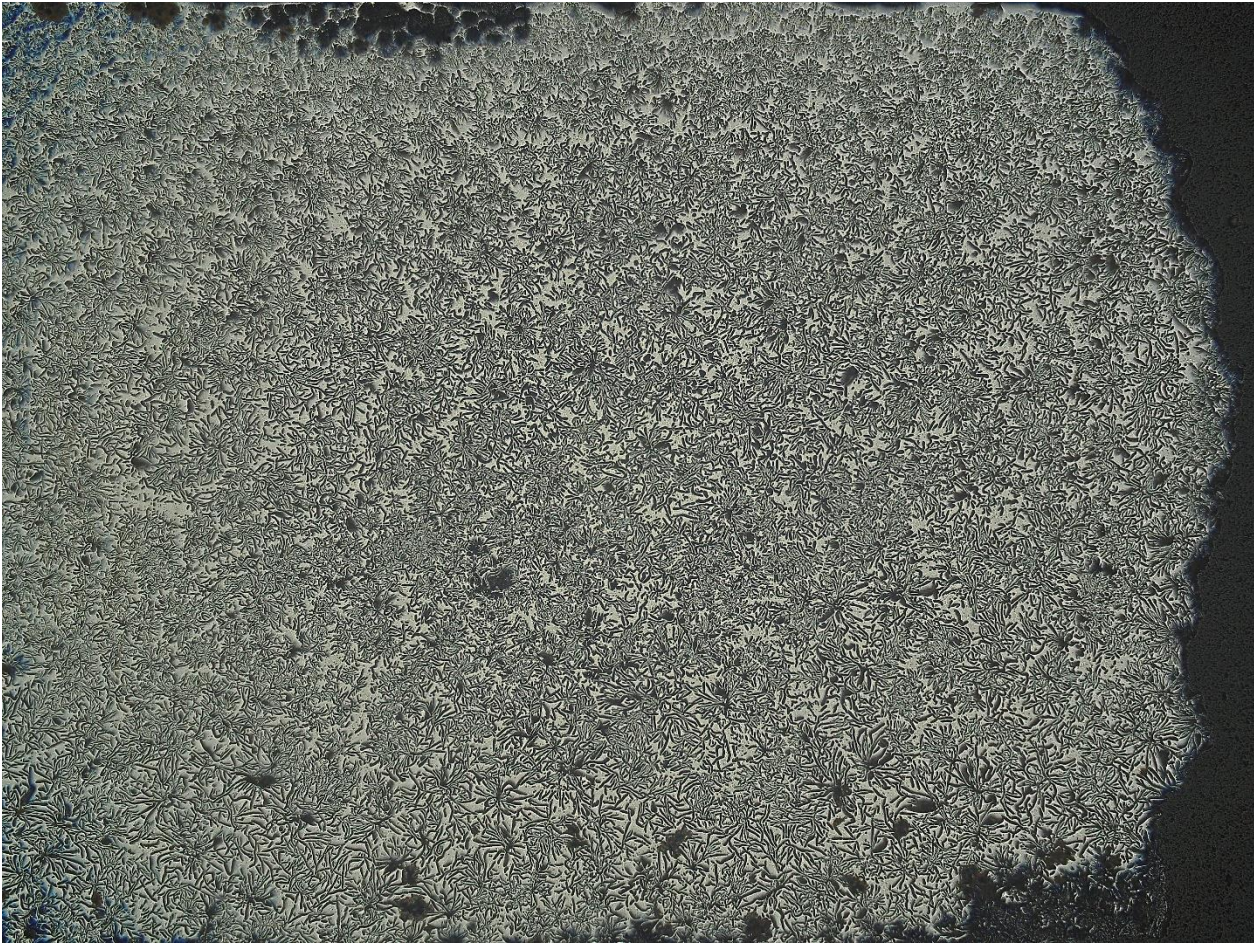
*Figure 2 O2 L Unetched microstructure showing dendritic center 20x*

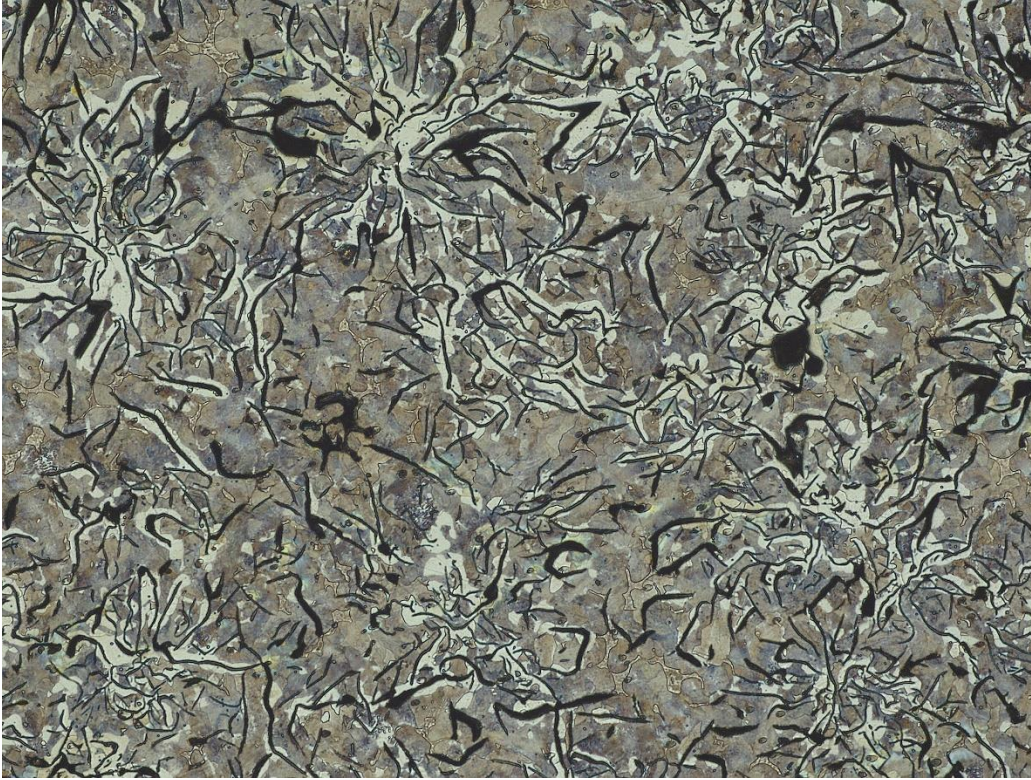
At 200X magnification in Figures 2 and 3 the dark graphite flakes can be seen in the rosette pattern in the etched microstructure. The matrix is the dark brown pearlite, along with areas believed to be ferrite. The graphite can be classified as type B, rosette grouping, random orientation or type D, interdendritic segregation, random orientation. The white ferrite is a softer phase that can lead to weakness in the microstructure, particularly if it is continuous.

*Figure 3 O1 L etched microstructure showing rosettes 200X*

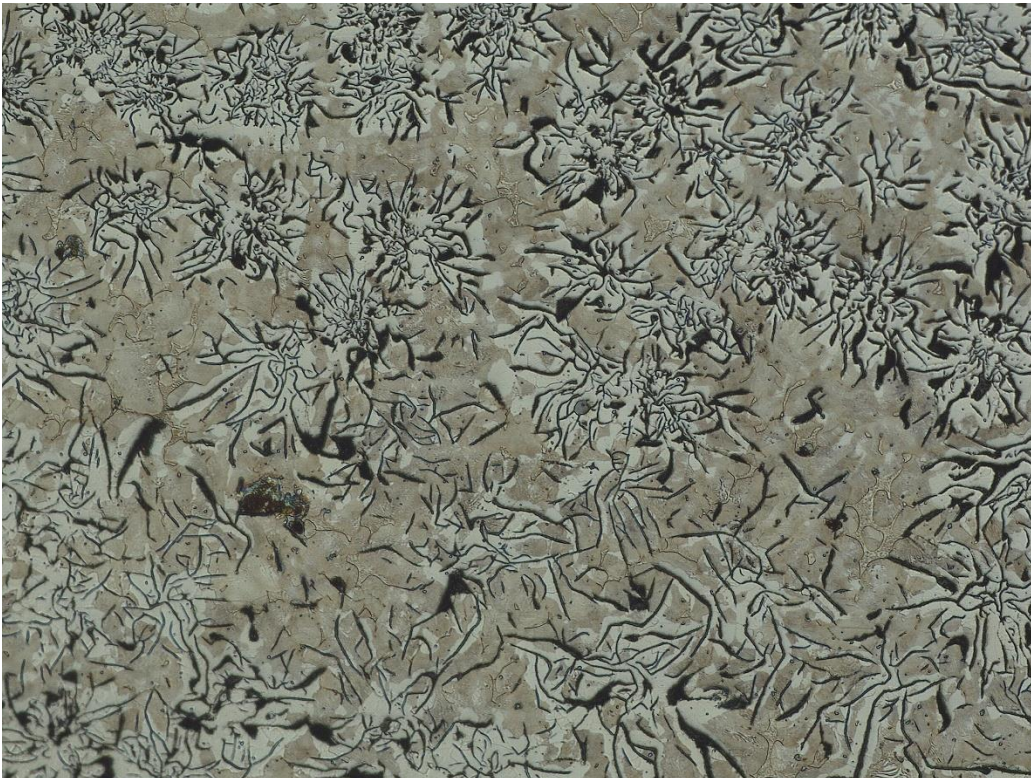
*Figure 4 O2 L Unetched microstructure showing rosette formations near outside 200x.jpg*

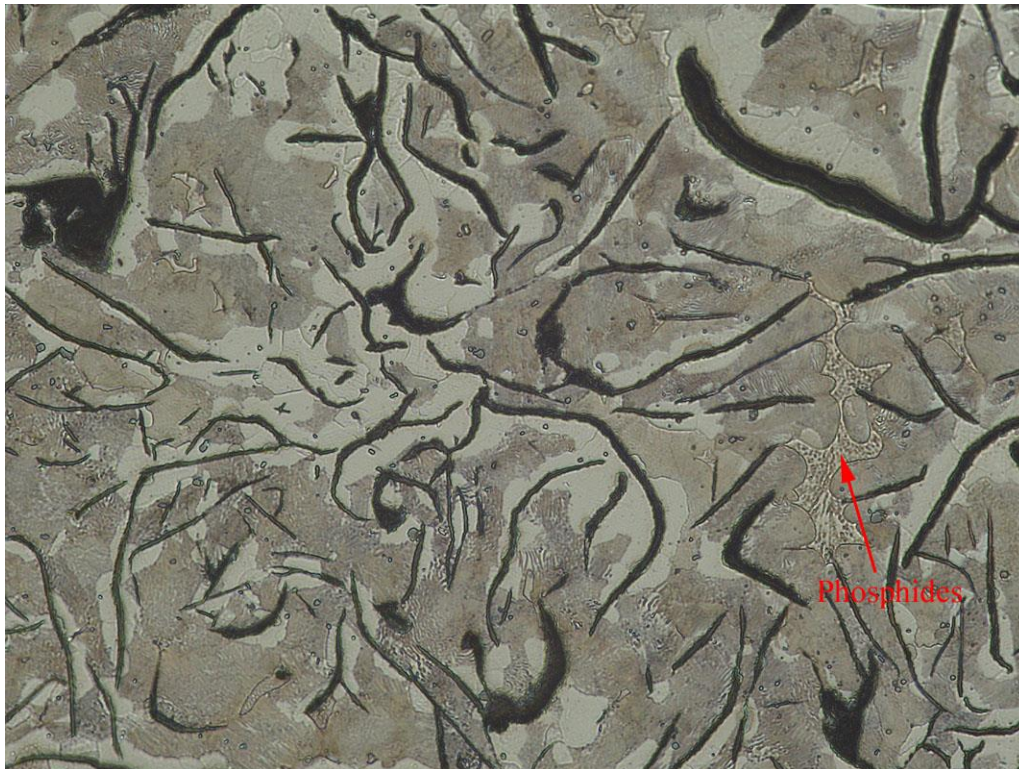
The whiteish lines through the microstructure that indicate dendritic cooling are evident. At greater magnification in Figures 5 and 6 there are phosphides apparent in the microstructure.

Figure 6 O2 T etched microstructure showing pearlite, phosphides 500x

The presence of phosphides weakens the microstructure along with the ferrite and larger graphite that is in rosette grouping. It is likely that the cause of the lower strength of the wicket gate materials is from these abnormal microstructures.

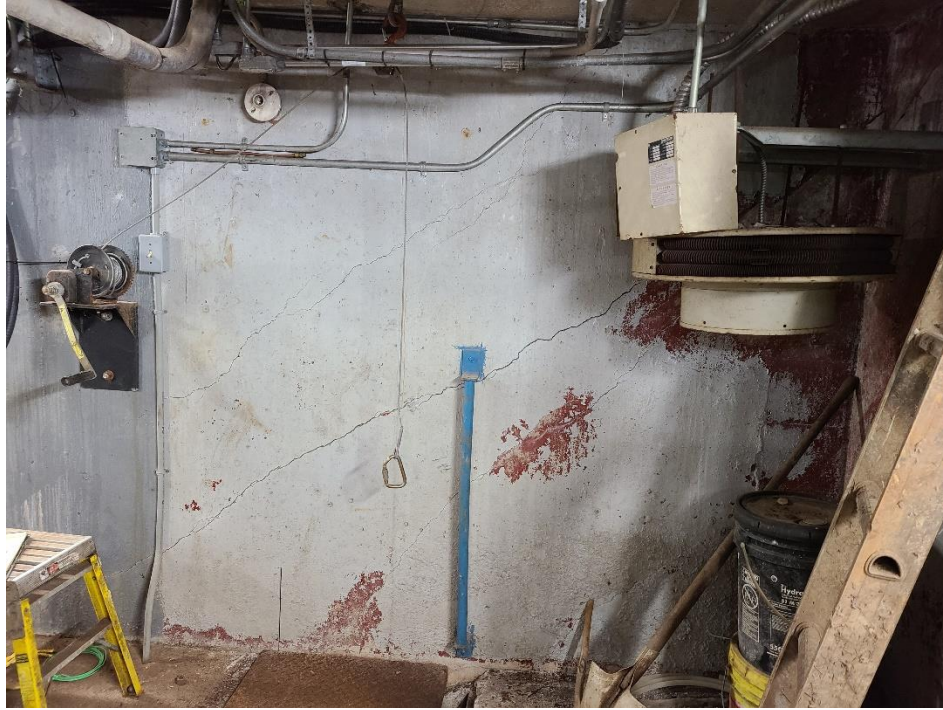
3. Cracks in North concrete wall at intermediate level.

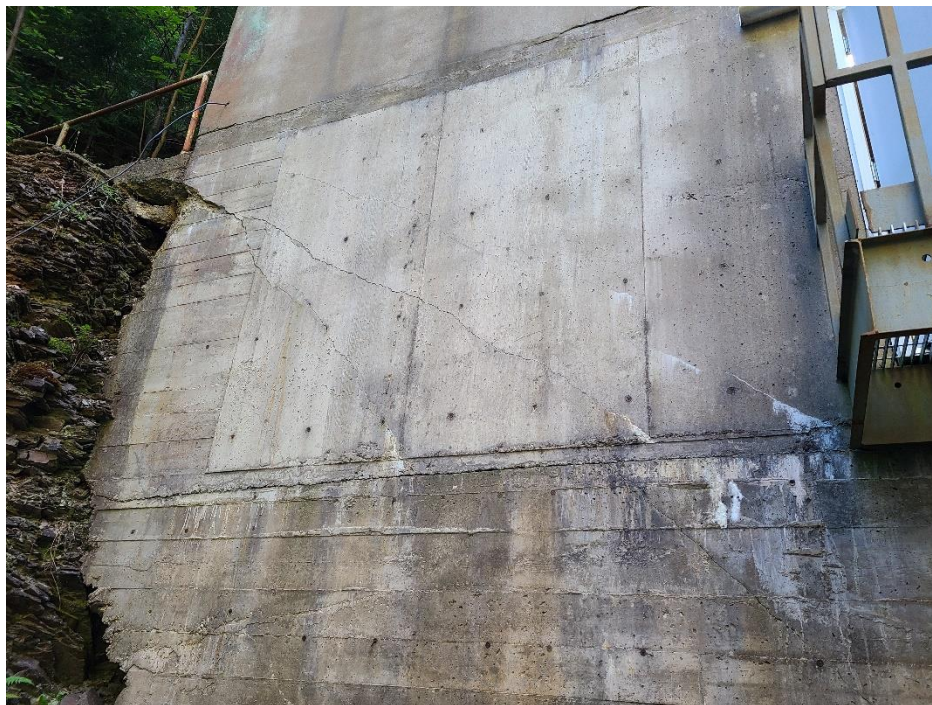
4. Wall cracks from previous photo on the exterior surface of the wall.

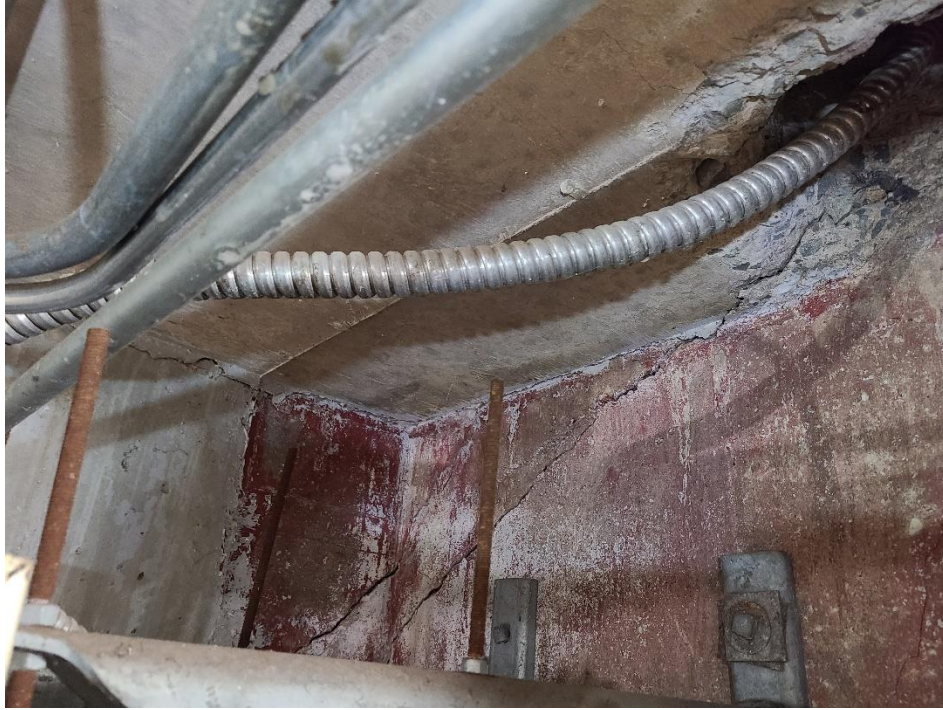
5. Interior wall cracks at northeast corner, Intermediate level.

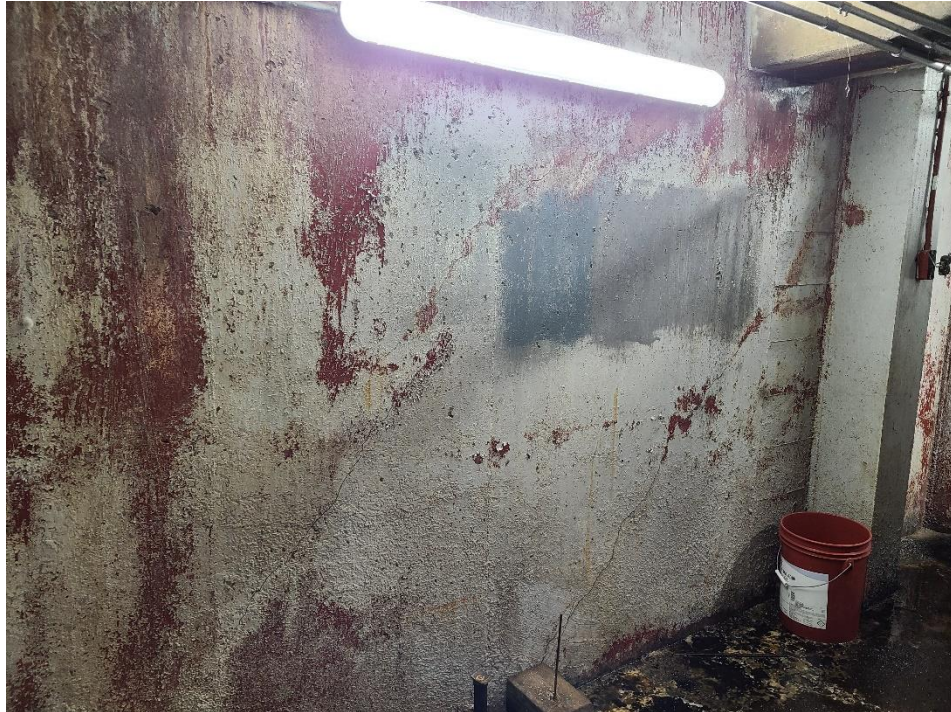
6. Interior cracks on east wall, intermediate level.

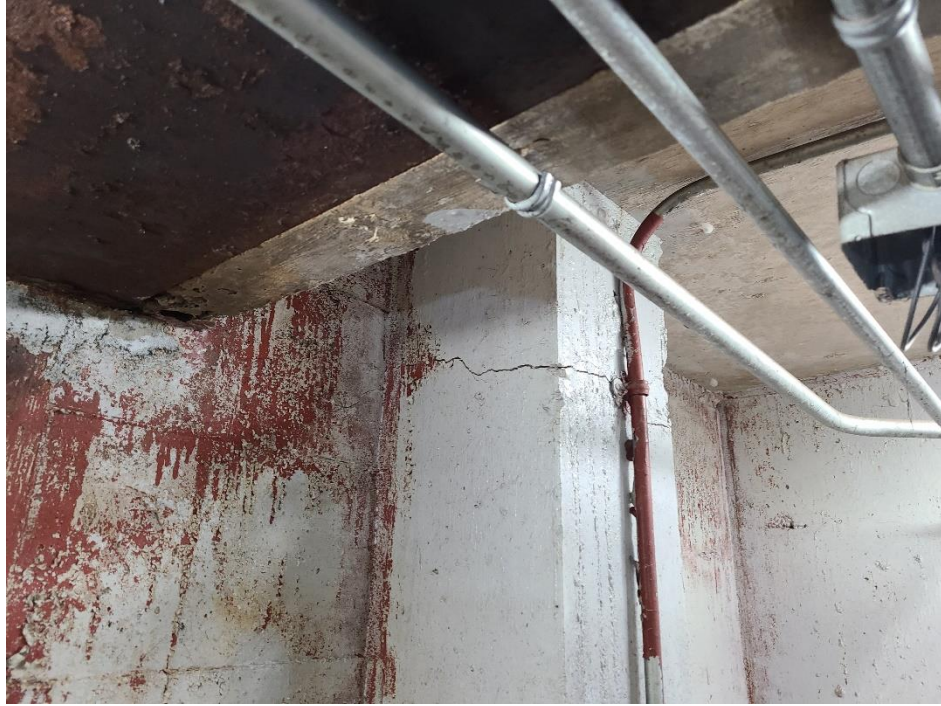
7. Wall cracks shown in previous photo that continue into column.
