# APPENDICES

BEC-M12795-Appendices

Proposal for Owner's Engineer Services:  
Factorydale Turbine Project – Town of Berwick Electric Commission

**Owner's Engineer for Factorydale  
Turbine Project**

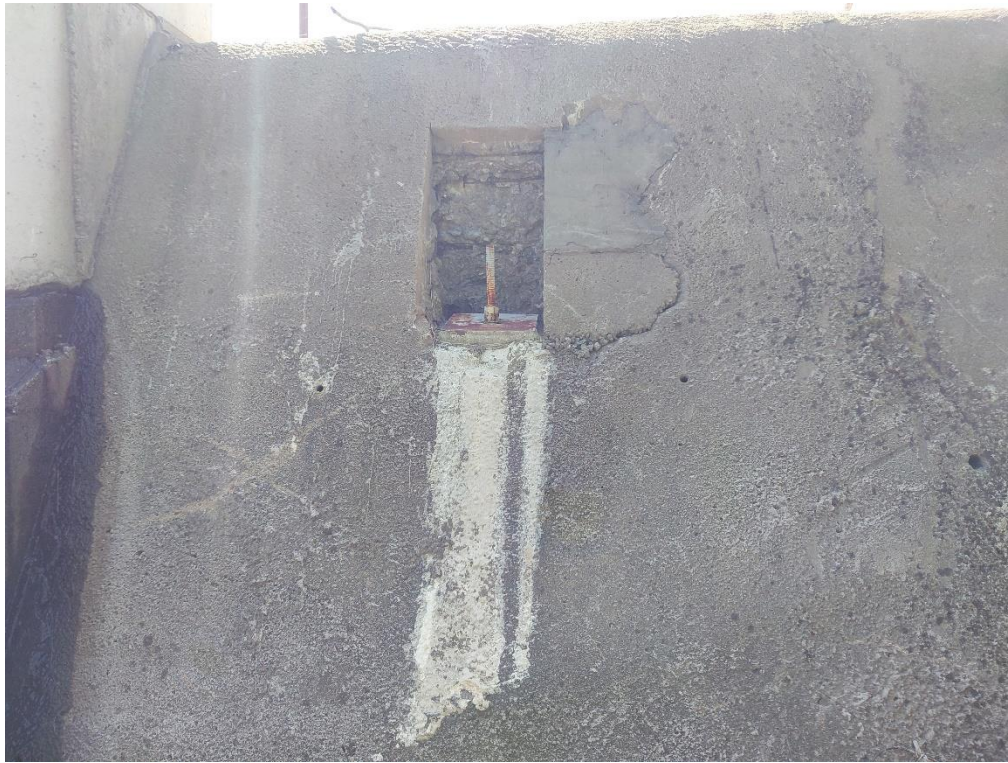
**Photo 7** Efflorescence Below Post-Tensioned Anchor at Exposed Portion of Left Dam Section

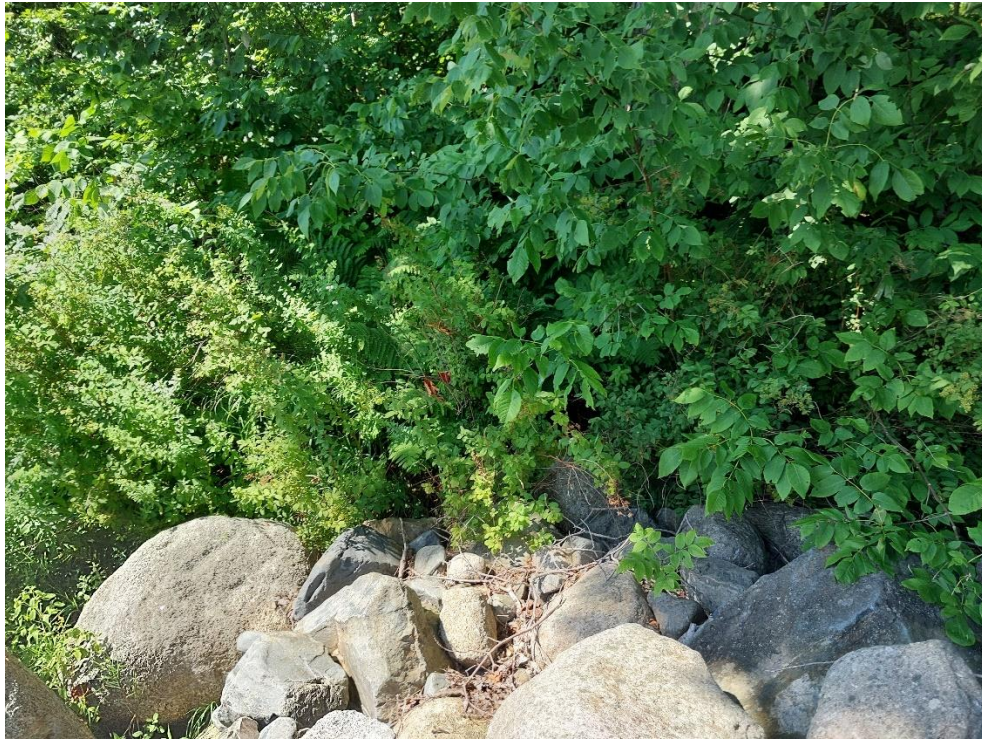
**Photo 9** Overgrown Left Abutment

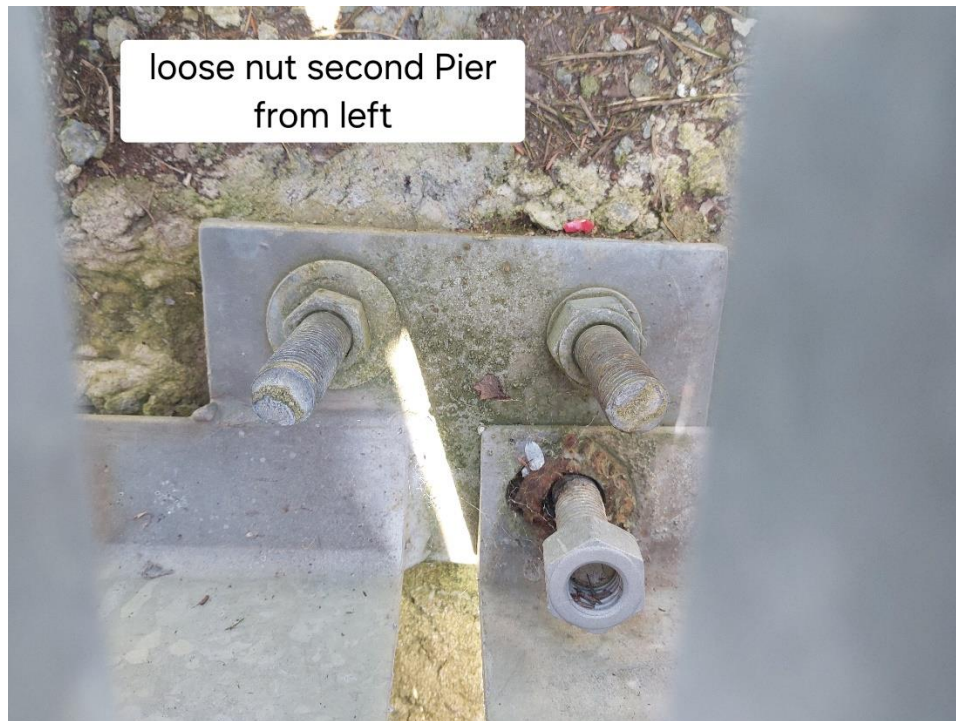
**Photo 15** Loose Nut on Catwalk Plate, Second Pier from Left

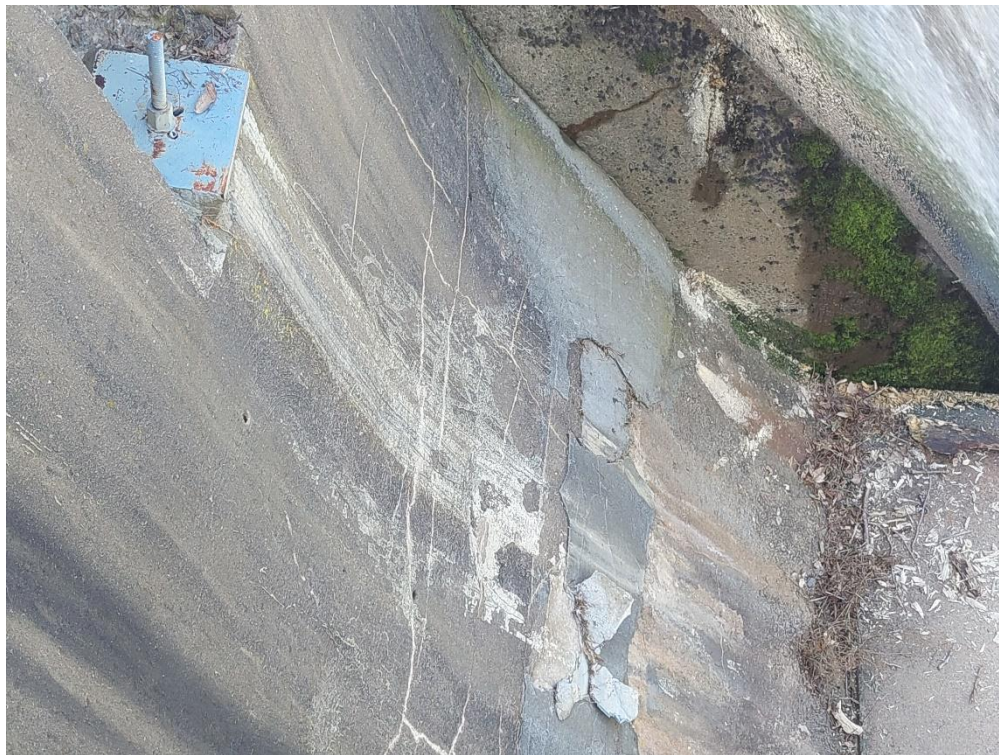
**Photo 20** Spalling and Efflorescence Next to Penstock

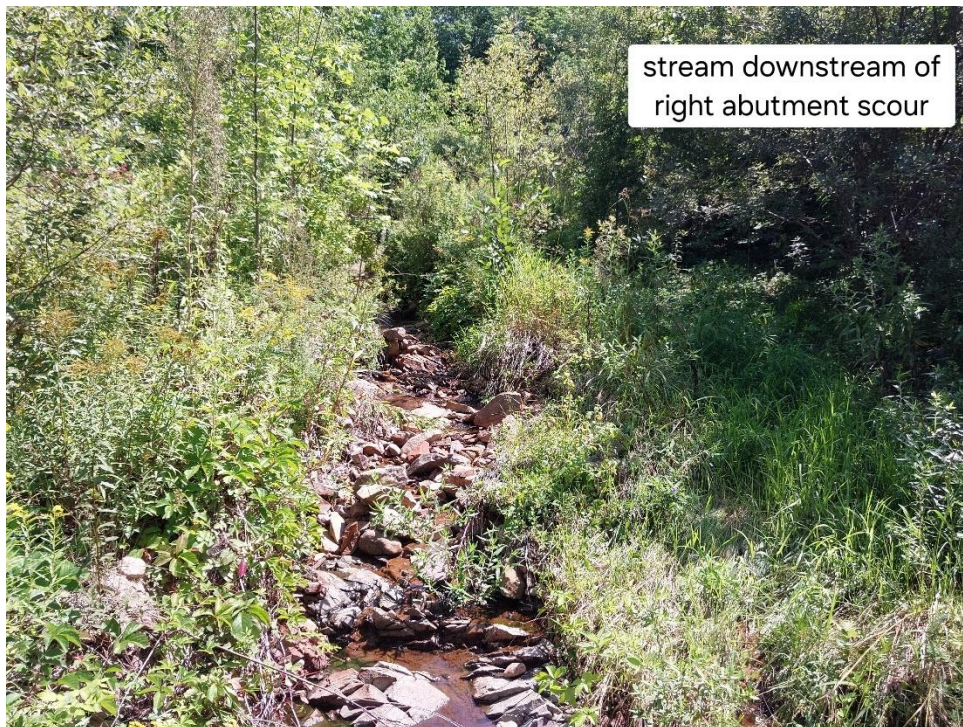
**Photo 24** Runoff from Seepage at Right Abutment

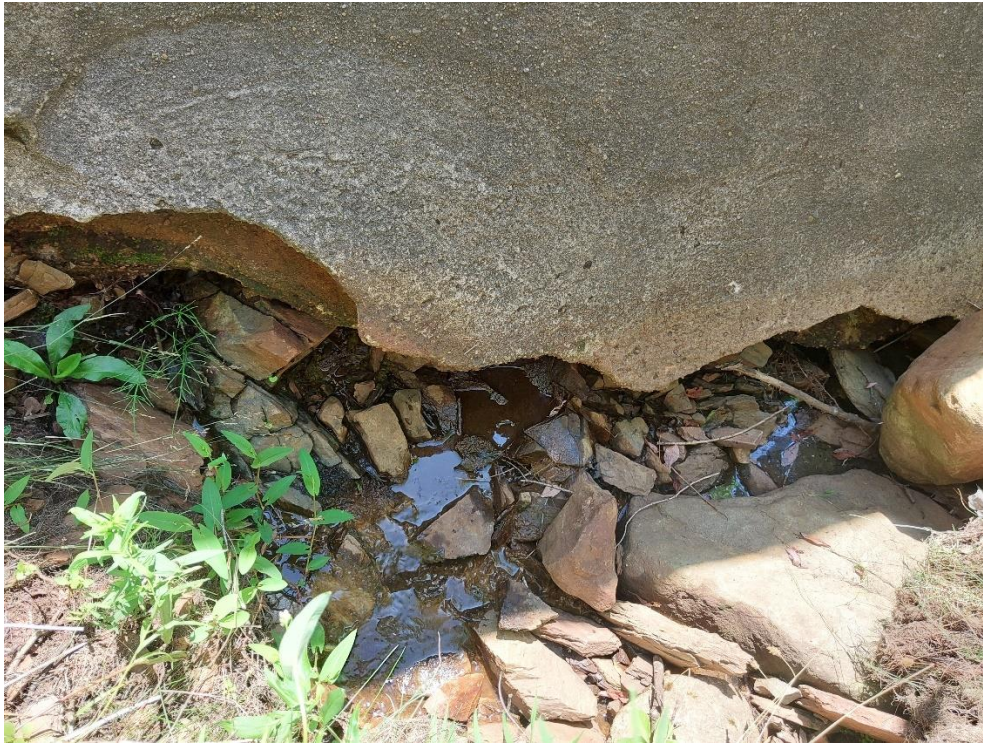
**Photo 25** Scour and Trickling water at toe of Right Dam Section

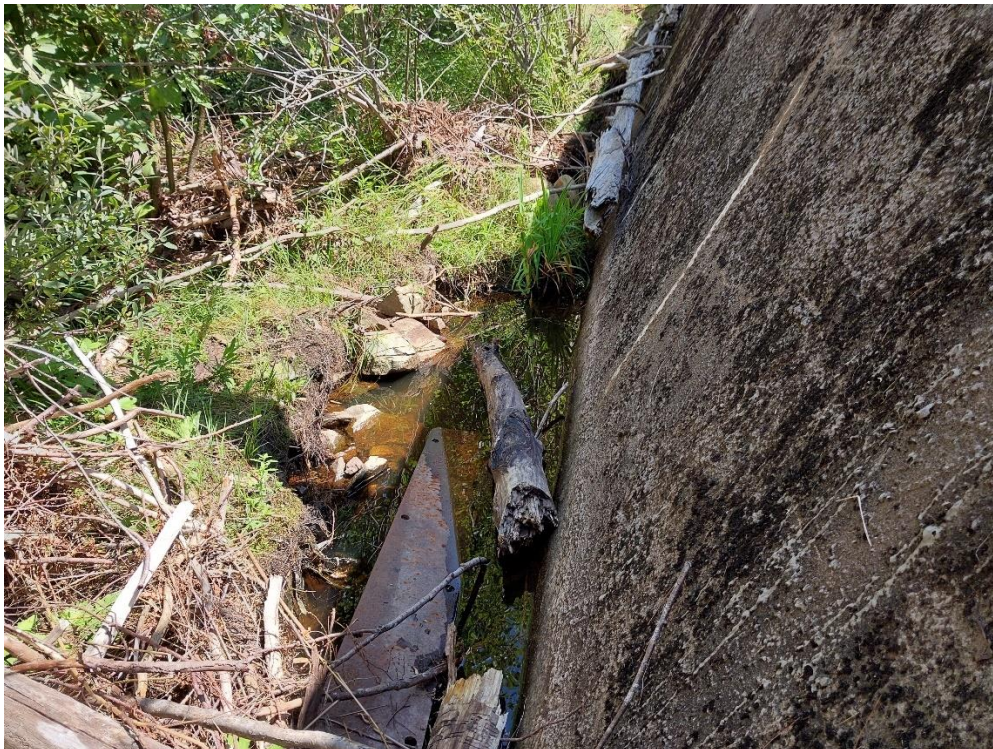
**Photo 26** Ponded water at toe of right dam section, next to Penstock intake

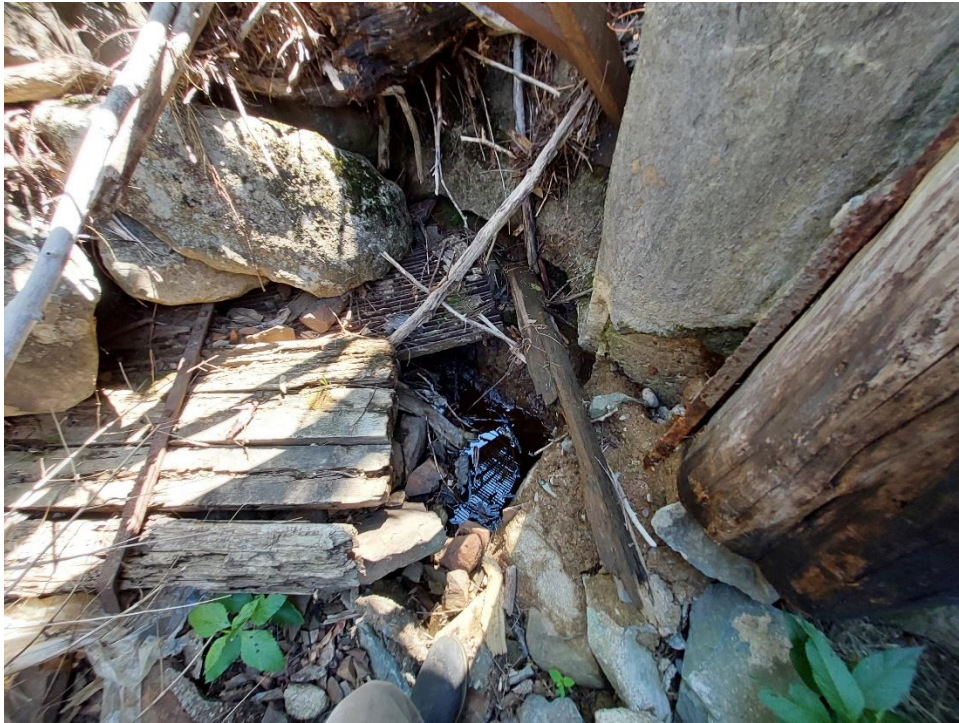
**Photo 27** Ponded water and scouring around base of power pole beside Penstock Intake

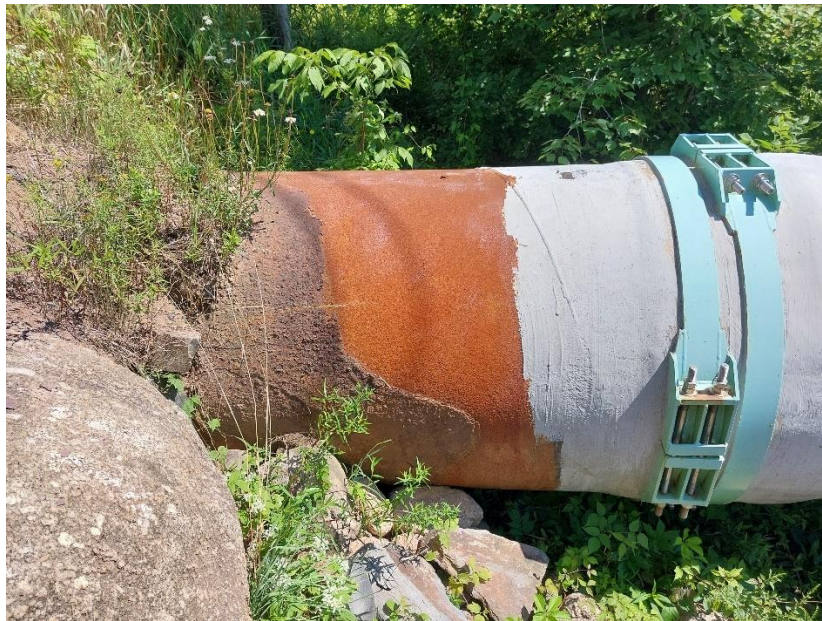
**Photo 31** Penstock Passing Under Harmony Road Showing Rust
