**Canso Crossing Vibration Mitigation**

Project Title: L7005 Canso Crossing Vibration Mitigation

CI Number: C0044172

## **Energy Delivery Engineering**

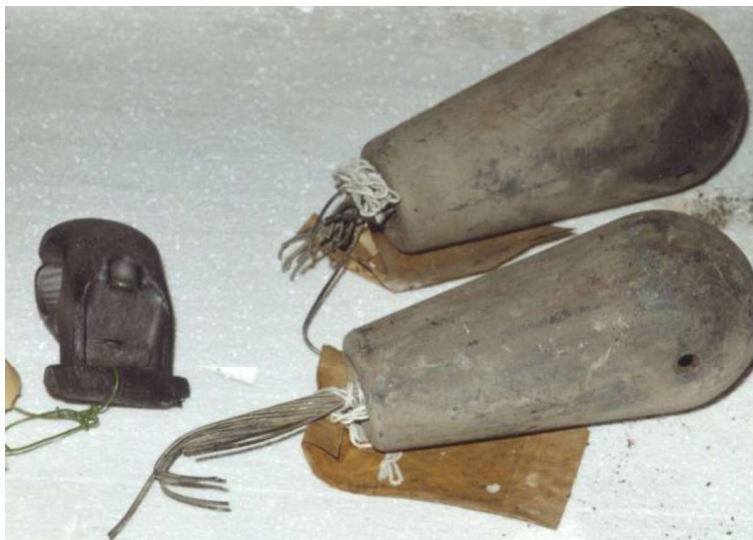
Figure 17 Low frequency Stockbridge damper with messenger wires fatigued due to galloping.  
(Havard Engineering In. Archive)

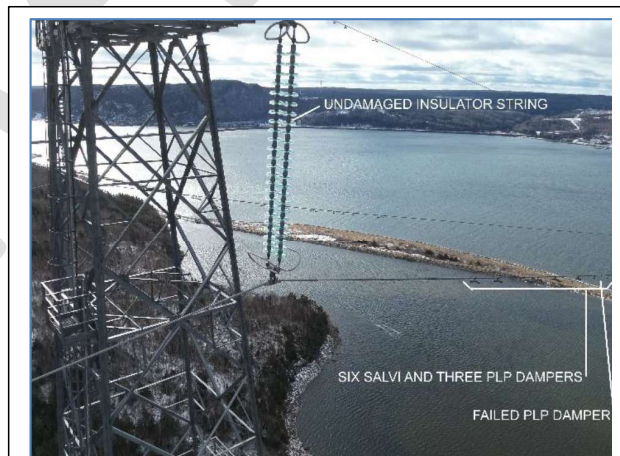
Figure 5 View of suspension structure on Cape Breton Island looking east, showing undamaged suspension insulator string and dampers on conductors, including the failed PLP damper on bottom conductor of the west

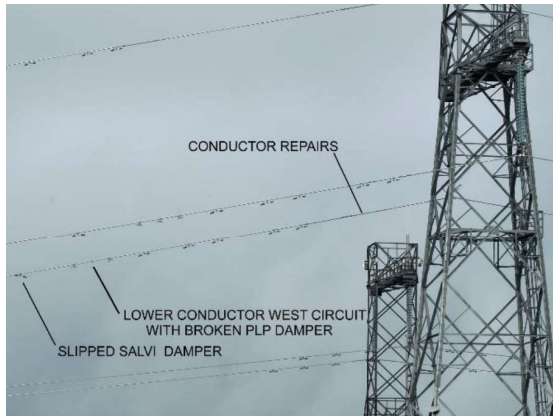
Figure 6 Closer view of bottom phases on crossing side of the suspension structure on Cape Breton Island looking west along the strait. Photo includes the slipped Salvi and broken PLP dampers. Repair sleeves can be seen between the array of dampers and the suspension clamp. Detail from photo No. DJI\_20240117231347\_0033\_Z.jpg

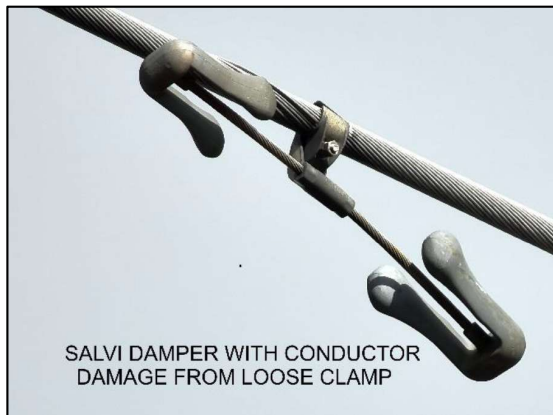
Figure 7 Loose Salvi damper clamp and conductor damage. Bottom phase, west circuit, near suspension tower on Cape Breton Island. Detail from Photo No. DJI\_20240117232412\_0059\_Z.jpg

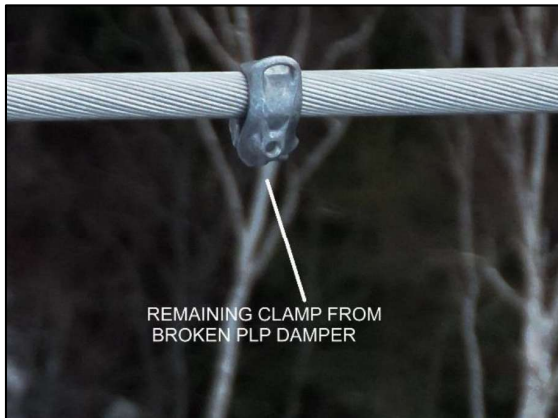
The photographs do not suggest that conductor damage has occurred under the PLP damper clamp, but visual inspections of this, and all other similar clamp locations that will be changed, are recommended.

Figure 8 Clamp from broken PLP damper.  
Bottom phase, west circuit, near suspension  
tower on Cape Breton Island. Detail from  
Photo No.

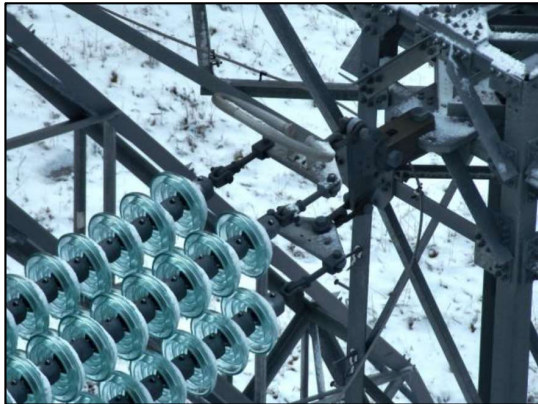
The back span on the mainland side of the Canso Strait crossing has a similar exposure to aeolian vibration and galloping as that on the Cape Breton Island side. Figures 15 and 16 show the two ends of this span, and they show that the terrain is covered with trees, and consequently winds impacting the conductors will be turbulent and less likely to lead to either of these modes of vibration. The drone-based survey did not reveal damage that is likely to be due to such motions. Details of the dead-end insulator strings are shown in Figures 17 and 18, and no damage is visible in the photographs of this or any other strings supporting the crossing. There are few locations where there are clamp impressions on the outer surface of the conductor. Figures 19 and 20 show samples of these impressions. These may indicate the damper has been removed and the clamp retightened, possibly as part of an inspection program. There is a remote possibility that such impressions could be due to slippage consequent to severe vibration.

Figure 17 Ground end of insulators on the dead-end structure on the back span on the Nova Scotia Mainland. Detail from Photo No. DJI\_20240116031651\_0028\_Z.jpg

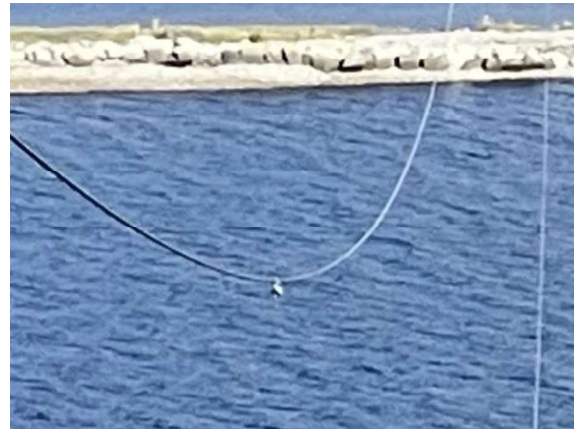
Figure 21 Damper slipped to mid span West circuit, middle phase, from climbing inspection in May 2022. (Figure 3 of August 2023 report)

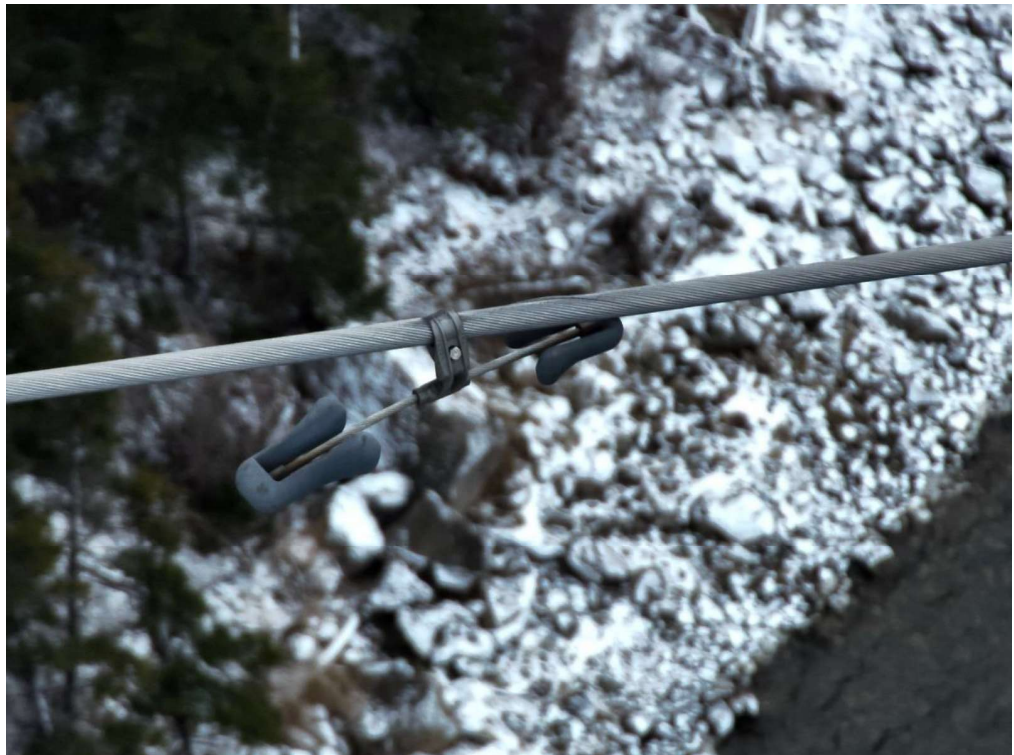
This appears to have resulted in an inability of the clamp to hold the damper properly on the conductor. The unbalanced force from each side of the damper applies a significant torque to the damper and it appears that the damper clamp has twisted on the conductor as a result. This has resulted in severe damage to the aluminium strands in a large number of places. This damage and the twist of the clamp on the conductor can be seen in fig X. below

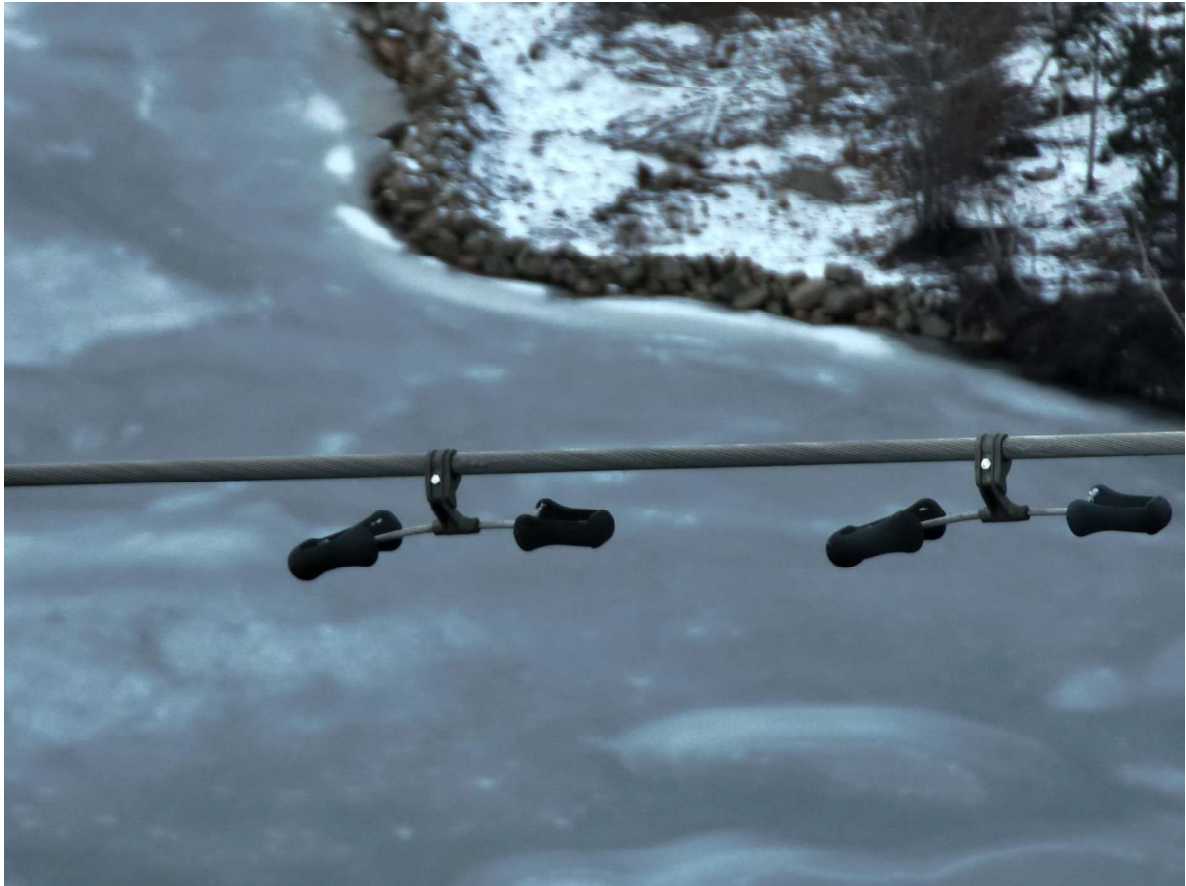
- Dampers may be getting “tired”
  - There are a number of places that the clamps appear to be sitting properly on the conductors, but the weights appear to have sagged. This often indicates that the dampers have been working hard, and may be starting to reach their end of life.

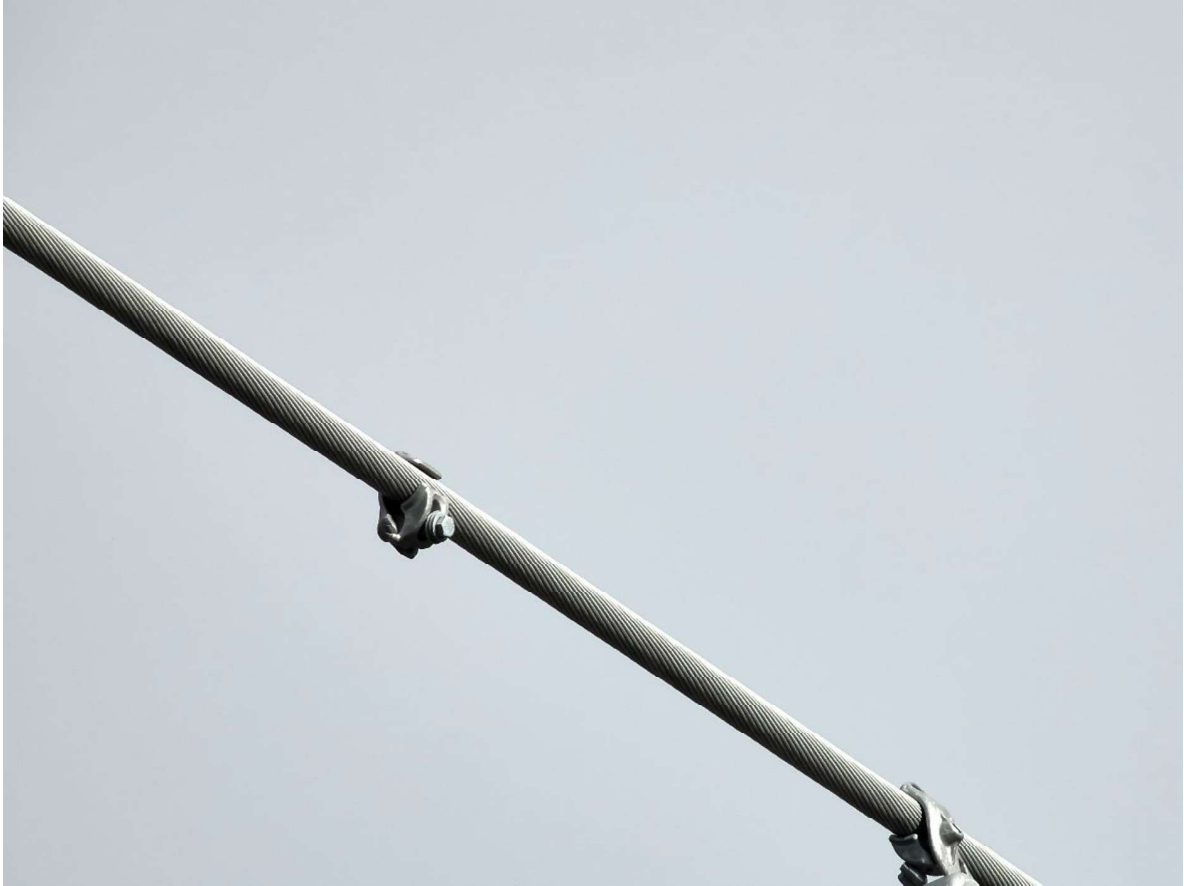
- Failure of elastomer type dampers
  - In one location it appears that the Riganti damper has failed. The cause of this is not apparent, but is of concern.

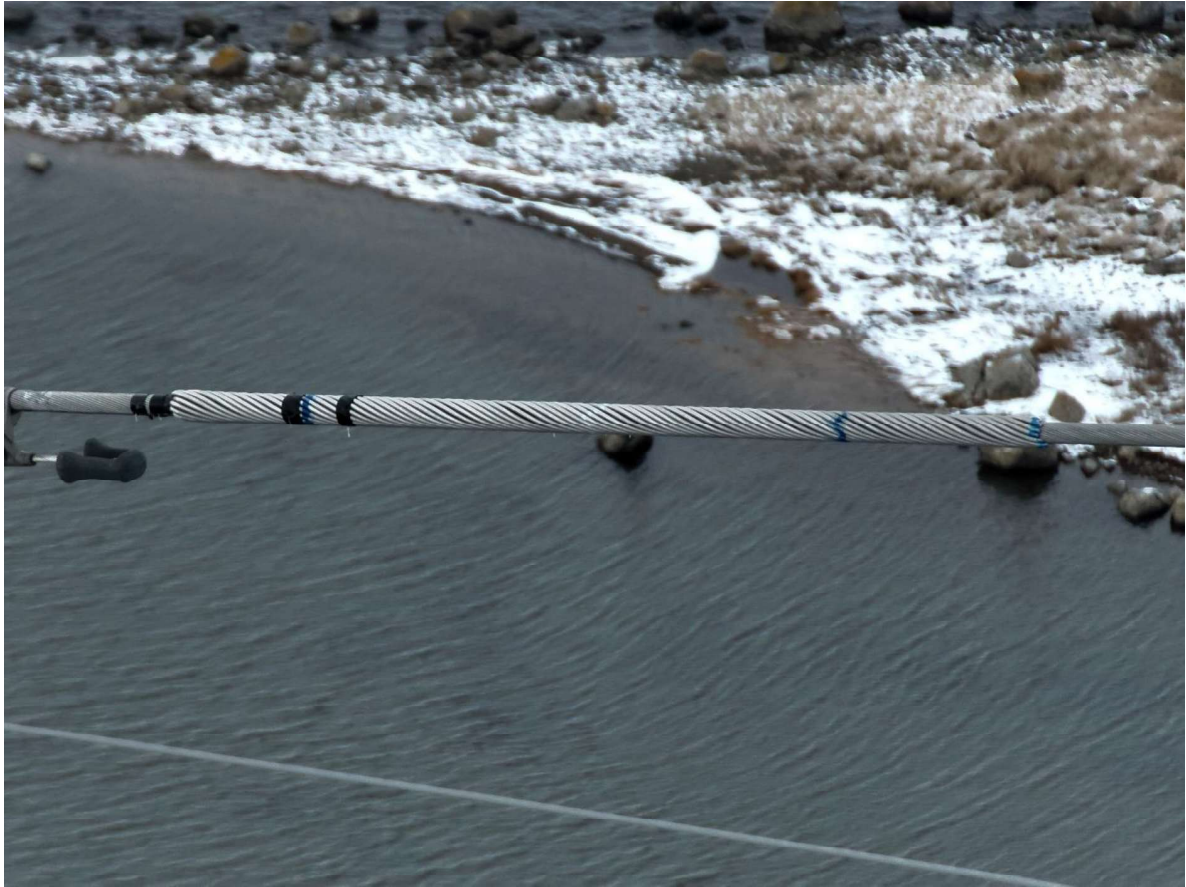
- Armour rods have been installed in some locations. It is not possible to estimate the number of broken strands (if any) under the armour rods

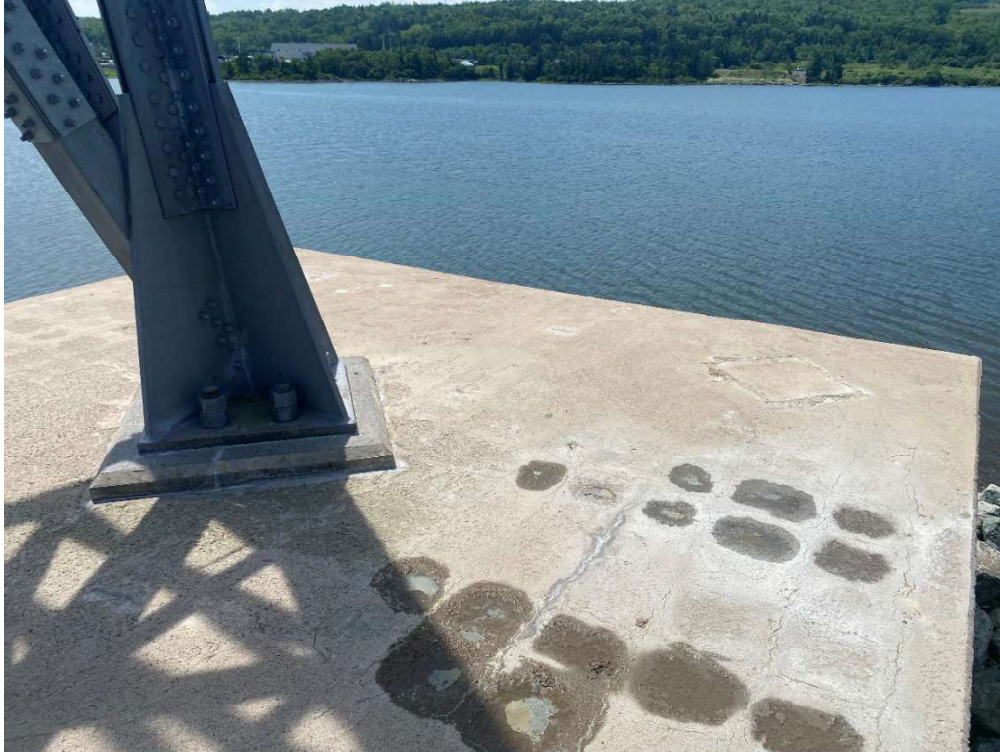
*Figure 1 - Str 730, NW foundation, cracking in square pattern*

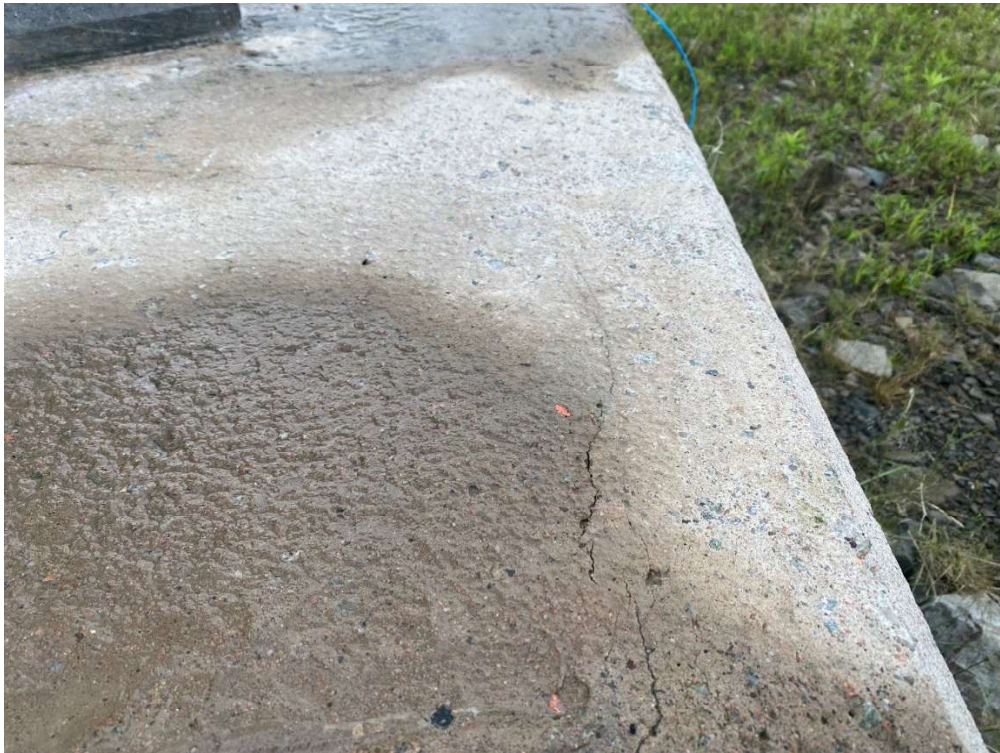
*Figure 2 - Str 731, NE foundation, cracking in square pattern*

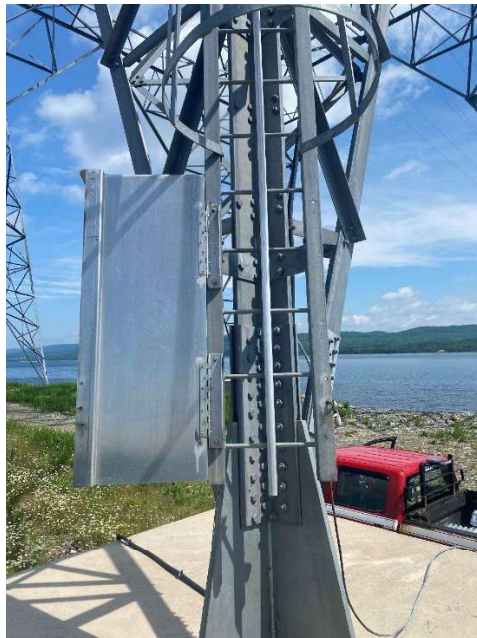
*Figure 5 - Str 730, bolts requiring retorquing behind door panel*
