**CI C0040106**

**HYD Tusket 1 Generator Refurbishment**

**Title: HYD Tuskett 1 Generator Refurbishment**

## FIELD TEST PLAN

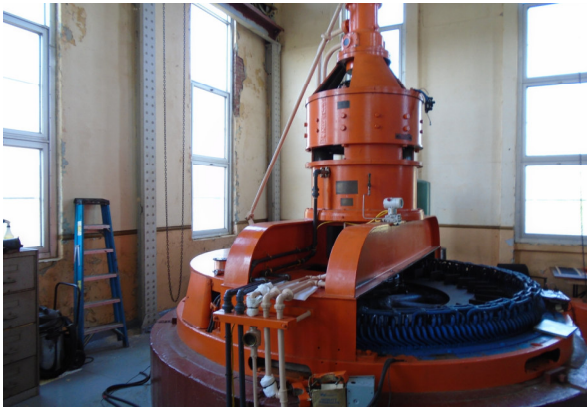
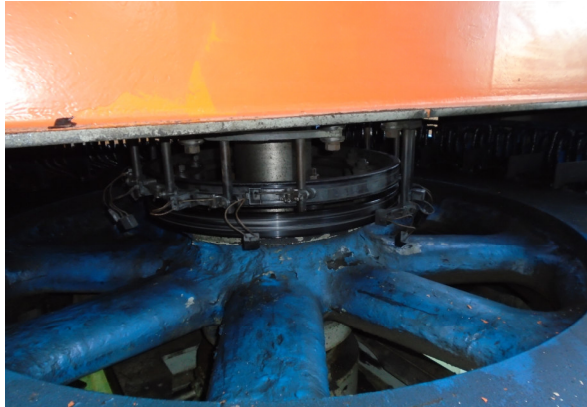
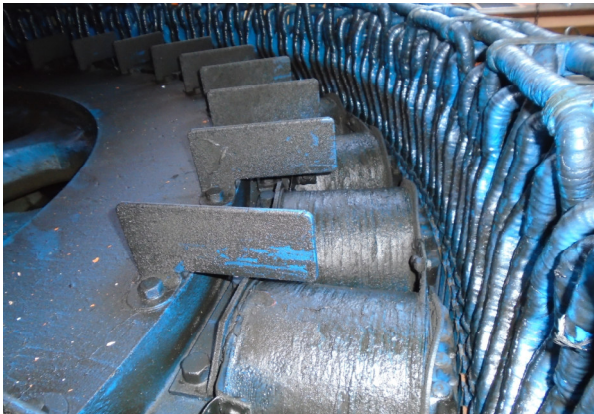
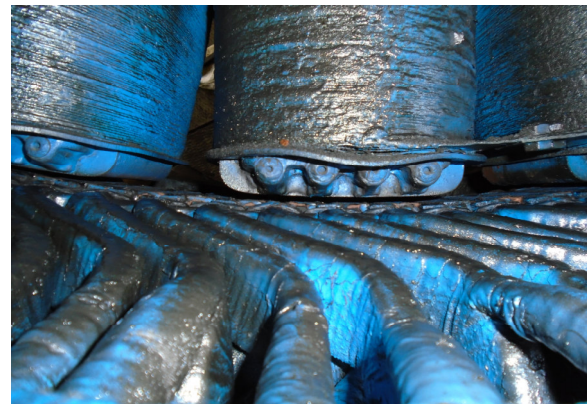
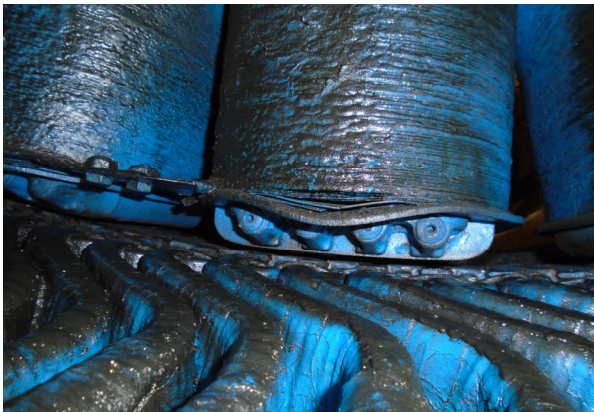
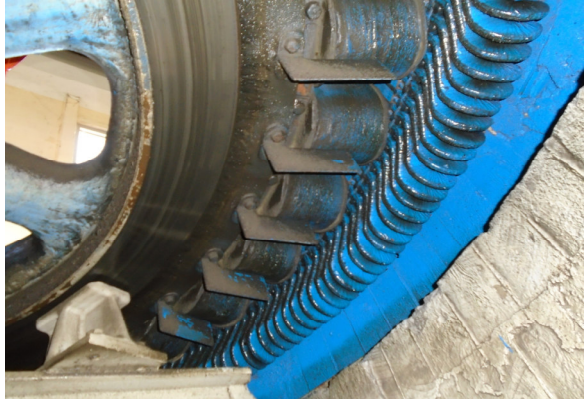
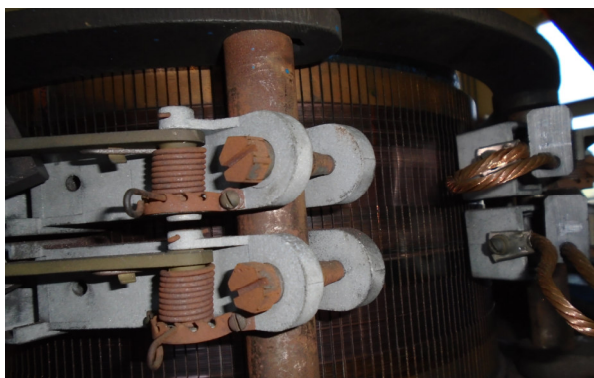
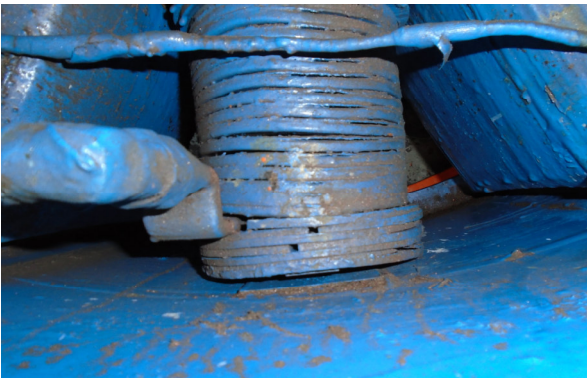
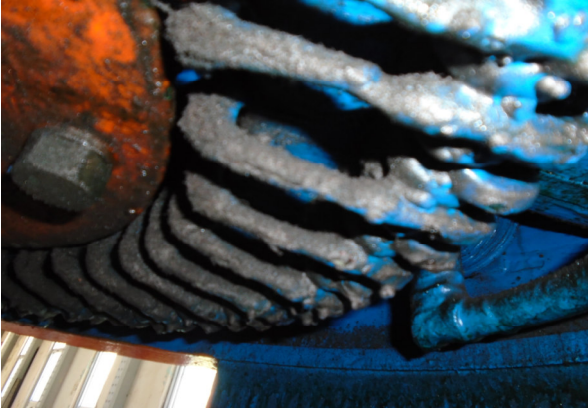
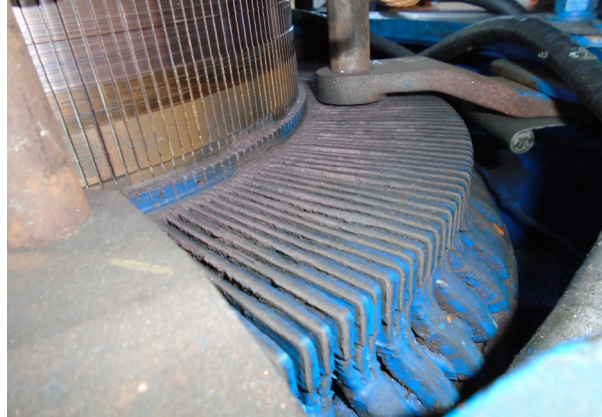
| | Comments And Recommendations |
|---|---|
| 1 | Rotor was at 0 Megs By cleaning the rings and the leads to try to get readings up, This will just be a fix. The rotor is original and needs a full refurbishment |
| 2 | Combined bearing is leaking oil. It has to be fixed, Leaking oil on rings |
| 3 | Exciter Armature has commutator wear and is blowing copper dust everywhere. Exciter needs to be taken off and sent to turn and undercut |
| 4 | Stator is original and pulling in a lot of moisture and causing very low megger reading .006M. They might come up with a cleaning and a paint but its just a patch. Recommend rewind |
| 5 | Pole washers are splitting Needs to be replaced Very soon |
| 6 | Neutral Leads needs to be replaced. They are original and are going through the wall and are not easily accessible. Did not test individual phases for that reason |
