**Undertaking U-1:**

**PHASE II ENVIRONMENTAL SITE ASSESSMENT**  
**116 Ruth Falls Road**  
**Sheet Harbour, NS**

PHASE III ENVIRONMENTAL SITE ASSESSMENT  
116 Ruth Falls Road  
Sheet Harbour, NS

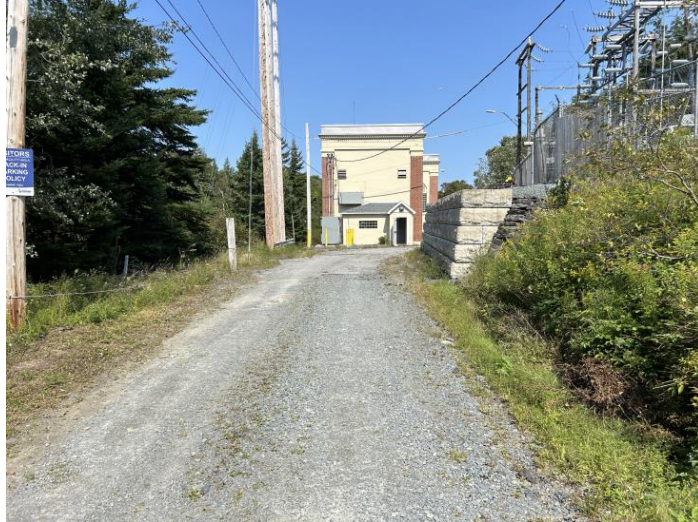
Photo 1: View of gravel driveway entry to the site and hydro-power plant building, looking north. Photo taken on September 5, 2024.

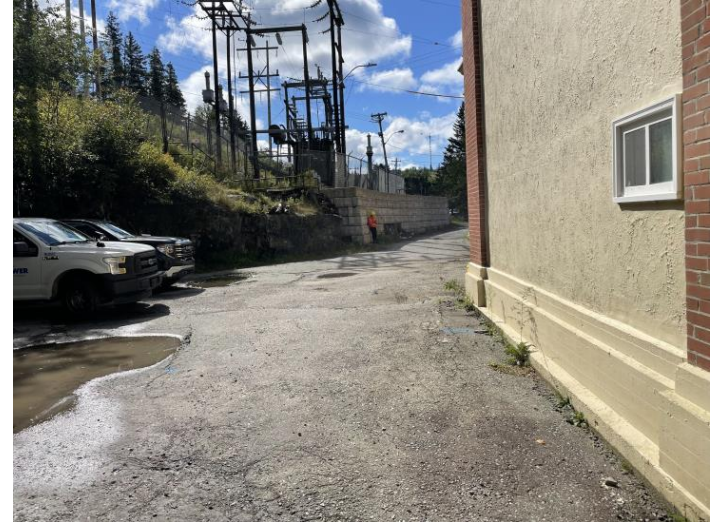
Photo 2: View of hydro-power plant and transformer substation on north side of the site, looking south. Photo taken on September 11, 2024.

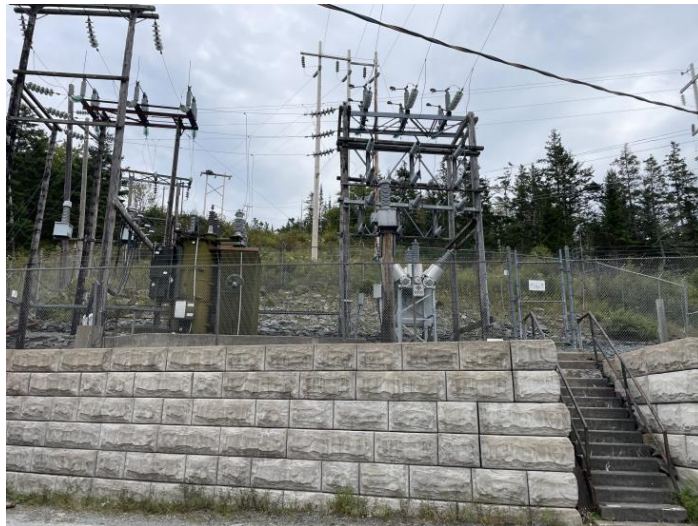
Photo 3: View of transformer substation on north side of the site, looking east. Photo taken on September 11, 2024.

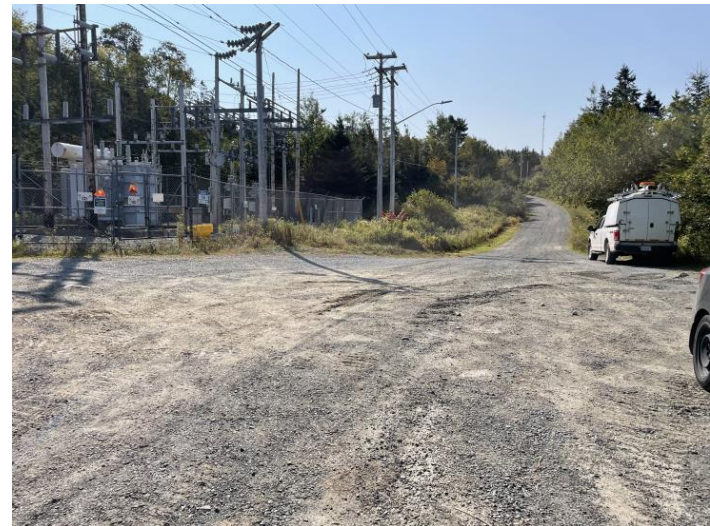
Photo 4: View of transformer substation on south side of the property, looking southeast. Photo taken on September 11, 2024.

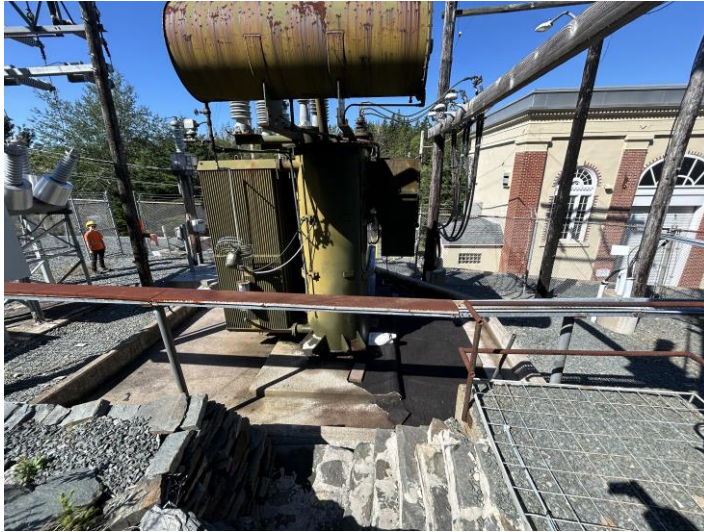
Photo 5: Transformer substation area of release and oil staining on concrete containment floor. Photo taken on August 30, 2024.

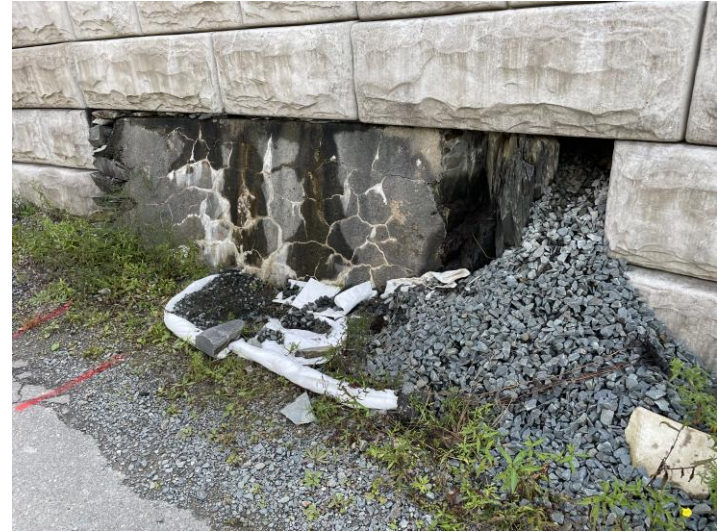
Photo 6: Hydrocarbon impacts in shallow soils/bedrock at base of substation retaining wall. Photo taken on September 11, 2024.

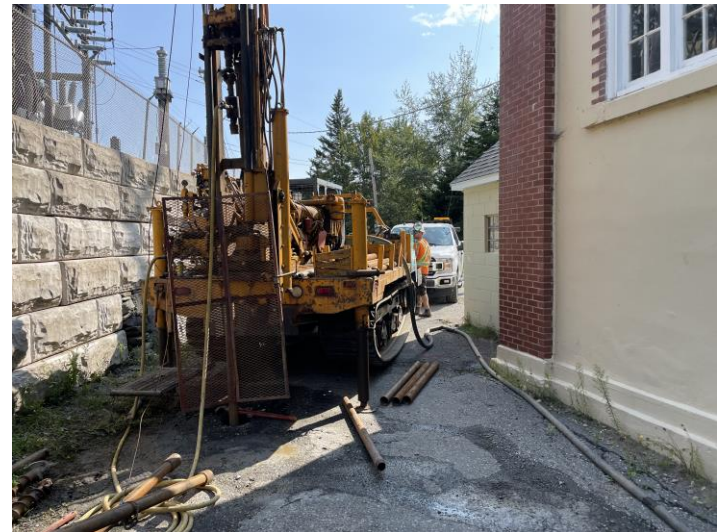
Photo 8: Drilling of borehole using CME-45 rig prior to monitoring well installation. Photo taken on September 11, 2024.

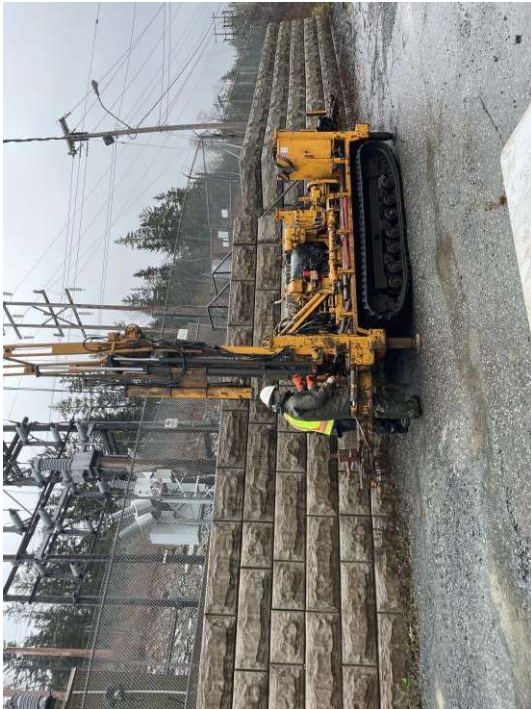
Photo 1: Drilling of borehole/monitoring well (BH/MW5).  
Photo taken on December 12, 2024.

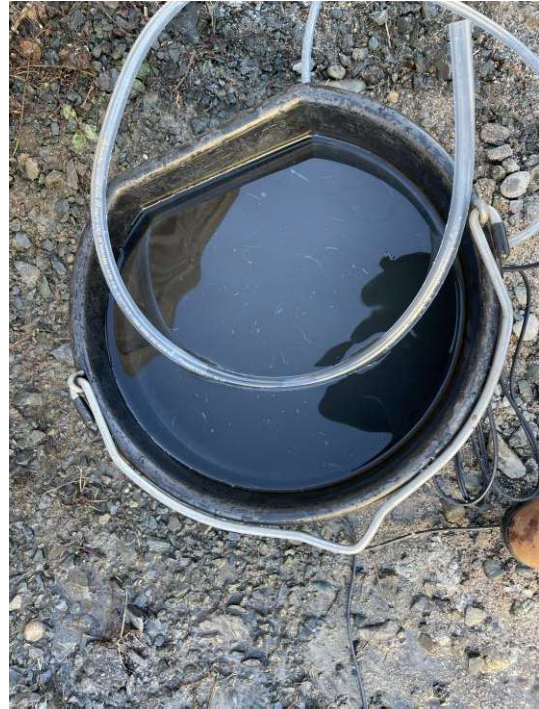
Photo 3: Observed mineral oil sheen in groundwater from monitoring well MW5.  
Photo taken on December 12, 2024.

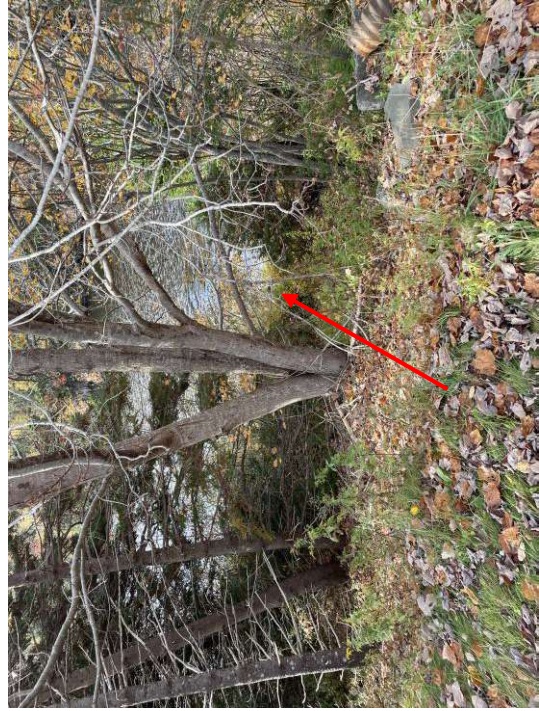
Photo 4: Approximate location of surface water sample SW1 (DE17).  
Photo taken on October 23, 2024.
