**Re: CI# 33942 - Coon Pond Pipeline Replacement - NSPI - Responses to Third Set of Information Requests (IRs) - P – 510**

Coon Pond Pipeline  
Woodstave Cores (Collected June 18, 2007)  
June 21, 2007.

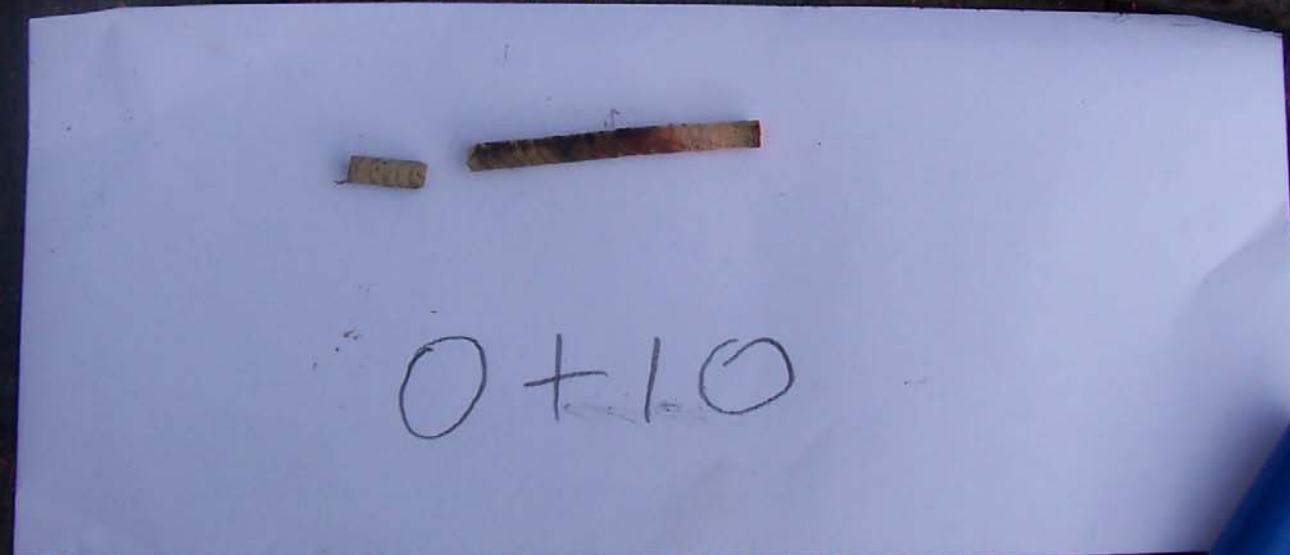
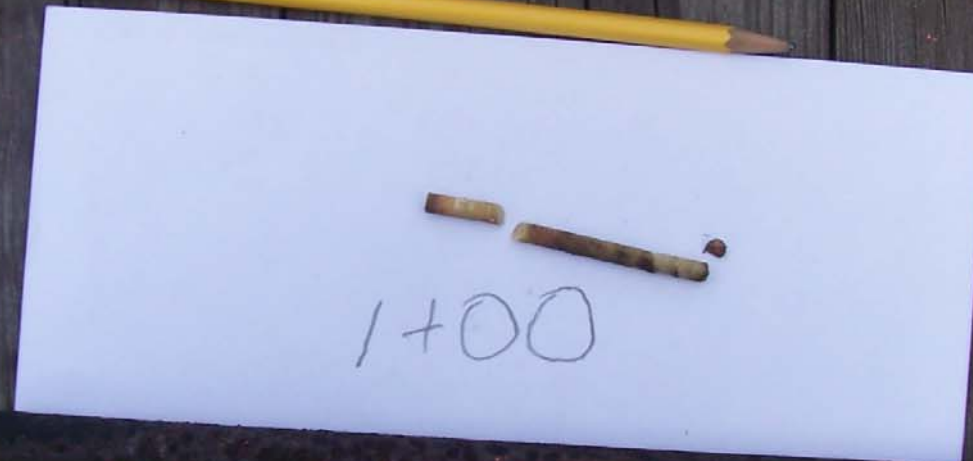
**Notes:** 1.) Where cores are fragmented individual wood grains have separated into sheets. This condition very severely compromises the structural integrity of wood staves in those locations. In the worst cases, the retrieved delaminated circular core samples closely resemble confetti.

2.) Most core samples showed varying degrees of discoloration. However, severely discoloured core samples (as found from chainage 20+00) suggest the presence of mildrew and rot within the wood strata.

3.) As chainage increases, so does pipeline pressure. Observations indicate that the weakest staves are found where pipeline pressure is greatest.

4.) Existing wood staves are fabricated from Red Pine, a readily available and inexpensive local species of wood not known for resistance to rot and related degradation. Preservative treated Douglas Fir, Hemlock and Cedar are preferred wood species for this sort of application.

5.) Condition transformation from Fair to Very Poor at about chainage 27+50 is sudden and quite remarkable. Wood staves from chainage 28+00 to 33+00 do not appear to be fit for service.
