**CI C0067183**

**TUC Wharf Access Bridge Replacement**

**August 5, 2025**

**NSEB APPROVAL SHEET**

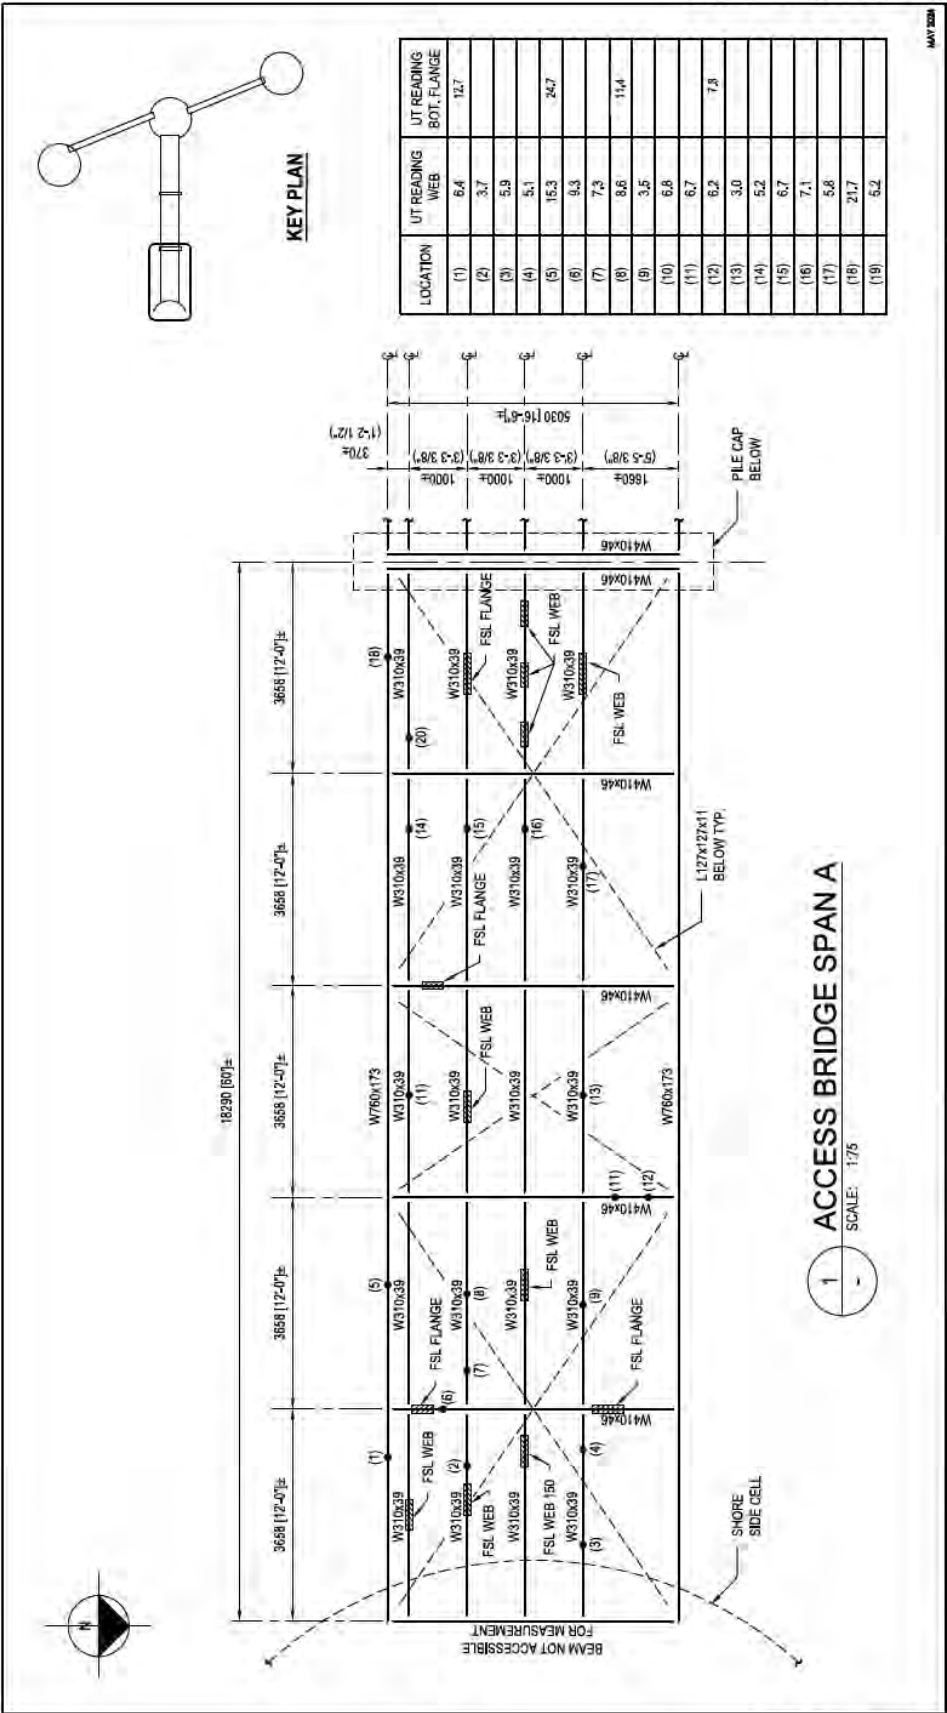
NOVA SCOTIA POWER INC.  
TUFS COVE WHARF INSPECTION  
Figure No. \_\_\_\_\_  
S01  
SPAN A SITE OBSERVATIONS AND  
U.T. MEASUREMENTS

The beams were observed to be in poor condition. Advanced corrosion was observed primarily on the flanges. UT measurements taken on these elements showed that the steel thickness was significantly reduced at these locations, having a negative impact on the structural capacity of the beams. The bolted connections between the joists and the beams were also in poor condition. Full material loss of the bolts was observed at most of these connections. Based on the condition observed on the beams, it is recommended to replace these members.

The joists were observed to be in poor condition with severe corrosion at multiple locations reaching full section loss (FSL) of the web on 16 joists throughout the platform. Due to the extent of the corrosion, repair operations are not considered to be suitable. Full replacement of the joists is recommended.

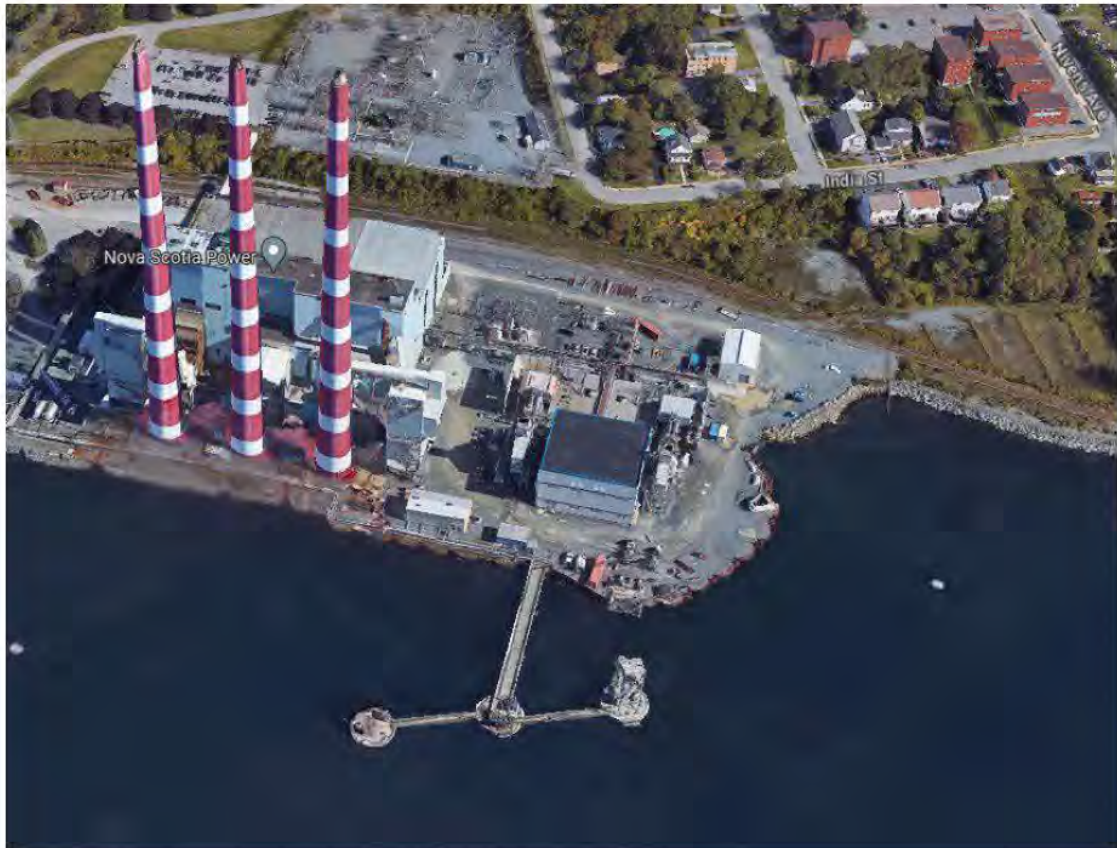
1. **Middle Dock Cell** – Cope Wall Deterioration/Loss of Concrete/Exposed Rebar
2. **Middle Dock Cell** – Steel Sheet Pile Deterioration/Contact Damage/NDT Testing
3. **Shoreline SSP Cell** - Steel Sheet Pile Deterioration/Contact Damage/NDT Testing
4. **Approach way Piles** – Concrete Jacket Deterioration/Loss of Concrete/Exposed Rebar
5. **Approach way Piles** – Steel Pipe Pile Deterioration/Contact Damage/NDT Testing
