**Request IR-1:**

**In the “DESCRIPTION” of NS Power’s application, NS Power notes that “This project is for the refurbishment of Upper Lake Falls Unit 2. The scope includes refurbishment of the turbine, headcover, turbine shaft, turbine bearings and housing, as well as all wear items. A re-alignment of the unit is required to ensure the unit will continue to operate reliably.”**

**Response IR-1:**

PLANT UPPER LAKE FALLS  
UNIT # 2

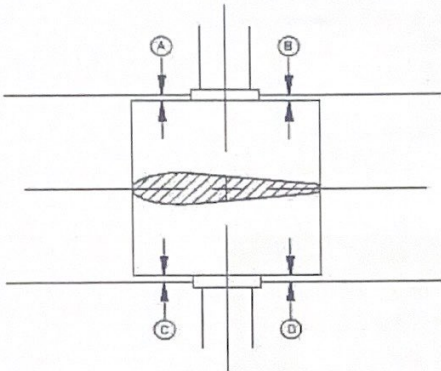
DATE SEPT. 25 2023  
CREW BT, AW, JB, DB  
WORK ORDER 152291

Unit = 1/100 mm

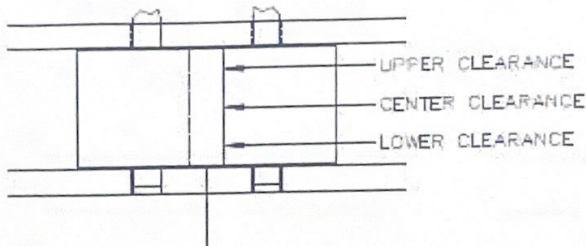
DATE SEPT. 25 2023  
CREW RH, DB, JB, AW  
WORK ORDER 152291

| GATE # | UPPER | CENTER | LOWER |
|---|---|---|---|
| 1 + 2 | Ø | .012 | .032 |
