**CI C0080112**

**HYD Big Falls Unit 6 Rotor Re-Insulation**

## TESTING

NorthPoint Job Number 57638

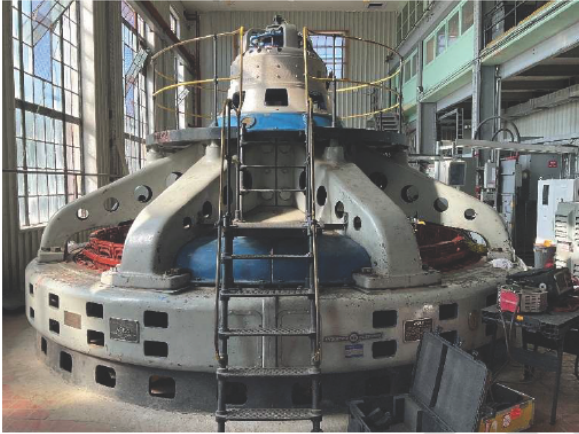
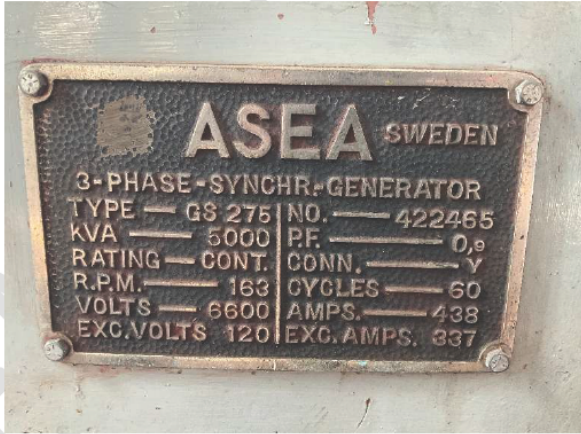
| UNIT | NAMEPLATE |
|---|---|
| AS FOUND INSULATION RESISTANCE | |
| TEST AT 500VDC | 1 MIN: 627.5MΩ |

INSULATION RESISTANCE AND POLARIZATION INDEX WAS FOUND TO BE ACCEPTABLE ON THE INITIAL TEST. THE REASON FOR NORTHPOINT TO BE ON SITE WAS TO ASSIST WITH EVALUATION OF ROTOR POLE CONDITION BASED ON EITHER ELECTRICAL TESTING RESULTS OR VISUAL CONDITION. THE FIRST TESTING AFTER CONFIRMATION OF THE INSULATION RESISTANCE WAS TO PERFORM A AC DROP TEST OF THE COMPLETE ROTOR.
