## CONDITION ASSESSMENT and COSTED OPTION ANALYSIS: Factorydale Turbine Project – Berwick Electric Commission

| <b>Document Number (Hysovent)</b> | HSV-2024-043-CA01 |
| <b>Title</b> | Condition Assessment and costed option analysis:<br>Factorydale turbine project |
| <b>Customer</b> | Town of Berwick – Berwick Electric Commission |

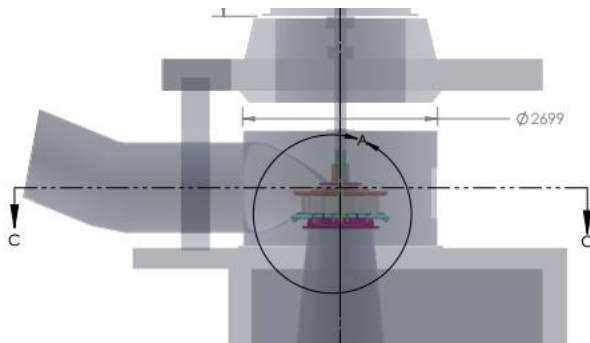
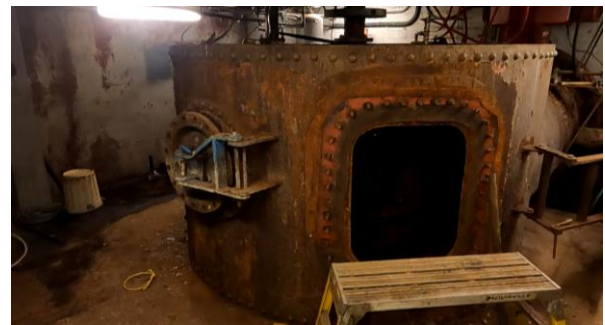
This machine has a cylindrical scroll case, fixed dimensions, which is very inefficient in terms of helping the runner to get the maximum amount of energy from the water. More details can be found on drawing HSV-2024-043-02 on the appendix and the SharePoint shared folder.

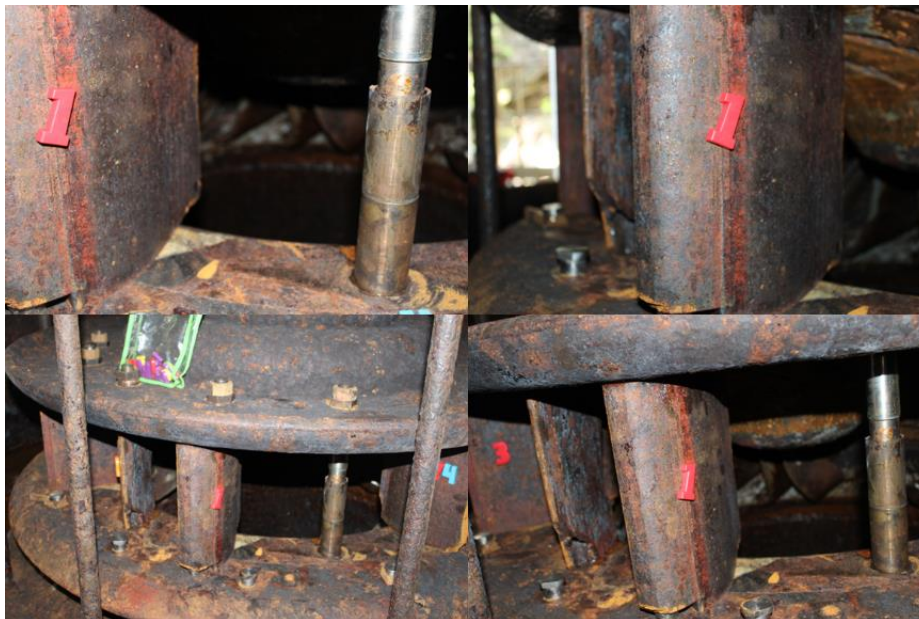
### **Wicket gate 01**

*Figure 11: Wicket gate 01*

The wicket gate 01 appears to be “intact”, even though it is just right next to the wicket gate 14, which was completely destroyed. The bronze link is not present; totally destroyed. The link pin is still present in place.

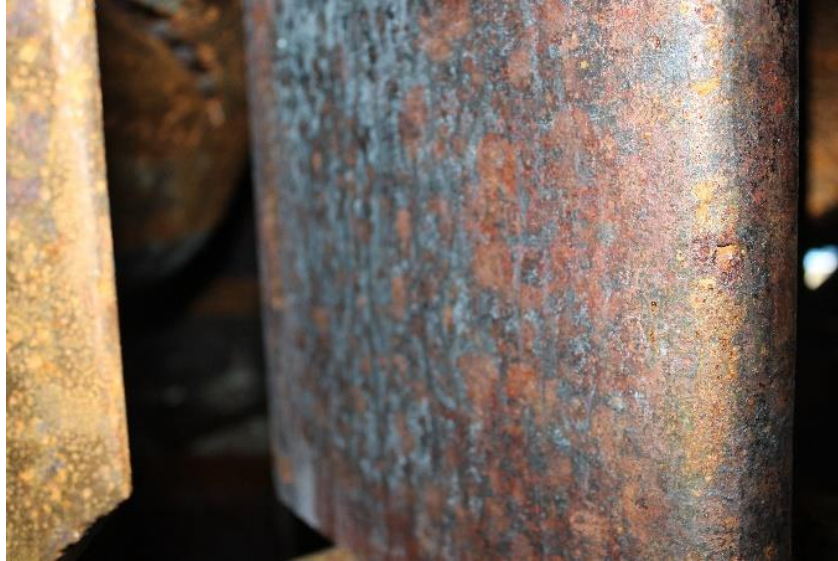
### **Wicket gate 10**

*Figure 21: Wicket Gate 10*

Apart from a control link destroyed, there were no signs of damage on this wicket gate. Was found in the correct position as well.

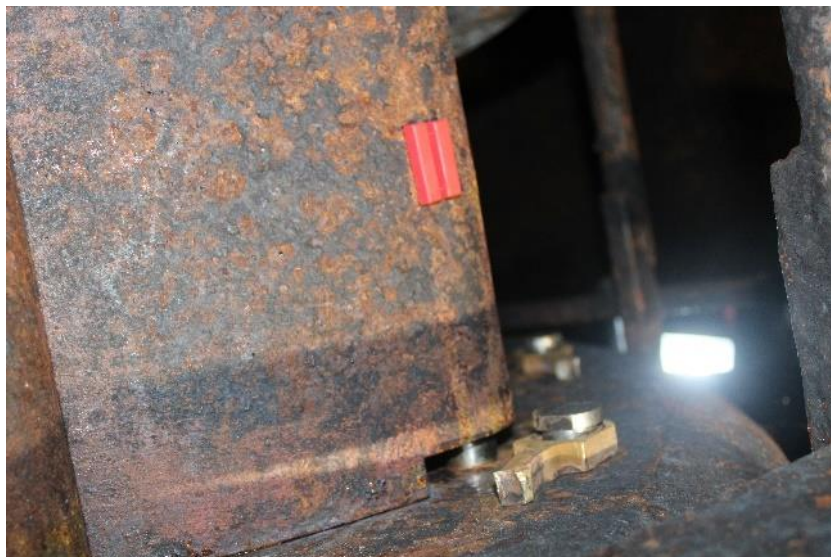
### **Wicket gate 11**

*Figure 22: Wicket gate 11*

Similar to Wicket Gate 10, apart from a control link destroyed, no signs of damage on this wicket gate. Was found in the correct position as well.

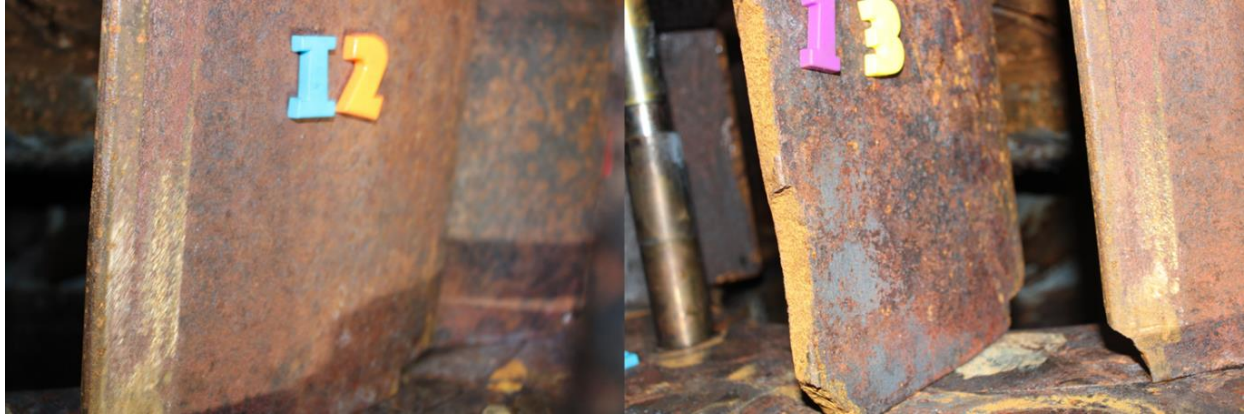
### **Wicket gate 12**

*Figure 23: Wicket gate 12*

This wicket gate only suffered damage on the lower tip of the edge. Most definitively caused by impact. Was found rotated over 180 degrees to its expected position. Control link completely destroyed.

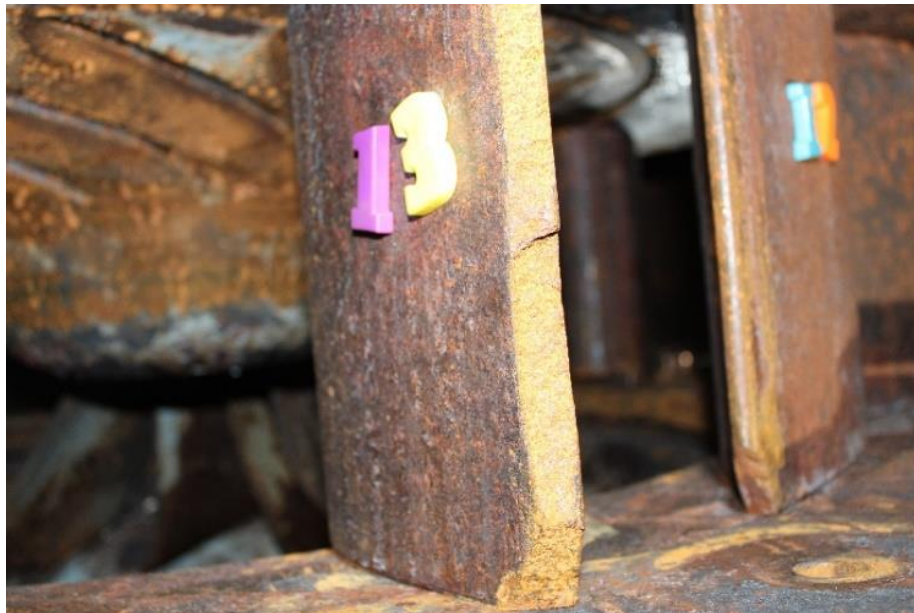
### **Wicket gate 13**

*Figure 24: Wicket gate 13*

This wicket gate only suffered damage on the lower tip of the edge. Most definitively caused by impact. Was found rotated over 180 degrees to its expected position. Control link completely destroyed.

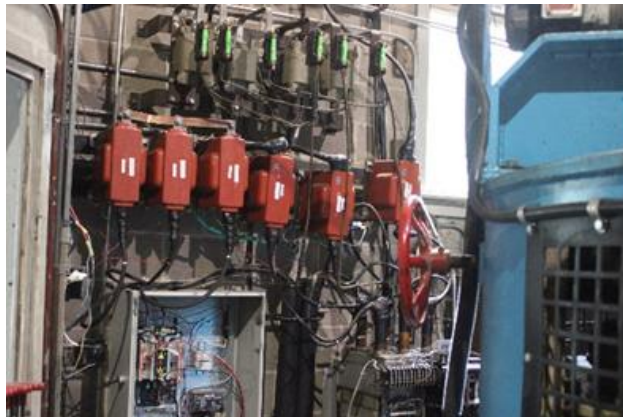
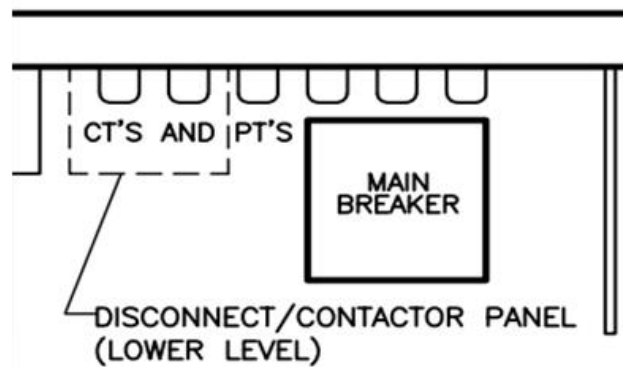
*Figure 30: Description Unit Circuit Breaker.*

A proper switchgear cabinet is not present in the plant. The breakers are exposed, even though they are individually guarded and insulated. As per the interviews with the personnel, there are not know electrical issues.

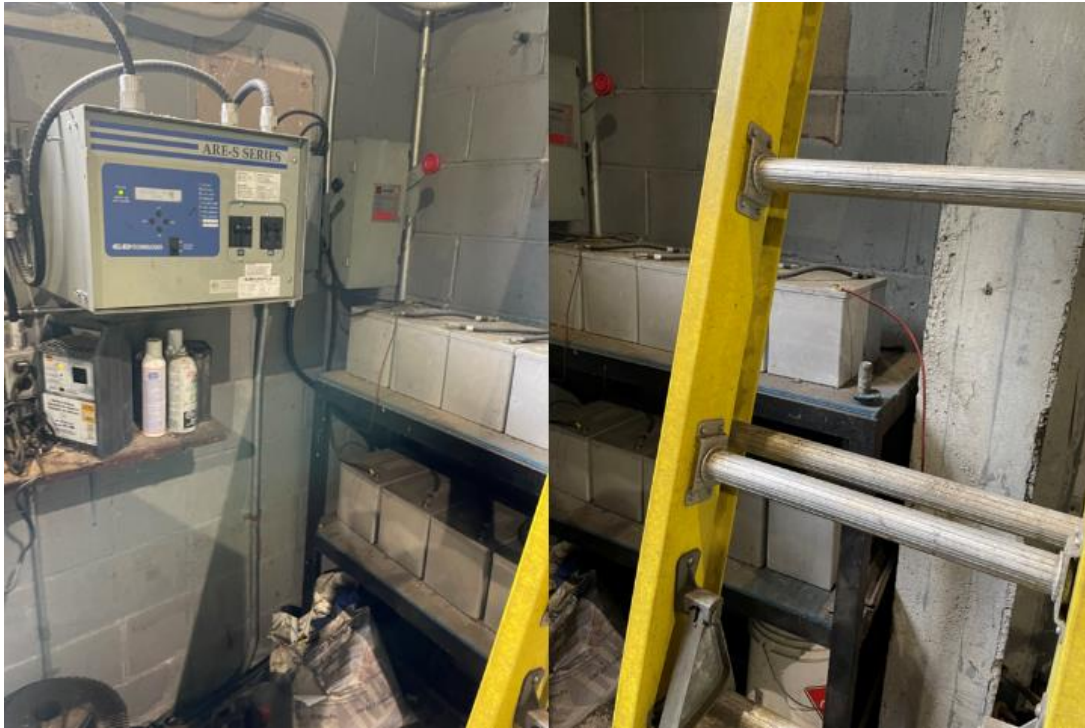
Figure 34: Battery bank and charger

Battery bank looks quite dirty, but it is functional. The charging system is working properly.

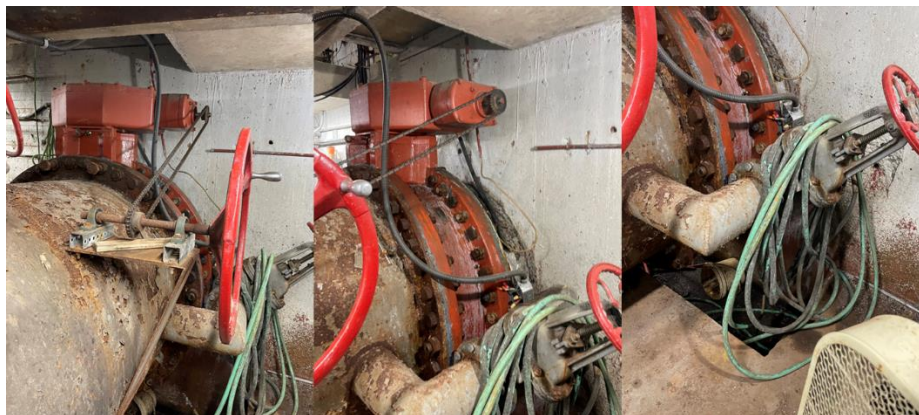
*Figure 36: Intake valve*

The valve is in very good condition, operates like it should be, and does not have any noticeable problems. From our inspection inside the scroll case there are no signs of leaks. The water in the case was leftover of the drainage. There are no concerns on the valve.

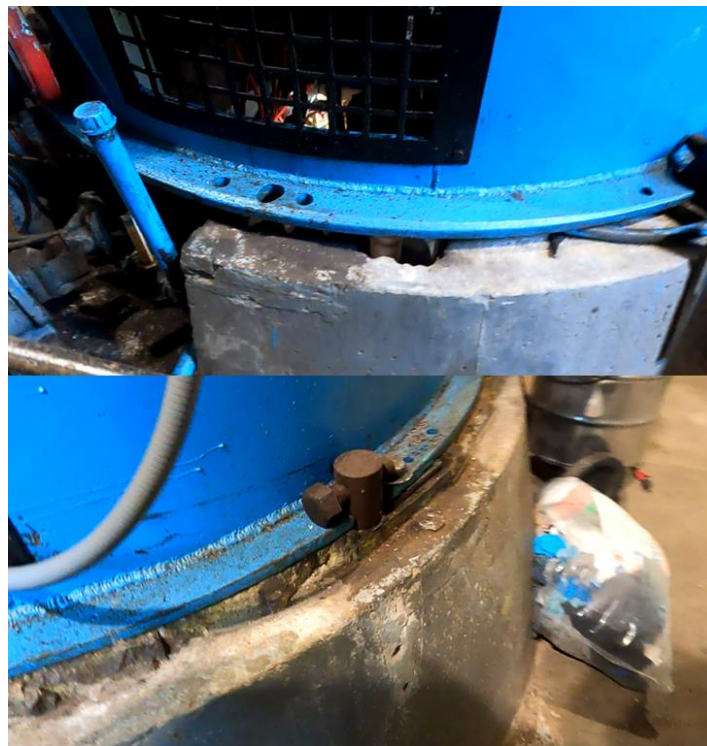
*Figure 41: Concrete base of the generator*

The concrete base of the generator as well is in good shape. Minor wear, expected for many years of service, but nothing that cannot be addressed without major effort. This was in fact checked from the inside of the unit, entering from the turbine floor.

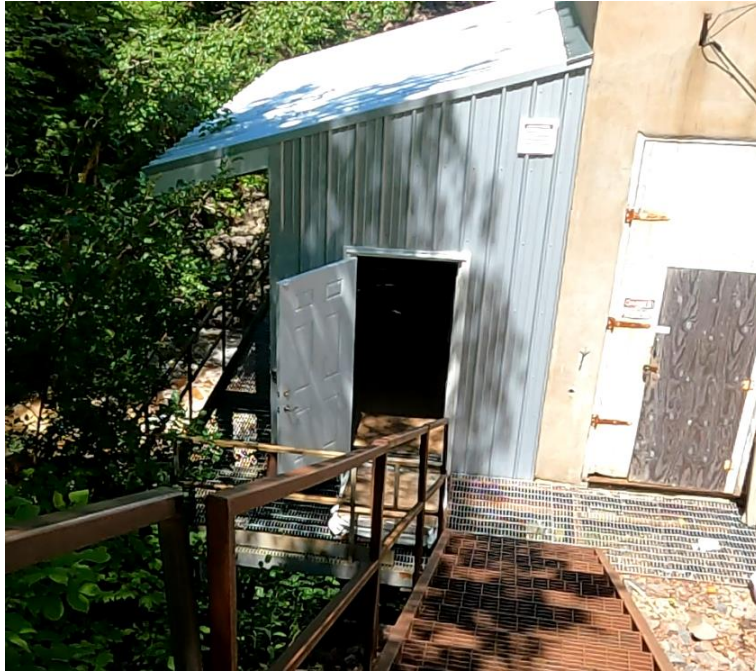
### 3.9.2 Building annex:

*Figure 42: Building annex*

This annex was built recently apparently, but we don't have the records of when that was done. Most definitely the construction was performed very professionally, and the design was done by engineers, there must be records. We didn't find issues with the building.

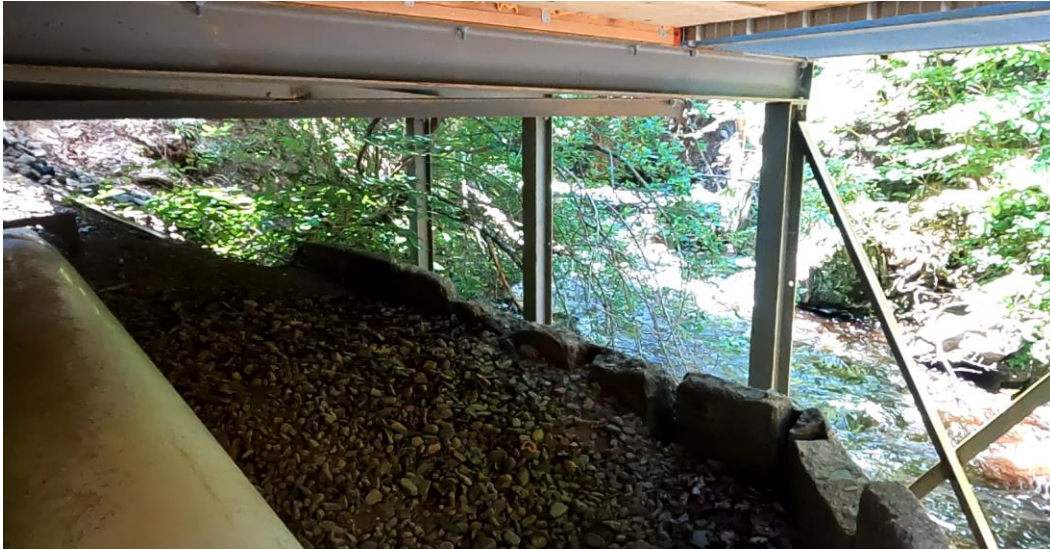
### 3.9.3 Gravel retainer wall:

*Figure 43: Gravel retainer wall*

Just below the building annex, a retaining wall is present, which looks like is original from the plant. The only drawing that we had access to does not shown this wall. It has a crack, that has been growing over the years apparently, and basically separated the wall in two.

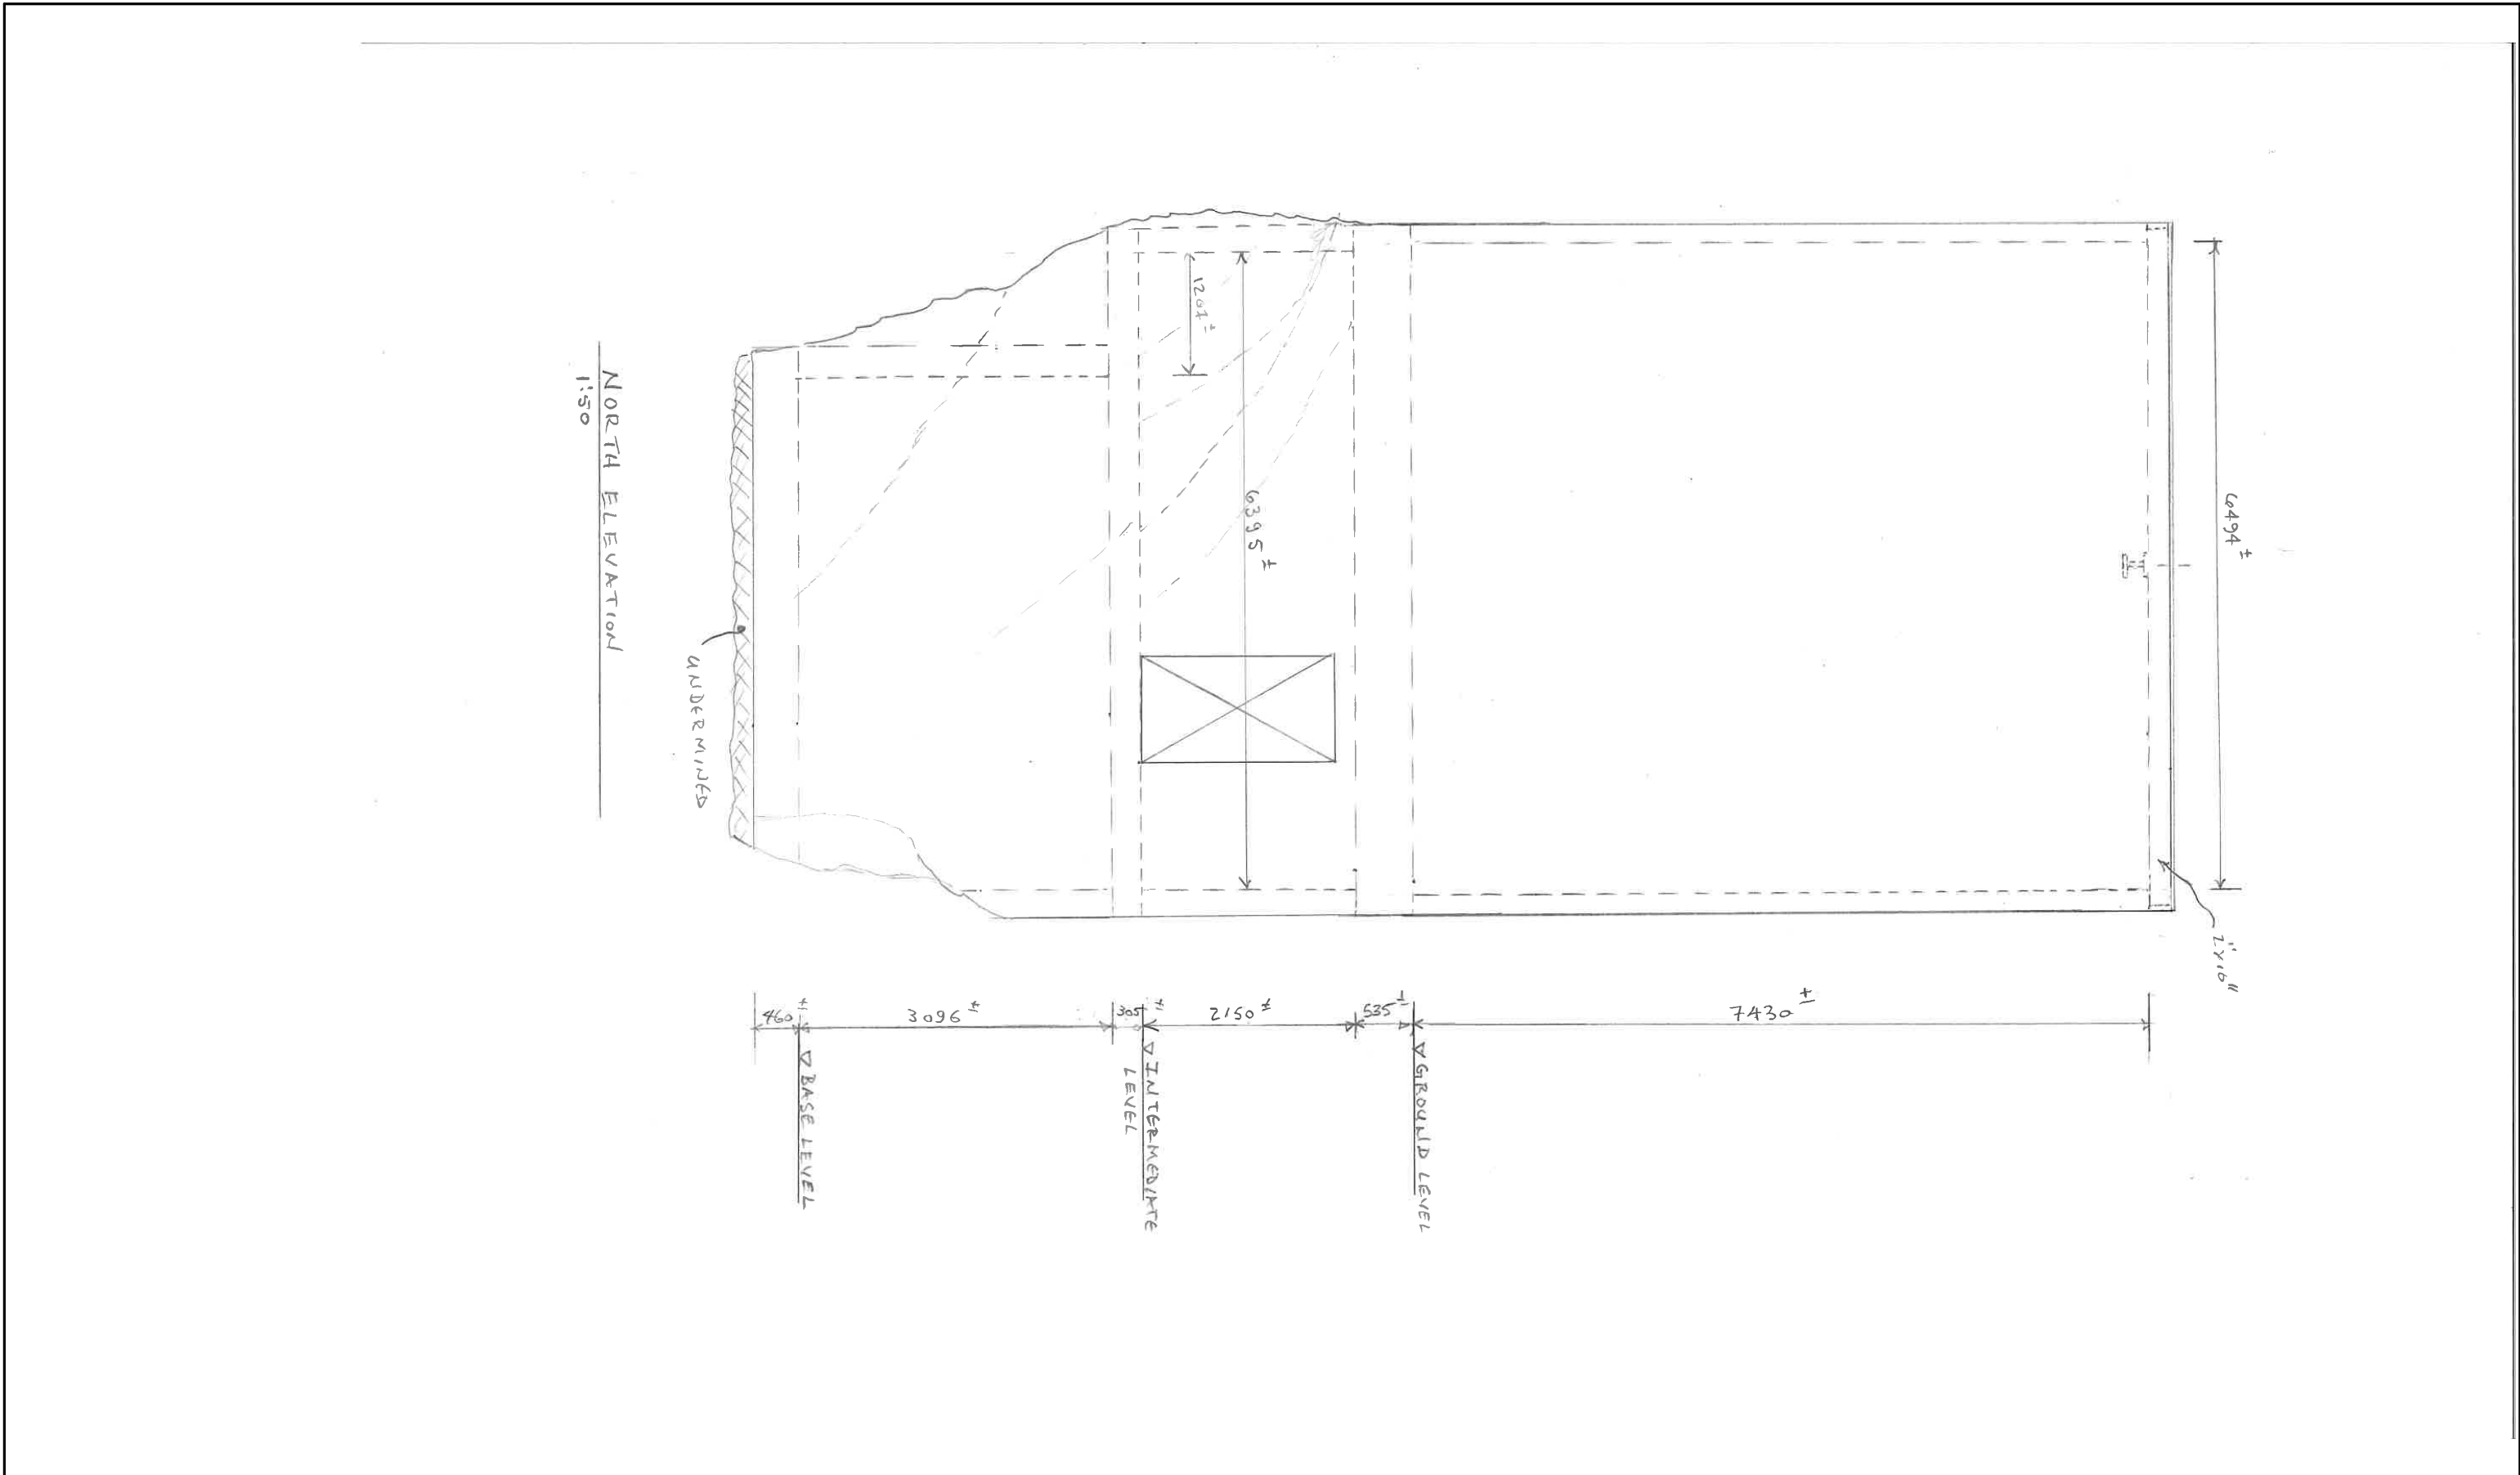
- 1) **Ground/Main Level:** The interior dimensions of the Ground Level are approximately 6,495 mm x 5,315 mm. Walls are constructed with concrete block masonry with an approximate wall height of 7,430 mm, as shown on the attached elevation sketch of the North side of the building. Due to the height of the block masonry, it is likely that the masonry is partially or fully grouted and may be reinforced. There were no cracks visible on the interior surfaces of the block walls and the masonry is in good condition.

There are diagonal cracks in the north wall that start near the top of the northeast corner, with maximum crack widths varying from 1.5 mm to 3 mm. Photo 3 shows the cracks on the interior wall face and Photo 4 shows the same cracks on the exterior building face. From the latter photo, it can be seen that the cracks propagate from a spalled area at the northeast corner. Efflorescence stains are visible near the bottom of the cracks, indicating water transmission, however, minimal or no rust stains from corrosion of reinforcing steel is visible. The cracks are roughly plotted on the attached sketch of the North Elevation. The cracks continue onto the east wall as shown in Photo 5.

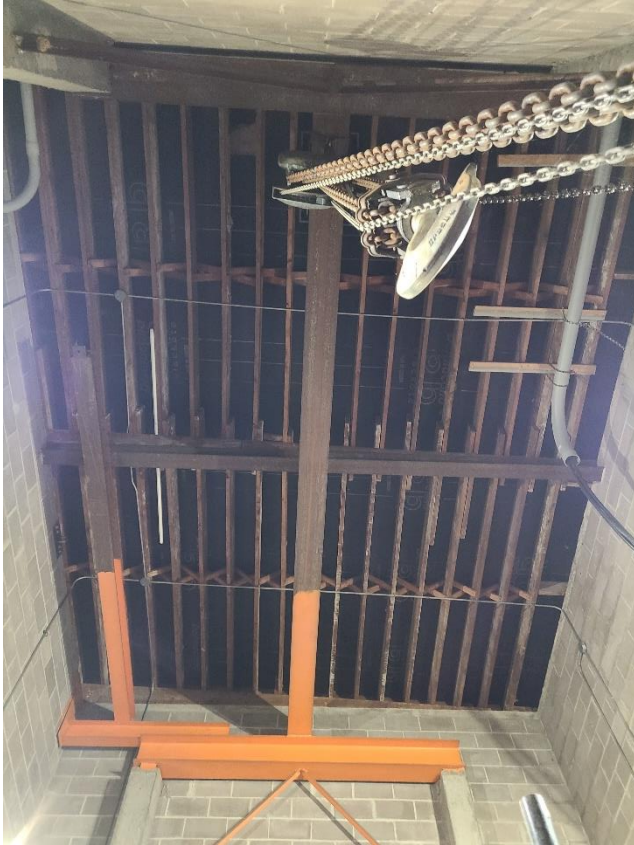
A W460 hoist beam runs from east to west at the center of the building. The beam is supported at each end by a cross beam on two concrete columns. The columns are 250 x 280 mm and appeared to be in good condition. The chain hoist on the hoist beam had been previously load tested and had a posted load limit of 9,991 kg.

1. Roof framing, hoist beam and chain hoist.

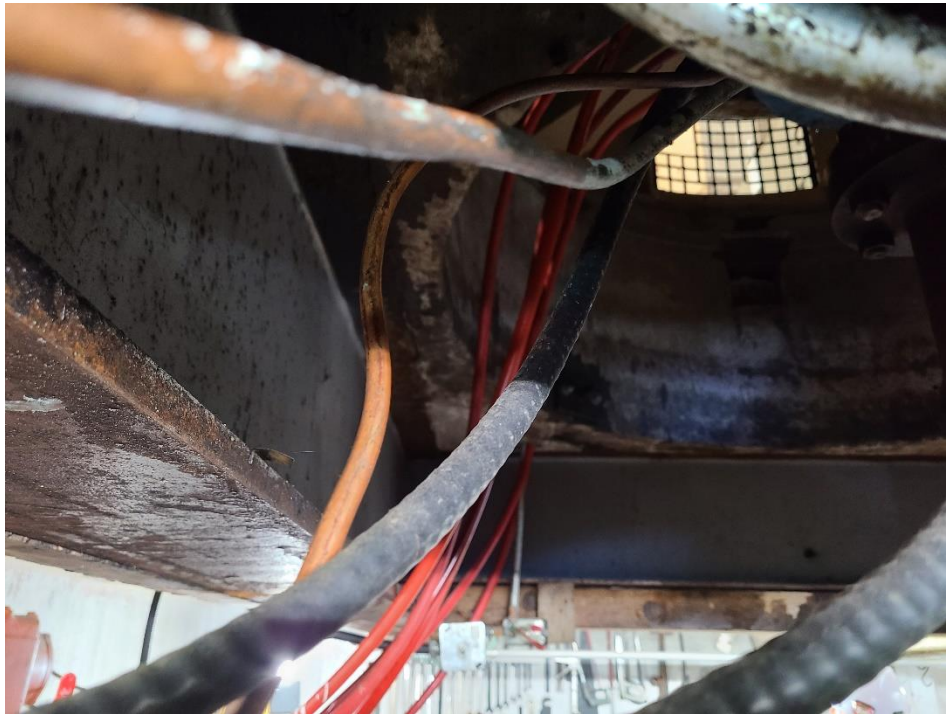
The Ground Level floor is a 535 mm (21") thick concrete slab. There is an opening in the center of the floor with a concrete perimeter curb that supports an electrical generator (Photo 2). On north and south sides of the opening, a W460 steel beam runs east to west and is supported on the concrete end walls. Running east to west on either side of the opening between the two W460 beams are two W360 beams. The underside of these four beams is 230 mm below the bottom of the slab. Steel beams are in good condition with only minor surface corrosion. The floor slab also appears to be in good condition.

2. Steel beams around floor opening below generator.

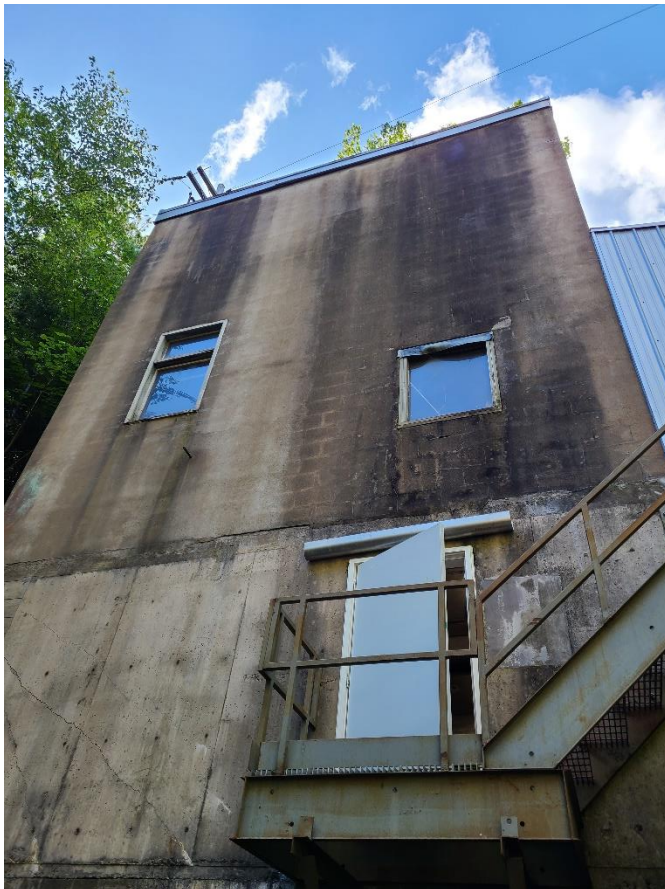
8. North face of building.

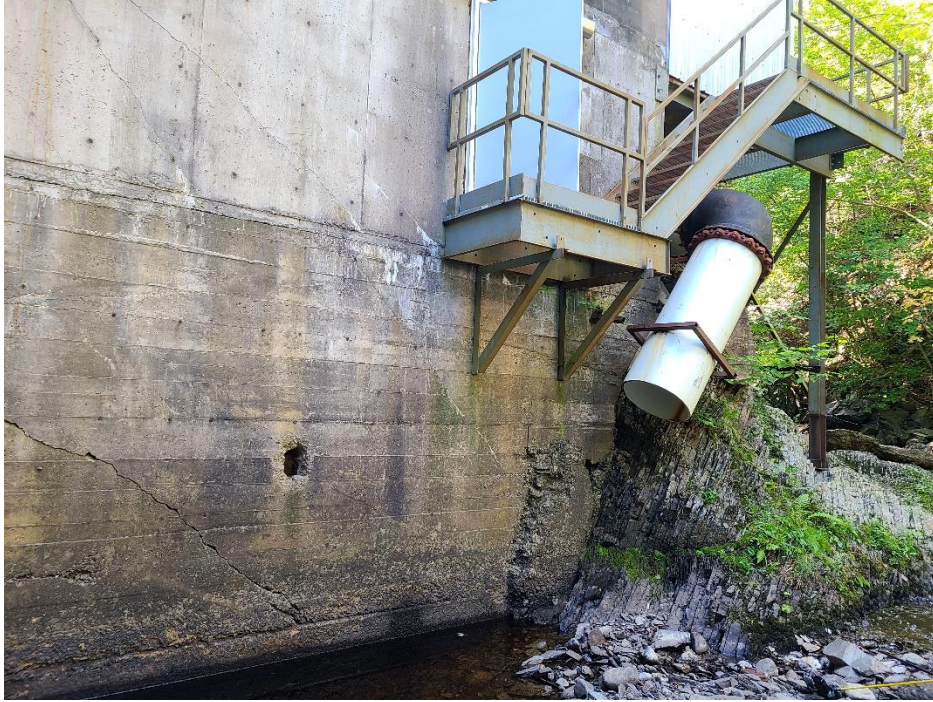
9. North face at Base Level.

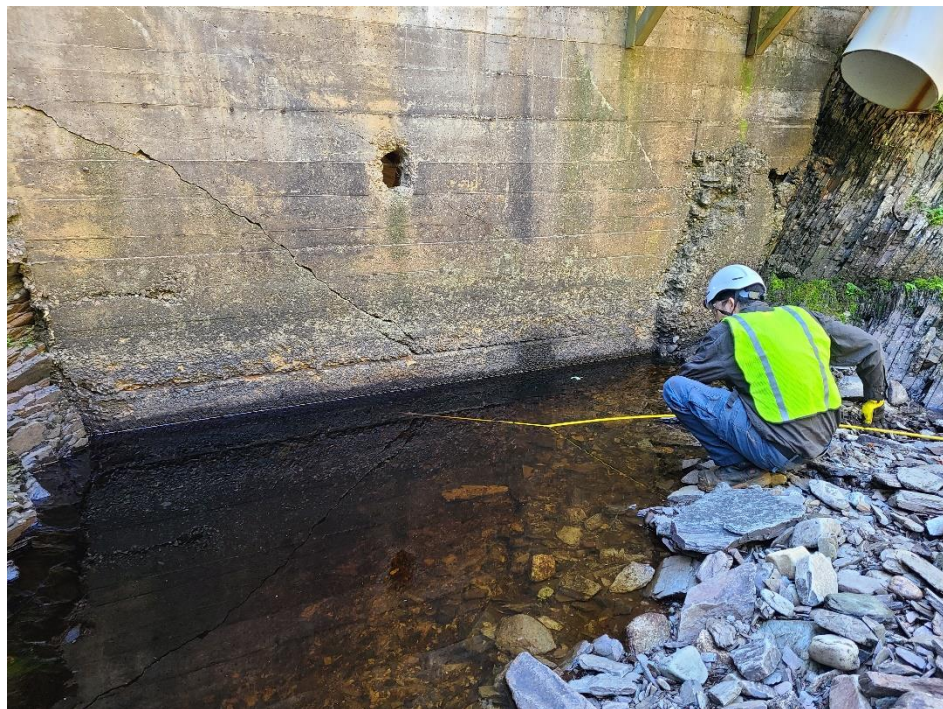
10. Probing undermined area below base slab.
