# APPENDICES

BEC-M12795-Appendices

Proposal for Owner's Engineer Services:  
Factorydale Turbine Project – Town of Berwick Electric Commission

**Owner's Engineer for Factorydale  
Turbine Project**

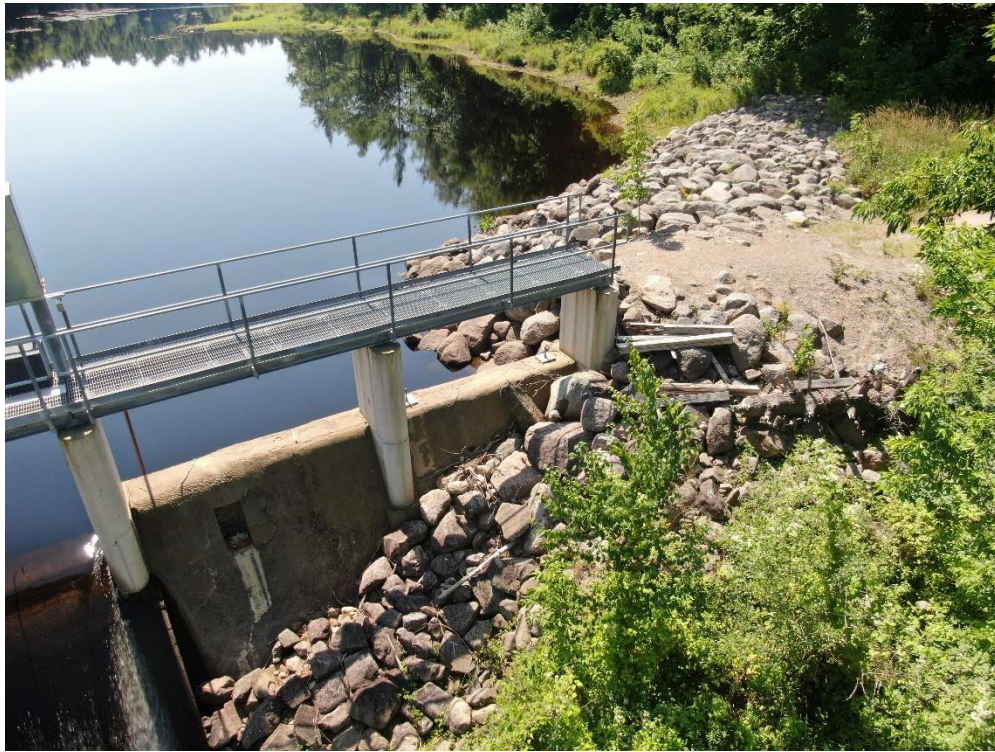
**Photo 3** Left Dam Section (Partially Entombed)

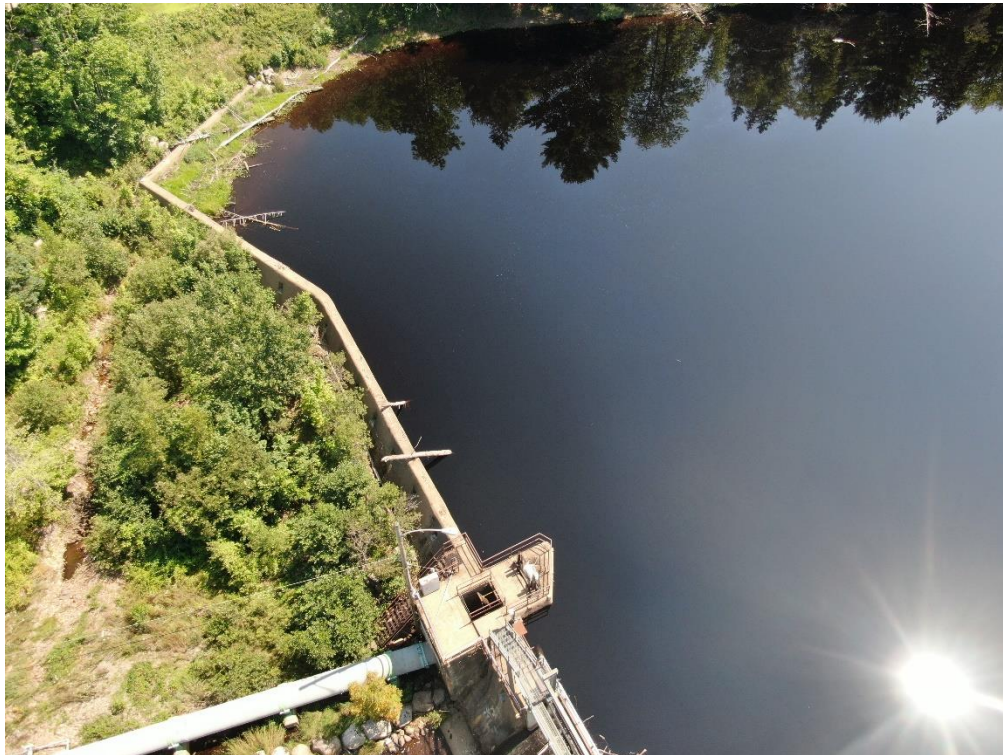
**Photo 4** Right dam Section

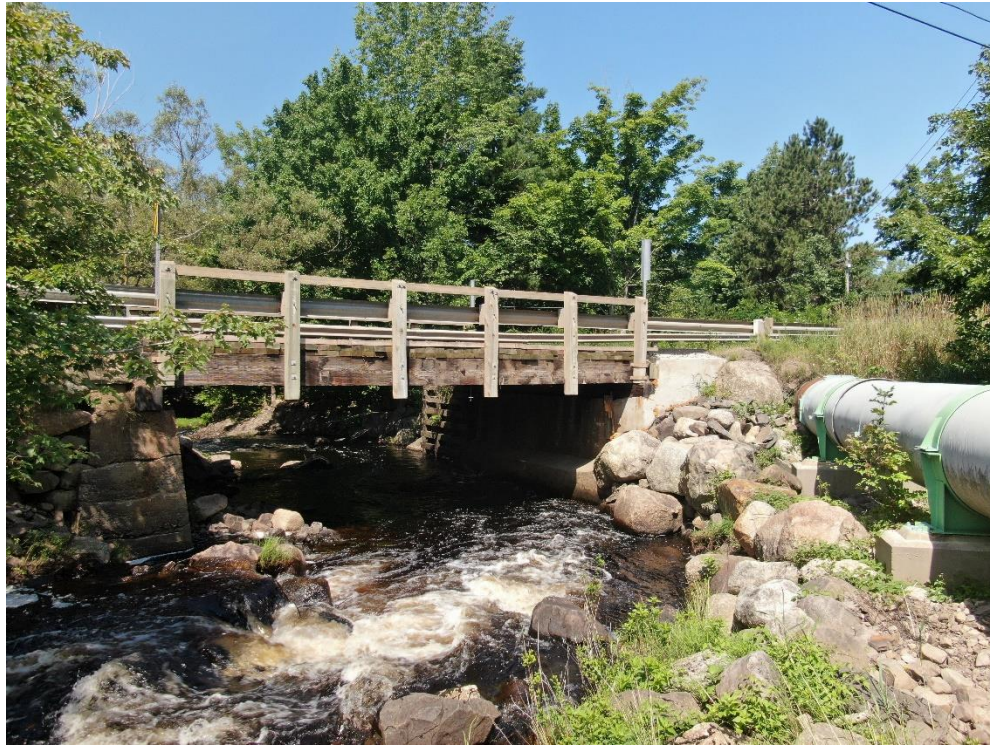
**Photo 5** Downstream Bridge (Harmony Rd)

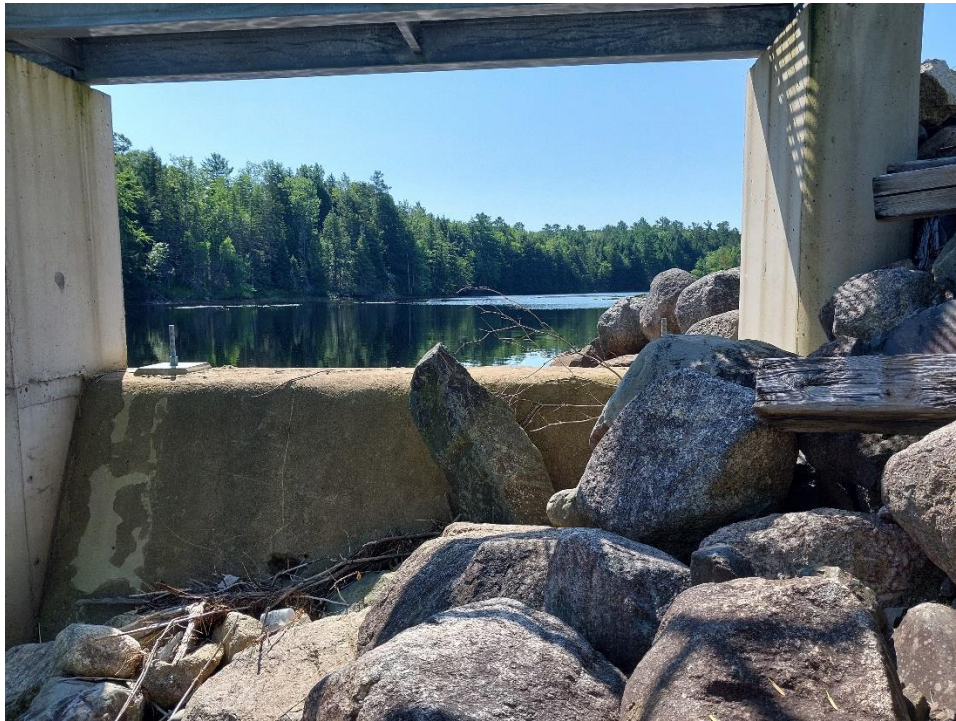
**Photo 6** Exposed Portion of Left Dam Section

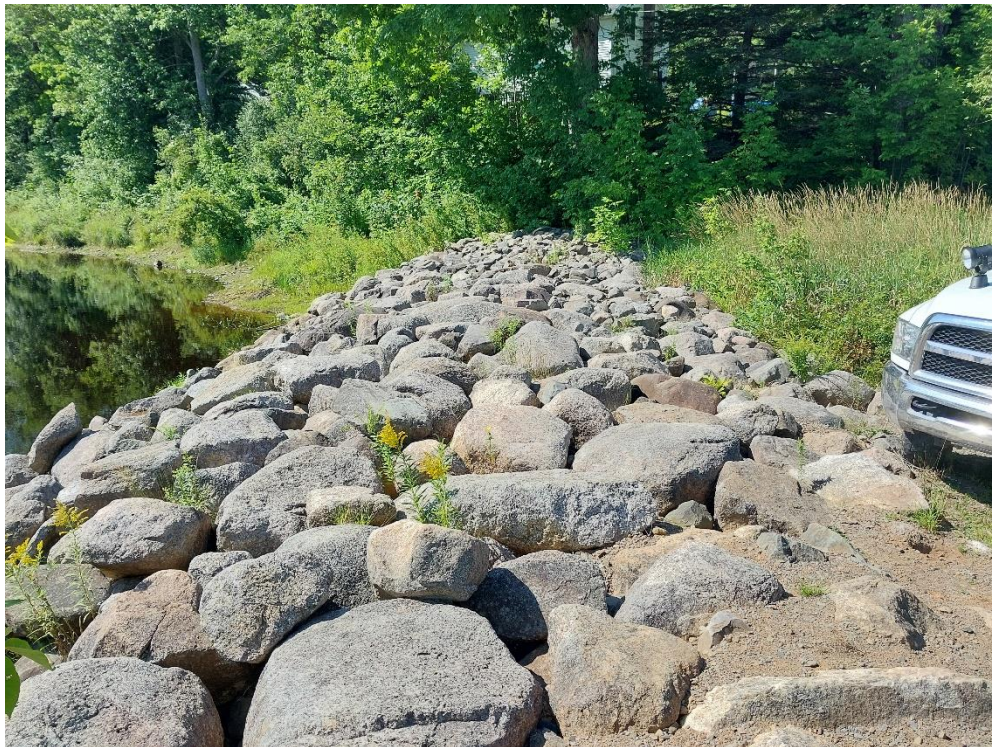
**Photo 8** Entombed Portion of Left Dam Section

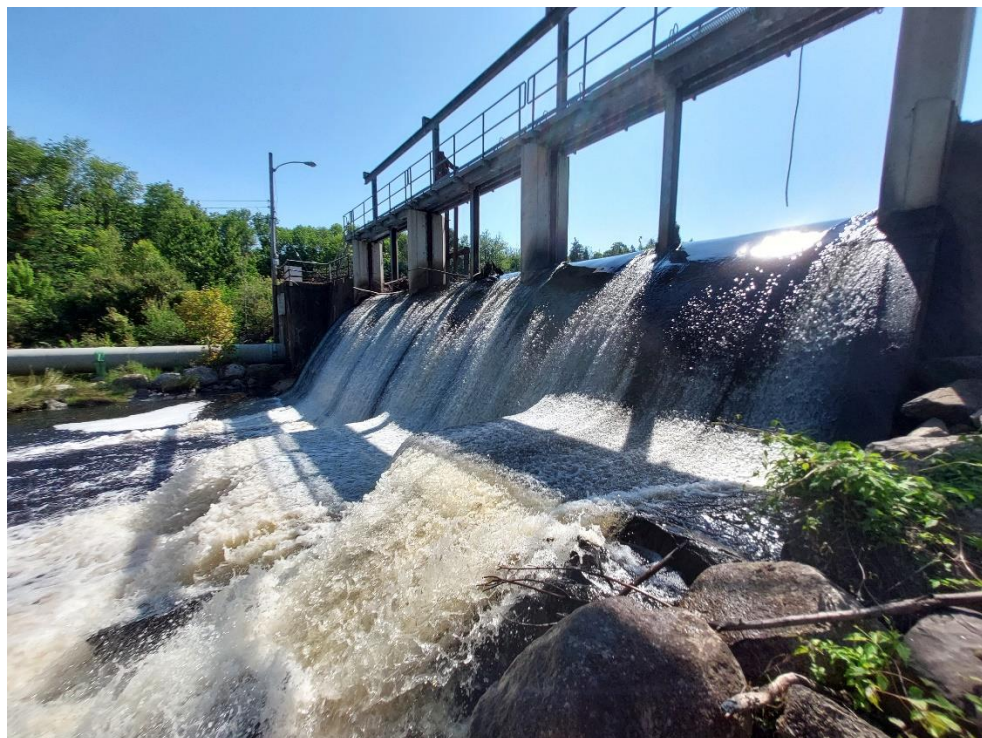
**Photo 10** Spillway Looking from Left Side

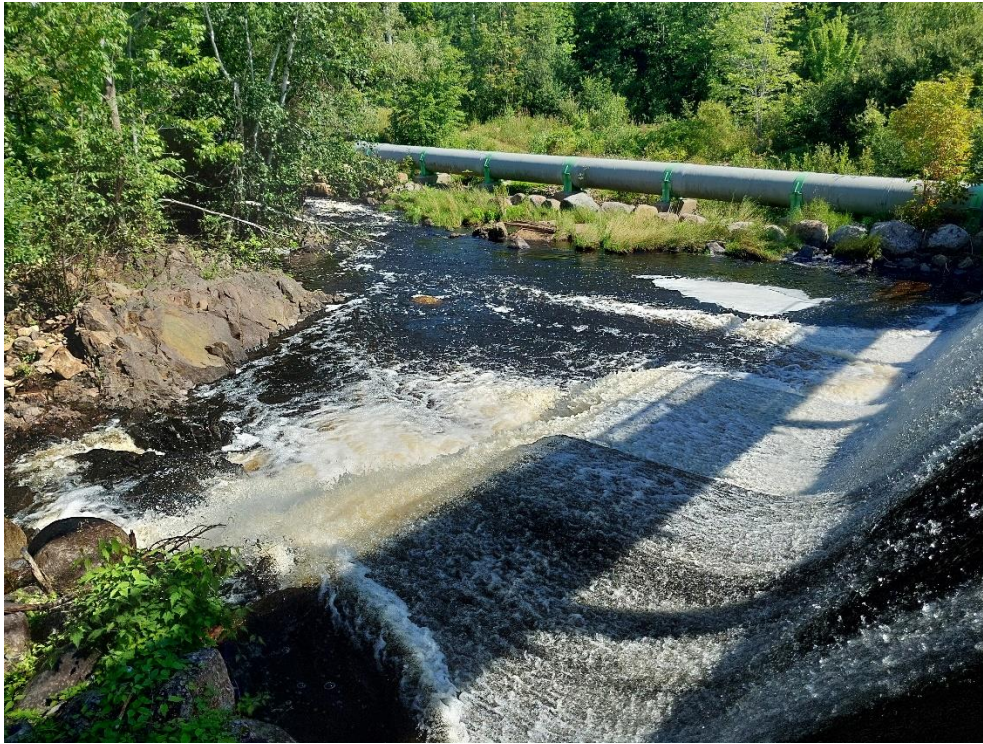
**Photo 11** Tailwater of Spillway Looking from Left Side

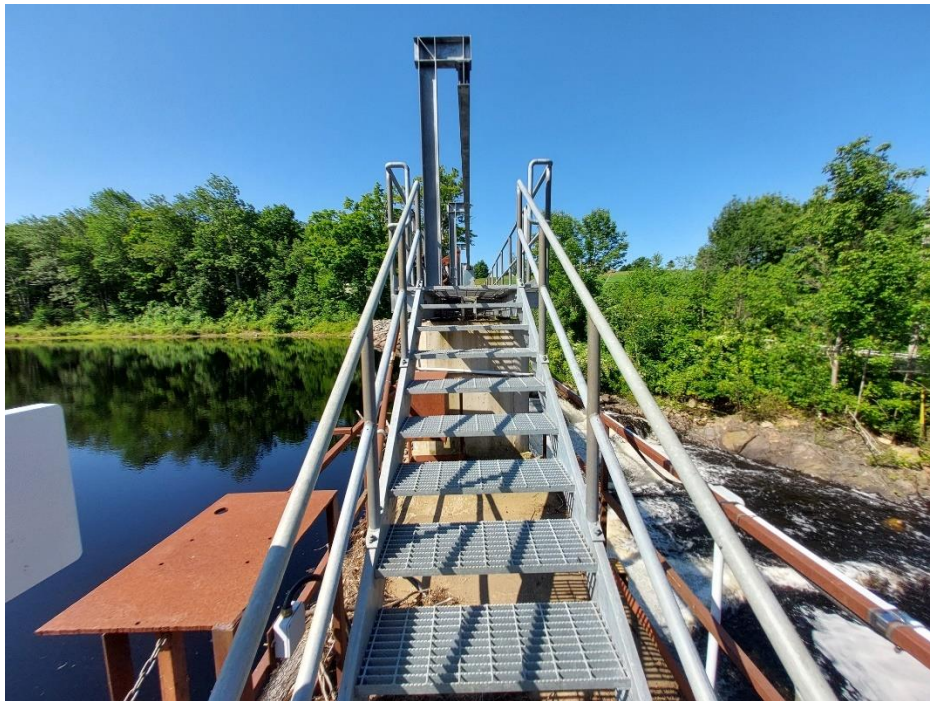
**Photo 12** Stairs to Catwalk and hoist mechanisms

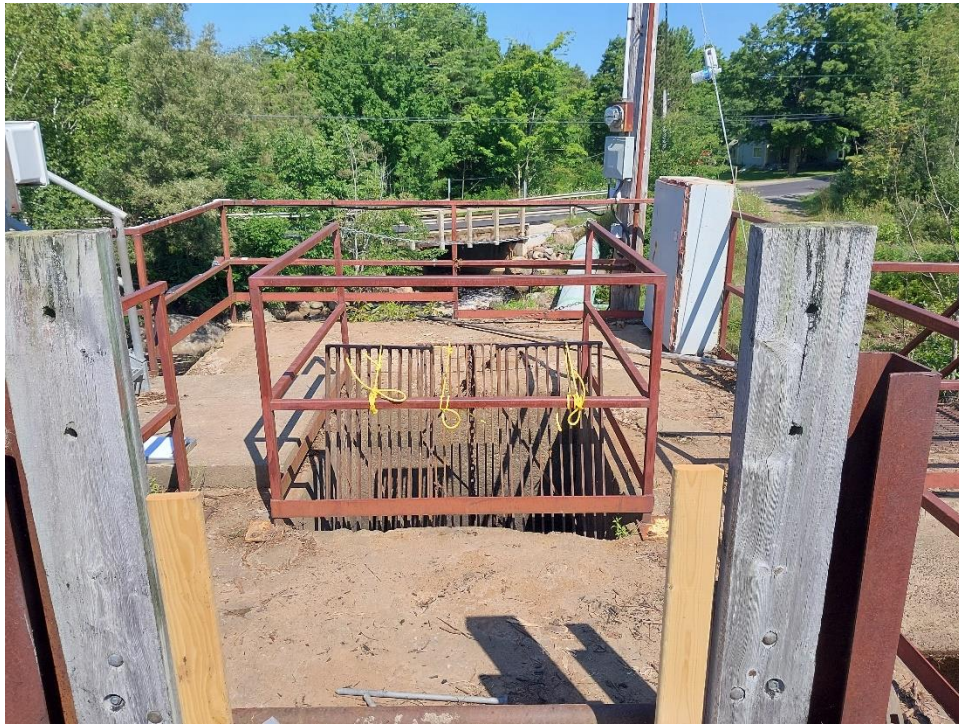
**Photo 17** Dewatered Penstock Intake Shaft During Maintenance

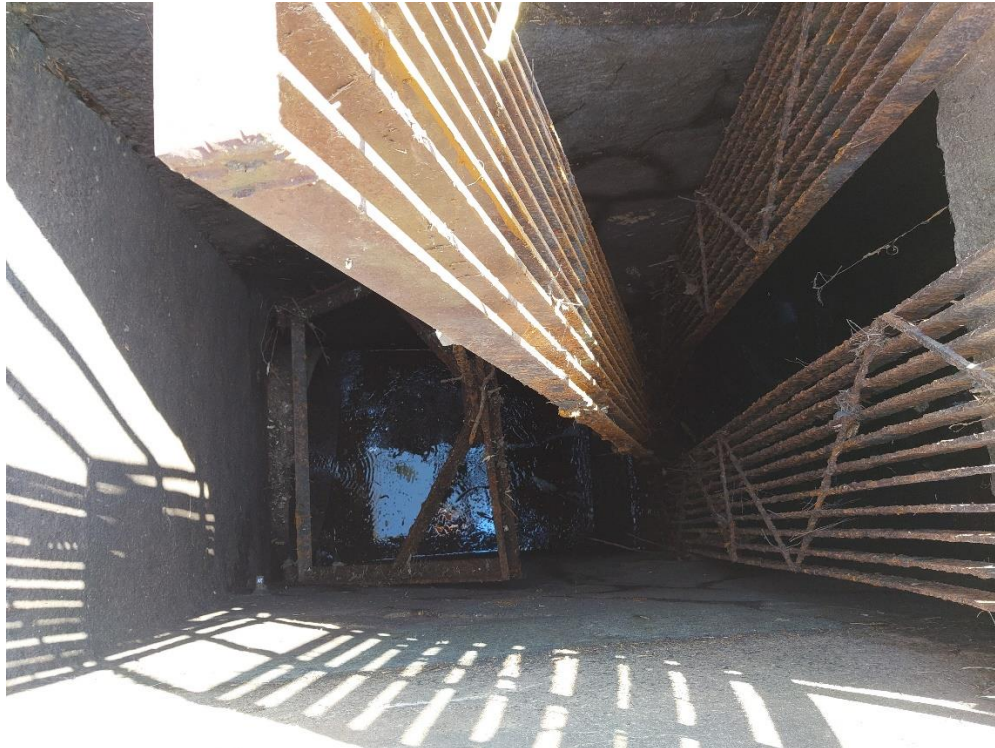
**Photo 18** Looking into Intake Shaft Dewatered for Maintenance

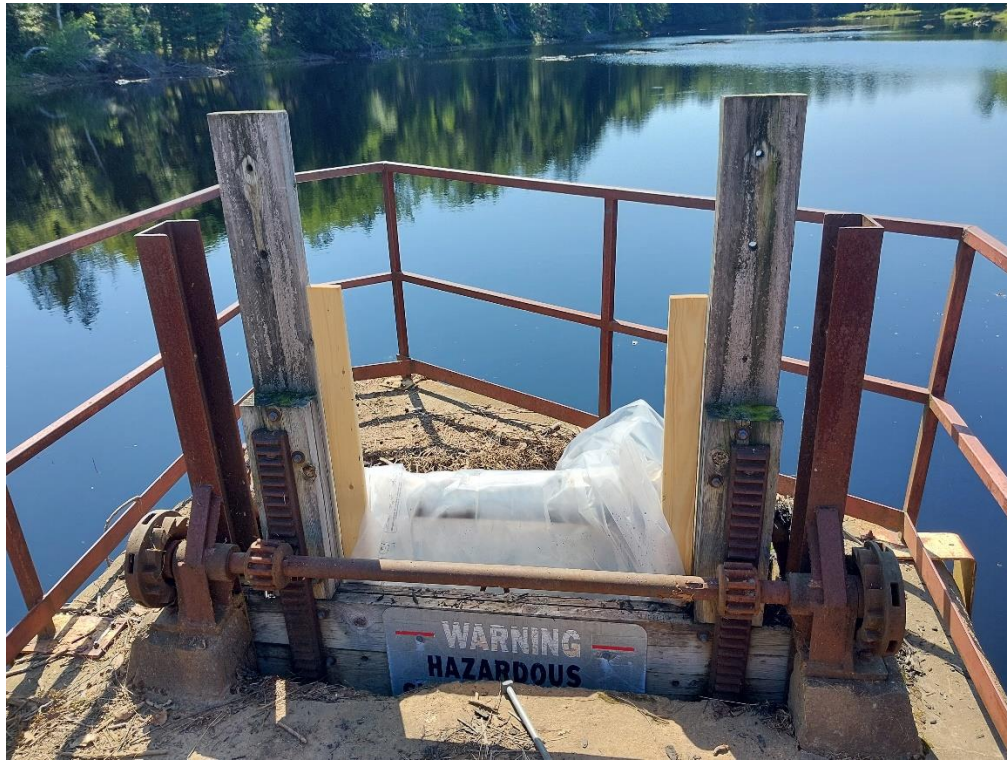
**Photo 19** Plastic Seal in Front of Dewatered Intake Shaft

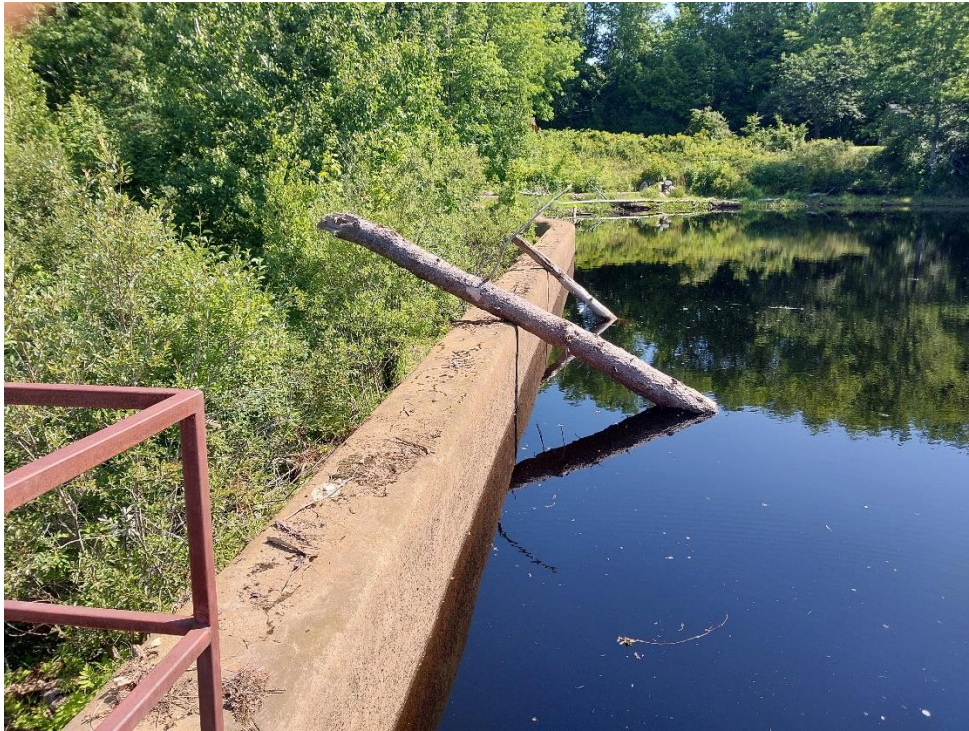
**Photo 21** Right Dam Section Looking from Penstock Intake

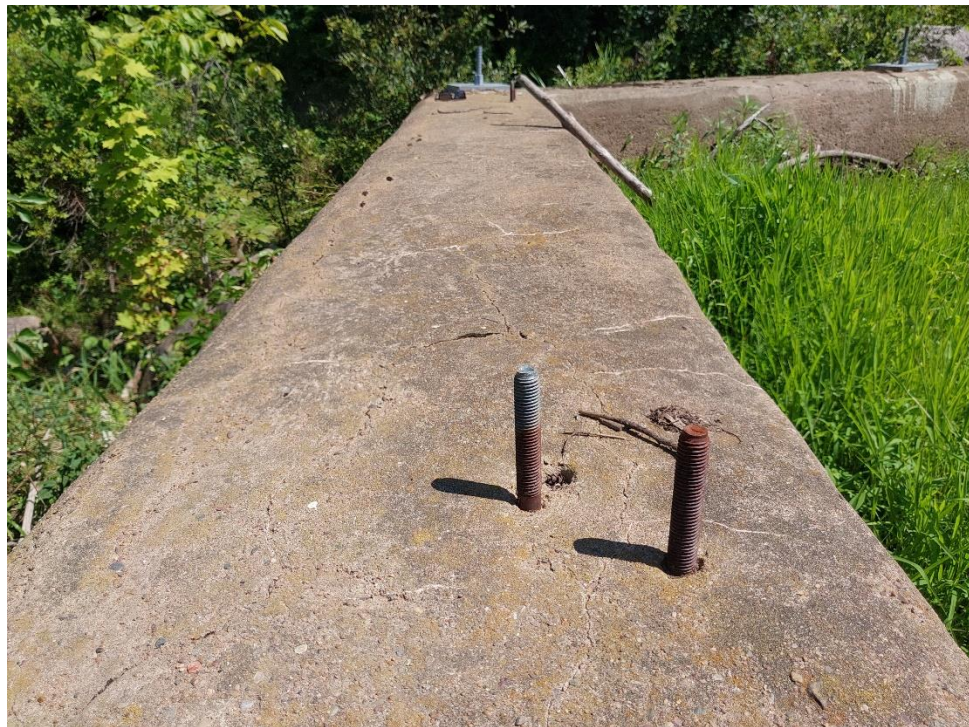
**Photo 22** Bolts for Stoplog Gains On Right Dam Section

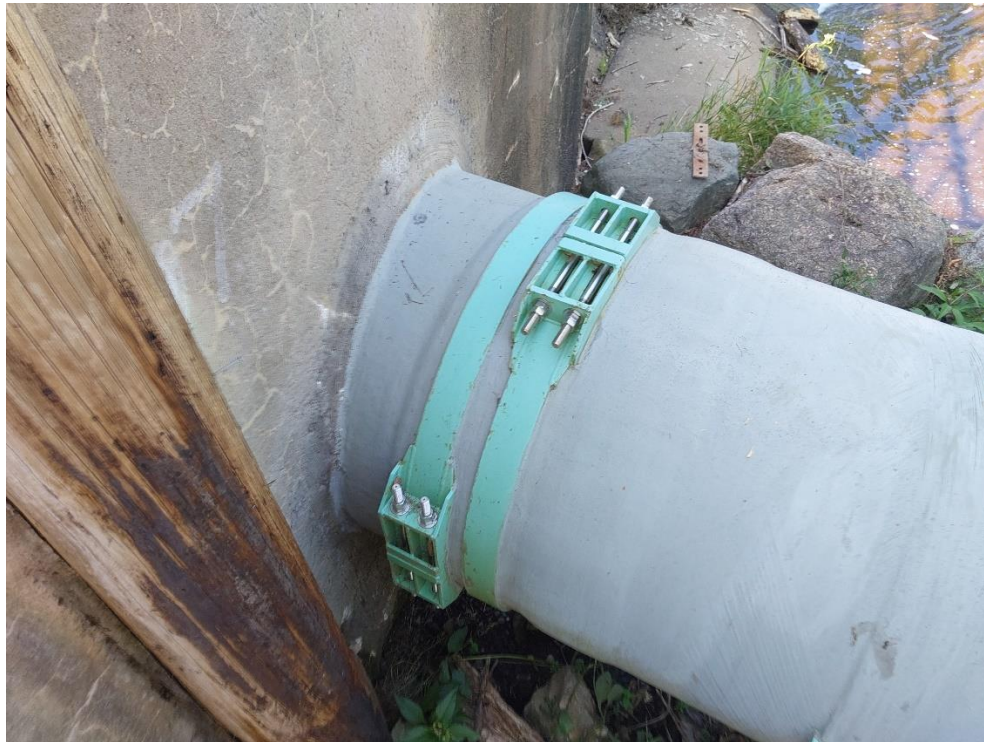
**Photo 28** Connection Point for Penstock

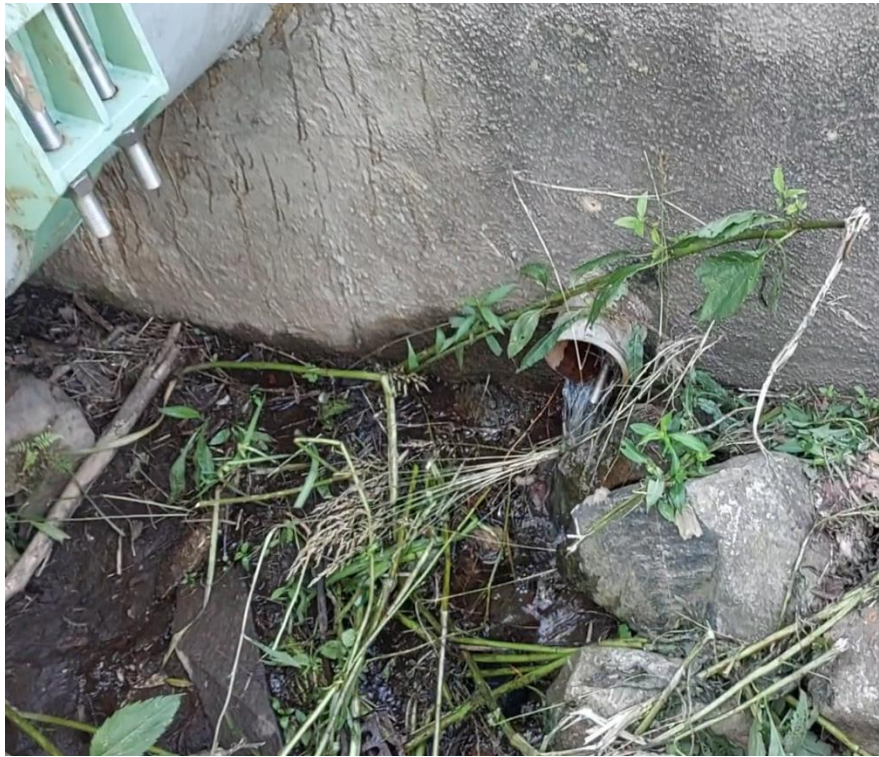
**Photo 29** Drain Pipe Next To Penstock

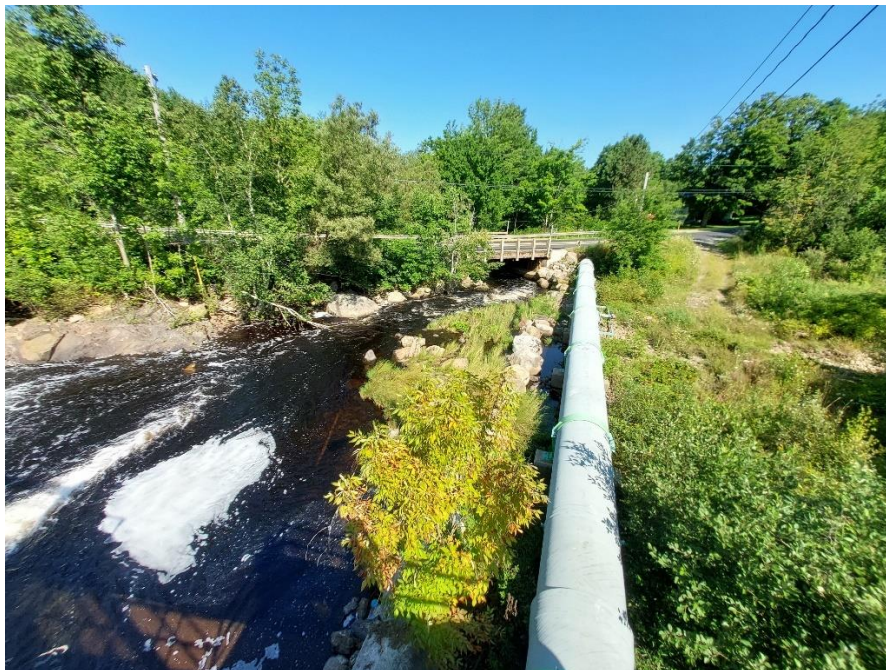
**Photo 30** Penstock Alignment Looking Downstream from Intake
