**Canso Crossing Vibration Mitigation**

Project Title: L7005 Canso Crossing Vibration Mitigation

CI Number: C0044172

## **Energy Delivery Engineering**

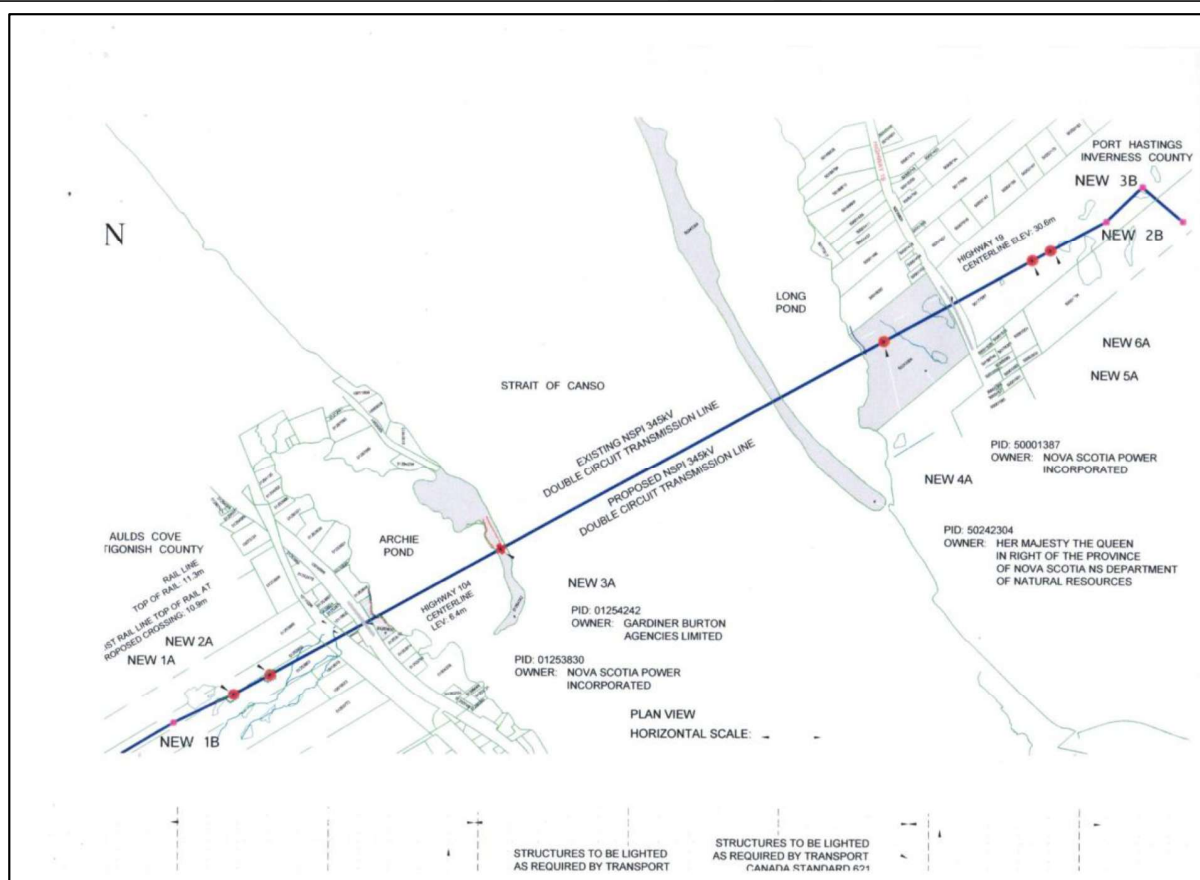
Figure 1 Plan of the new towers and 345 kV double circuit spans across the Strait of Canso

The 345 kV crossing of the Canso Strait is the second crossing span and was built in 2017. Figure 1 shows the plan of the crossing including the new towers. Initial operation is at 230 kV, but the line was designed for ultimate use at 345 kV. The location is across a narrow waterway between the mainland of Nova Scotia and Cape Breton Island. Damage to the main conductor during the first years of service is severe and attributed to the limited capability of the design to control wind induced vibrations. This interim report is intended to review the available data, and to propose short term and long-term corrective measures going forward.

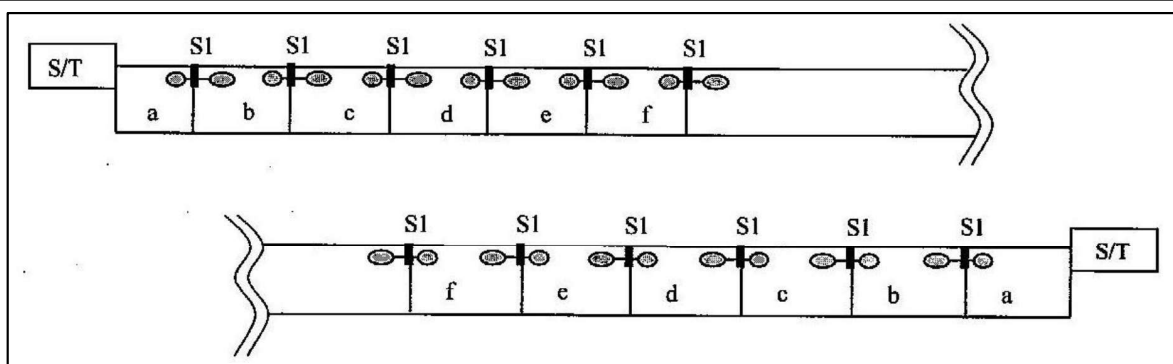
Figure 3 Array of 6 Salvi 4MS529VZ0952X vibration dampers on AACSR conductor for each end of the 1445 m Canso crossing span.

Dimensions: a 1.8m, b 2.0m, c 2.3m, d 1.5m, e 0.8m, f 1.3m

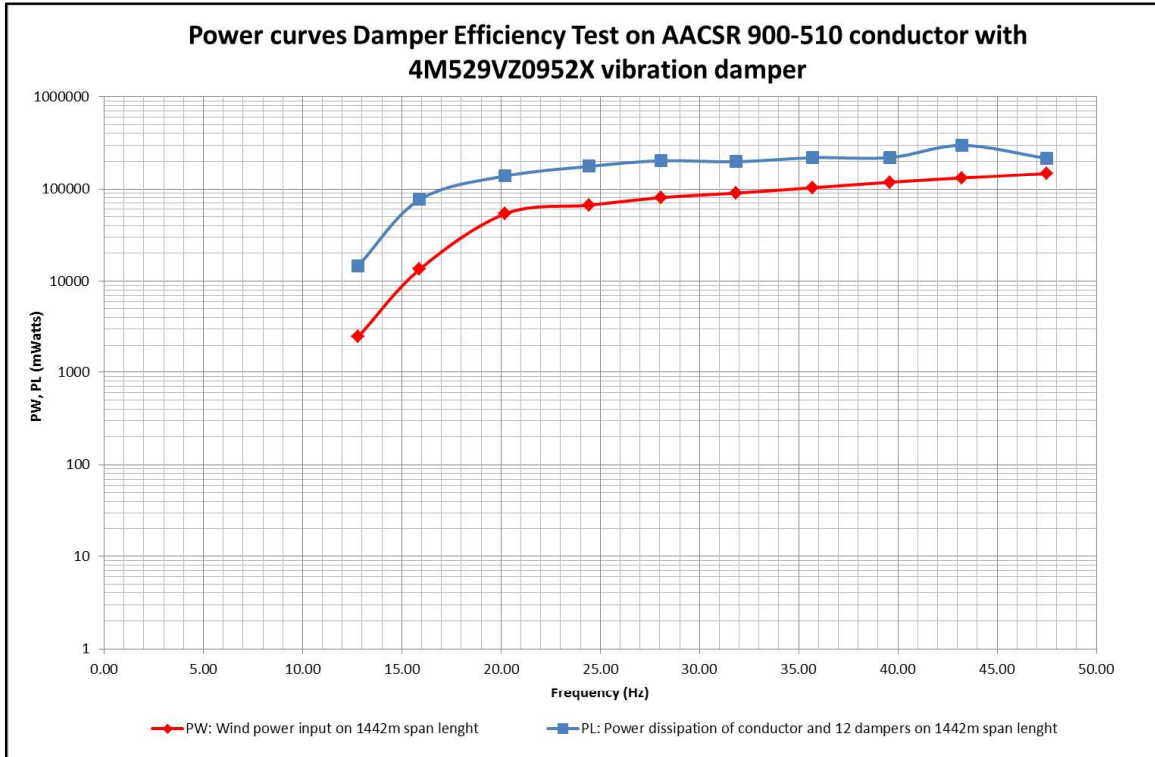
The damping scheme was replicated on the Dervaux indoor test span. The test is described in Dervaux' document PV20\_17 Damper Efficiency Test on AACSR 900-510.pdf. Figure 4 shows the resulting comparison between the computed aeolian wind power transferred to the 1445 m length of conductor (with no ice), and the scaled energy absorbed by the six-damper array at each end of the span. The figure shows that the energy absorbed exceeds the wind energy applied over the test range.

Figure 4 Power versus frequency for array of 6 Salvi 4MS529VZ0952X vibration dampers on AACSR conductor for the 1445 m Canso crossing span

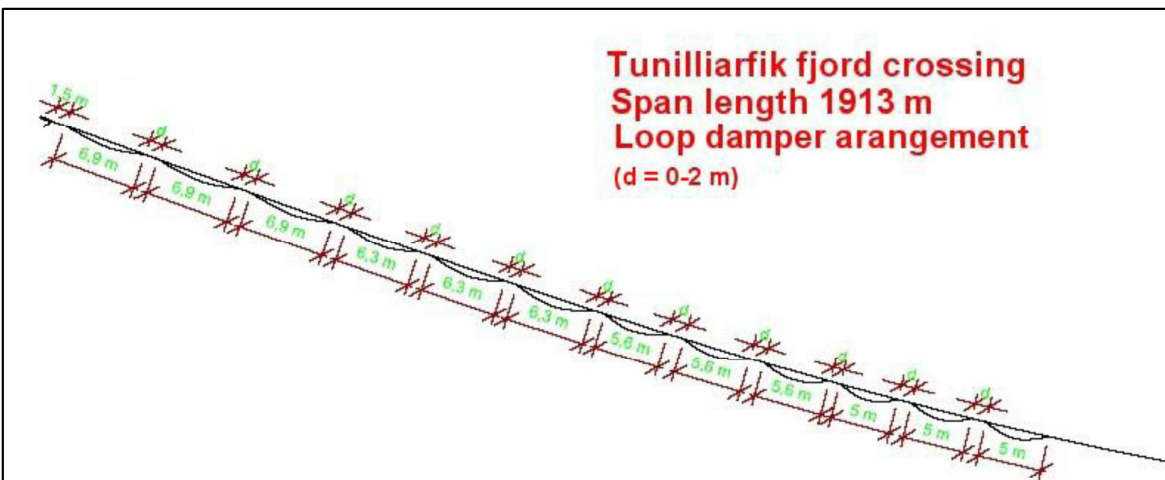
Figure 6 Loop Dampers Installed at each end of the Tunilliarfik Fjord crossing.

Total Length of Loop Dampers is about 84 m

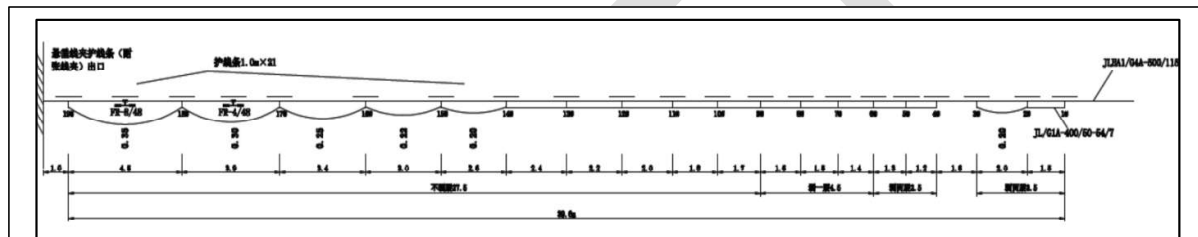
ZTT cable was critical of the SALVI damping scheme, and also of the design of the end fitting for the main conductor, before the crossing was erected (About Canso Crossing – 200170203 .docx “Some questions and concerns about 345 kV overhead transmission line Strait of Canso crossing”) The outlined their check of fittings and damper design by Salvi from ZTT and state that the string fittings were comparable to ZTT practice but the tension clamp design and the damping scheme were different. In their opinion, the damping scheme with 6 SALVI dampers per end has long term risks, especially with ice present. ZTT offered an alternative damping scheme with dampers plus damping wire loops. This is shown in Figure 7. The report cites a previous failure of a Yangtse river crossing with a Salvi designed damping scheme.

Figure 7 Diagram of combined loop dampers and Stockbridge dampers from ZTT  
(ZTT document About Canso Crossing – 20170203.docx)

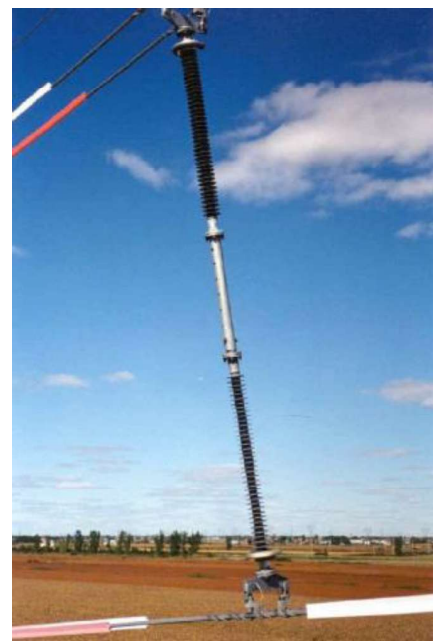
Figure 8 interphase spacer for Hydro Quebec Power lines

the three full sized test spans, and the circuit was vertically aligned. But the principle is ready adaptable to the long span and delta configuration of the Canso crossing spans. Figures 8 and 9 shows one of the interphase spacers and the span configuration at the Hydro Quebec outdoor test site.

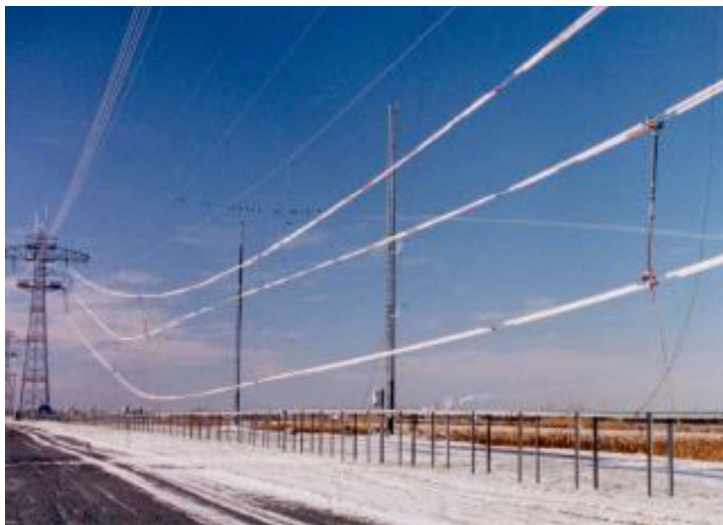
Figure 9 Hydro Quebec outdoor test line with four interphase spacers in the span during galloping.

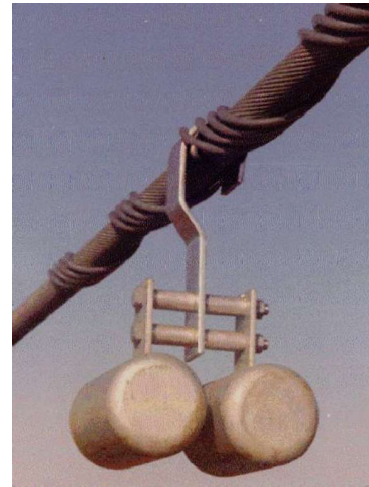
Detuning pendulums are weights attached to the conductor, either single or bundle, at a prescribed arm length to impose a torsional rotation on the conductor that is different from the normal wind driven torsional motion seen during galloping. This torsional motion interferes with the resonance between vertical oscillation and torsional motion that is a natural component of galloping of overhead conductors. In the normal range of span lengths and diameter encountered on overhead transmission lines, their effectiveness is well established

Figure 10 Detuning pendulum

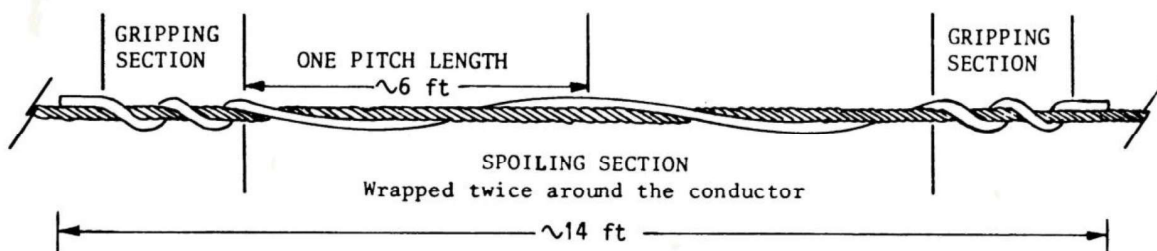
Air flow spoilers are a wrap of PVC rod designed to modify the flow of the wind around the conductor to break up coordinated eddies from vortex shedding, in a similar fashion to strakes of a vertical chimney. They are most suited for small single conductors, such as overhead ground wires and distribution lines. They are installed in two clusters at the one quarter and three-quarter

Figure 11 Air flow spoiler

points in the span. Each cluster covers one quarter of the span length. In field trials carried out in the 1980s, they were shown to provide good control of galloping up to ice or wet snow coverage less than about 25 mm (1 inch). [Whapham 1982]. Air flow spoilers were used on the first crossing span to overcome severe galloping motions.

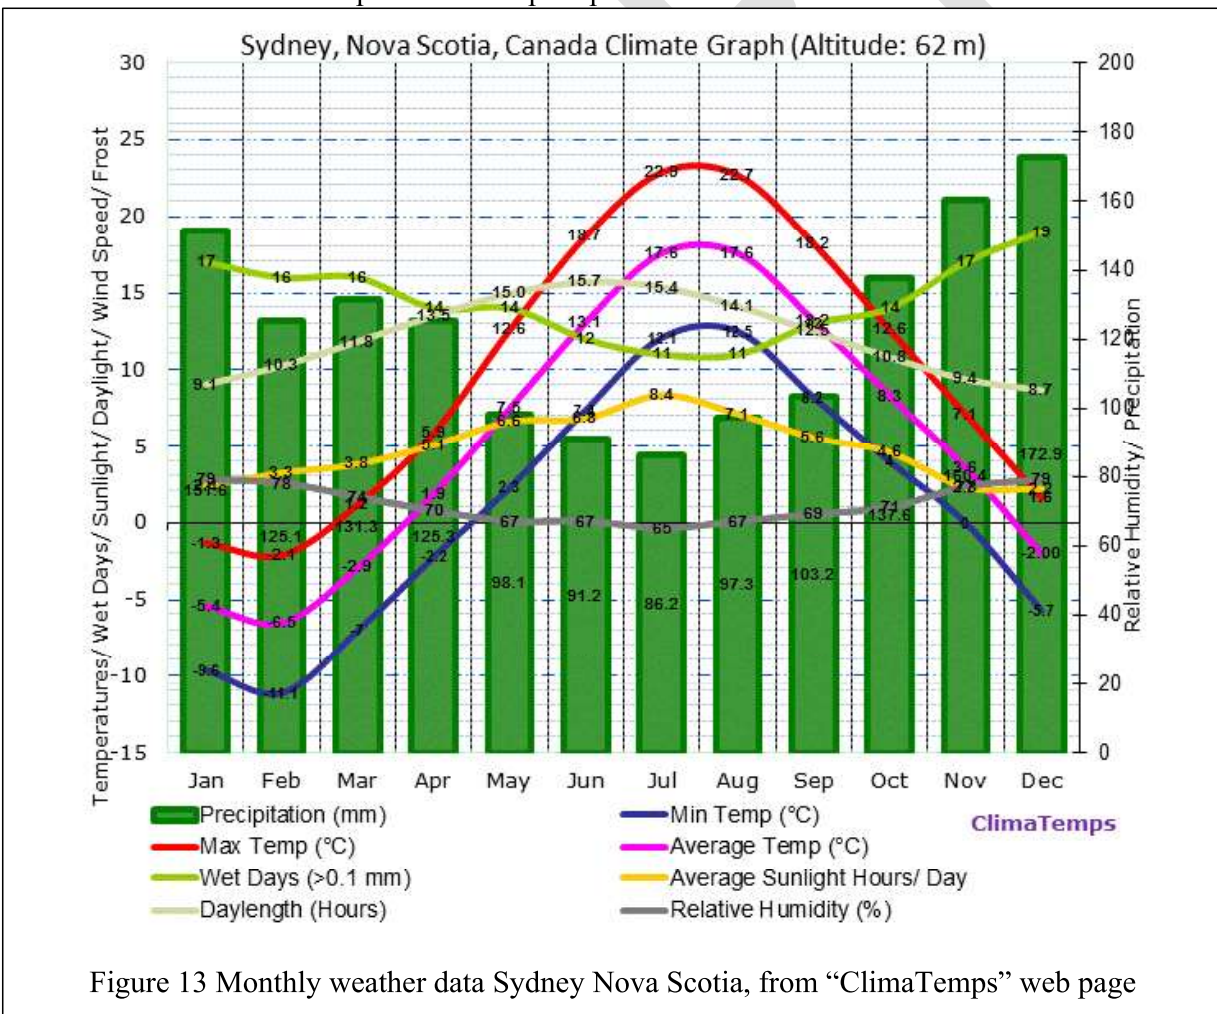
The closest data set is that shown in Figure 13, from a weather station in Sydney, on Cape Breton Island. This is approximately 110 km north-east of the crossing and the other side of the high point in the island. The data shown are the long-term monthly averages of maximum wind speed, maximum and minimum temperatures and precipitation in all forms.

Considering future weather monitoring with respect to the possibility of galloping events, Figure 13 offers an insight as to the months when the temperature is below freezing, and glaze ice or wet snow can occur. The figure shows that the minimum temperatures fall below 0°C during the six months from November until April. Experience of galloping events suggests that they occur most often when the temperature is around freezing at the beginning and the end of winter, but not so often at the coldest part of the winter.

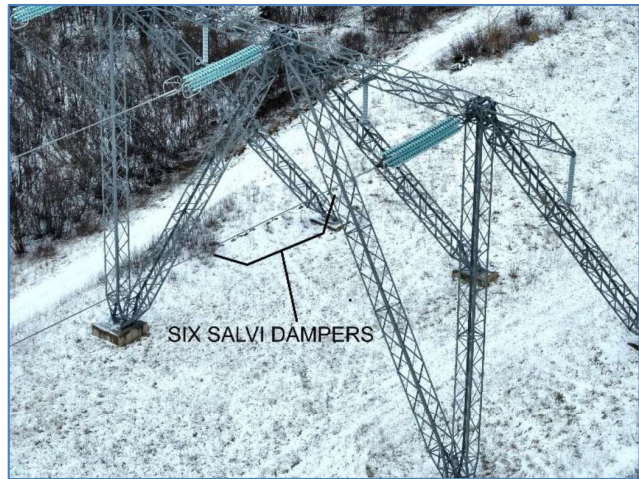
Figure 1 shows a general view of the dead-end structure at the north end of the back span on Cape Breton Island. The collection of photos shows many details of the structure and includes nuts and bolts all of which appear secure. But a close-up climbing inspection would be required to establish more definitively that no nuts are coming loose. The ends of the conductor in this section are protected by the original

Figure 1 Dead end structure on Cape Breton Island from the drone. From photo No. DJI\_20240116014927\_0004\_Z.jpg

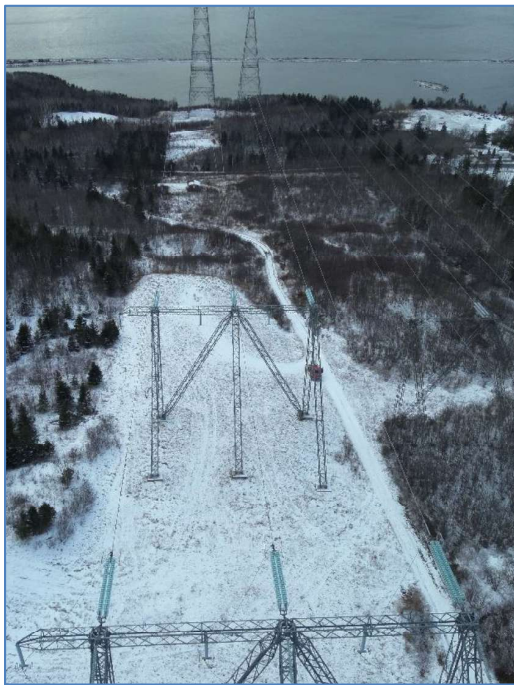
Figure 2 View along back span on Cape Breton Island from the drone. Structures supporting the new (left) and old (right) spans across the Canso Strait are shown in the far distance. Detail from Photo No. DJI\_20240116015020\_0011\_Z.jpg

Figure 2 shows the view looking south along the length of the back span on Cape Breton Island and includes the new and old structures at the edge of the Canso Strait, on the upper left and right respectively. The terrain on each side of this span can be seen to be forested and provides shelter from the cross-winds, reducing the effects of aeolian vibration and galloping on this span.

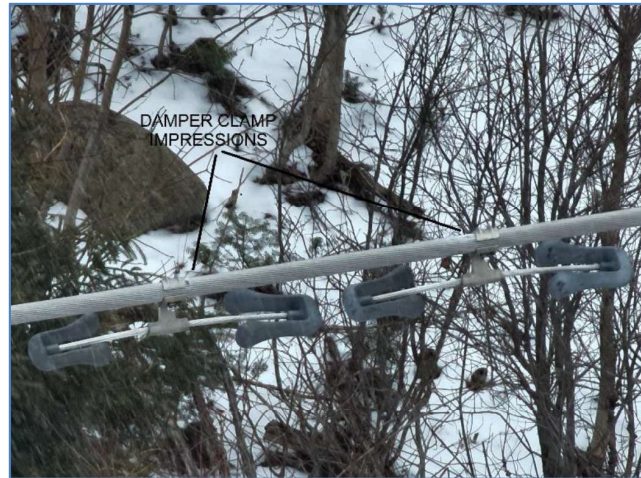
Many damper locations on the back span include impressions of previous damper clamps on the nearby conductor surfaces. Figure 3 shows an example of two of these impressions. It is not clear whether these are from adjustments made to the damper positions during the original installation or are the results of some slippage of the Salvi damper clamps. The photos were not well labelled and consequently it is unclear which dampers, which phase, and which of the two circuits are shown in

Figure 3 Salvi dampers on the back span on Cape Breton Island showing impressions of previous damper clamp positions, or possible slippage. Detail from Photo No. DJI\_20240118000143\_0026\_Z.jpg

Figure 3. All similar damper clamps need to be checked to ensure that they are firmly attached to the conductors.

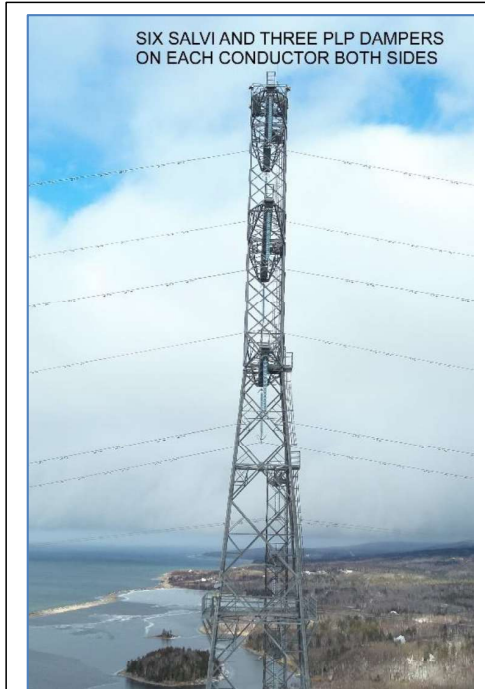
Figure 4 General view looking west along the Canso Strait including the suspension structure on Cape Breton Island. Detail from Photo No. DJI\_20240117231058\_0029\_w.jpg.

The photographs from the drone survey of the “L7005” 345 kV power line crossing the Canso strait, around the suspension tower on Cape Breton Island are captured in file “7005-4a”. The photo in Figure 4 provides a general view of the situation showing the Canso Strait looking toward the west. The conductors crossing this strait are exposed to uninterrupted winds and subject to severe stresses from aeolian vibration, and from galloping when ice or wet snow is present if appropriate damping and galloping controls are not in place. The conductors near this structure have undergone many repairs from damage from these effects that were not controlled in the initial design of the crossing.

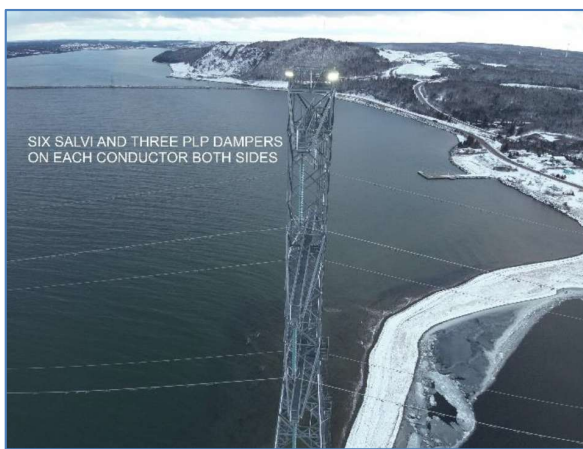
Figure 9 Suspension structure on Nova Scotia Mainland looking east along the Canso Strait.

Figure 9 shows the suspension structure on the mainland side of the Canso strait looking east, and Figure 10 shows the same tower looking west. All conductors are protected against aeolian vibration by the arrays of Salvi and PLP dampers similar to those shown on the four phases visible in the photograph. The conductors on this end of the main span did not suffer the same amount of damage as on the Cape Breton Island end. Figure 11 shows one of the Salvi dampers and marks on the conductor, from a damper's previous location. One of the sets of three PLP dampers used on each conductor is shown in Figure 12.

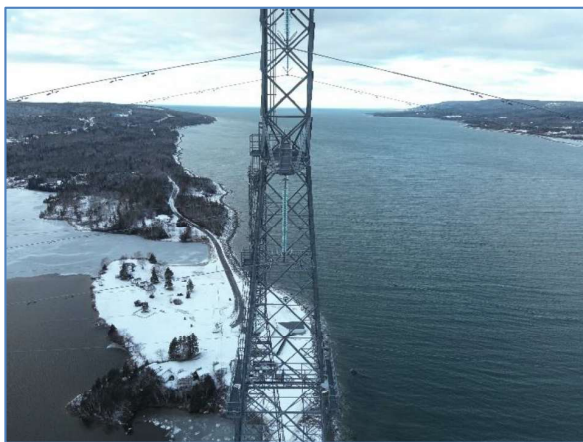
Figure 10 Suspension structure on Nova Scotia Mainland looking west along the Canso Strait.

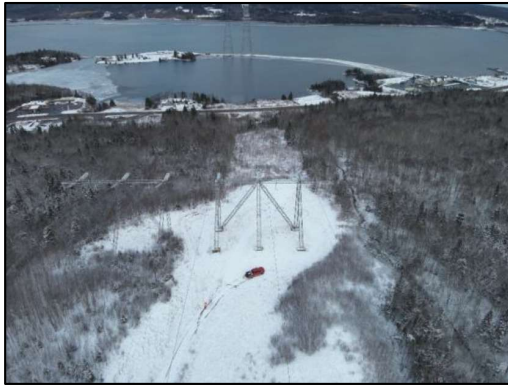
Figure 15 View of the back span looking north towards the suspension structures on the Nova Scotia Mainland. Detail from Photo No. DJI\_20240116031218\_0001\_w.jpg

The back span on the mainland side of the Canso Strait crossing has a similar exposure to aeolian vibration and galloping as that on the Cape Breton Island side. Figures 15 and 16 show the two ends of this span, and they show that the terrain is covered with trees, and consequently winds impacting the conductors will be turbulent and less likely to lead to either of these modes of vibration. The drone-based survey did not reveal damage that is likely to be due to such motions. Details of the dead-end insulator strings are shown in Figures 17 and 18, and no damage is visible in the photographs of this or any other strings supporting the crossing. There are few locations where there are clamp impressions on the outer surface of the conductor. Figures 19 and 20 show samples of these impressions. These may indicate the damper has been removed and the clamp retightened, possibly as part of an inspection program. There is a remote possibility that such impressions could be due to slippage consequent to severe vibration.

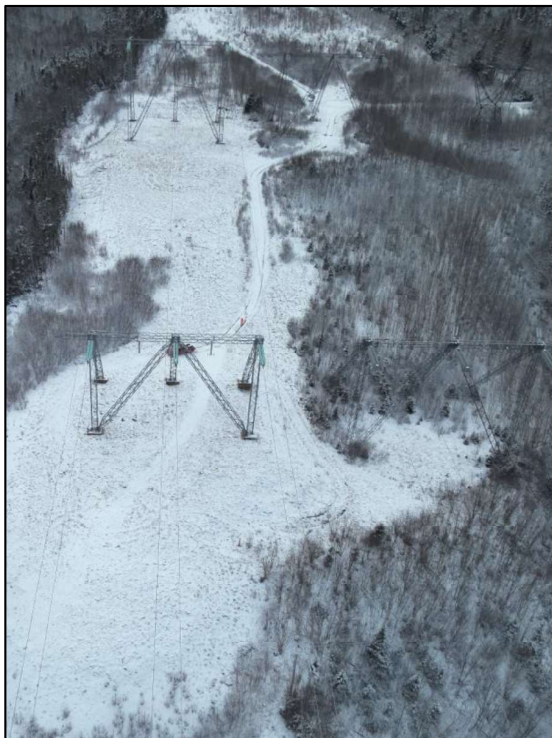
Figure 16 View looking south showing dead end structures on the back span on the Nova Scotia Mainland. Detail from Photo No. DJI\_20240116031338\_0010\_w.jpg

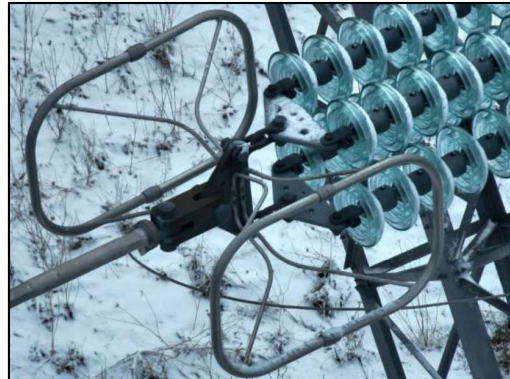
Figure 18 High voltage end of insulators on the dead-end structure on the back span on the Nova Scotia Mainland Detail from Photo No. DJI\_20240116031655\_0029\_Z.jpg

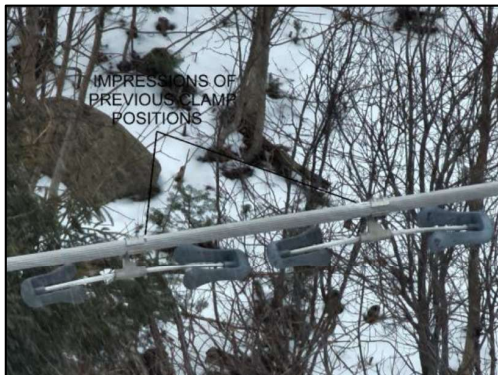
Figure 19 Conductor impressions where previous Salvi damper clamps were located, or clamp slippage had occurred on the back span on the Nova Scotia Mainland. Detail from Photo No. DJI\_20240118000131\_0025\_Z.jpg

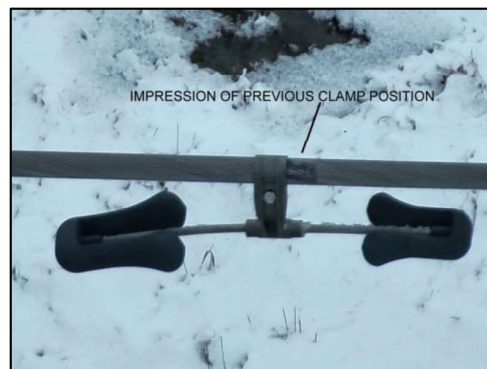
Figure 20 Conductor impressions where Salvi damper clamps were located or clamp slippage had occurred on the back span on the Nova Scotia Mainland Detail from Photo No. DJI\_20240116031756\_0035\_Z.jpg
