**Re: CI 40425 – Kempt Road Transformer - NSPI Information Requests (IRs) -  
Second Set P –510/Matter No. 03715**

CI 40425 - Kempt Road Transformer (NSUARB P-510)  
NSPI Responses to UARB Information Requests

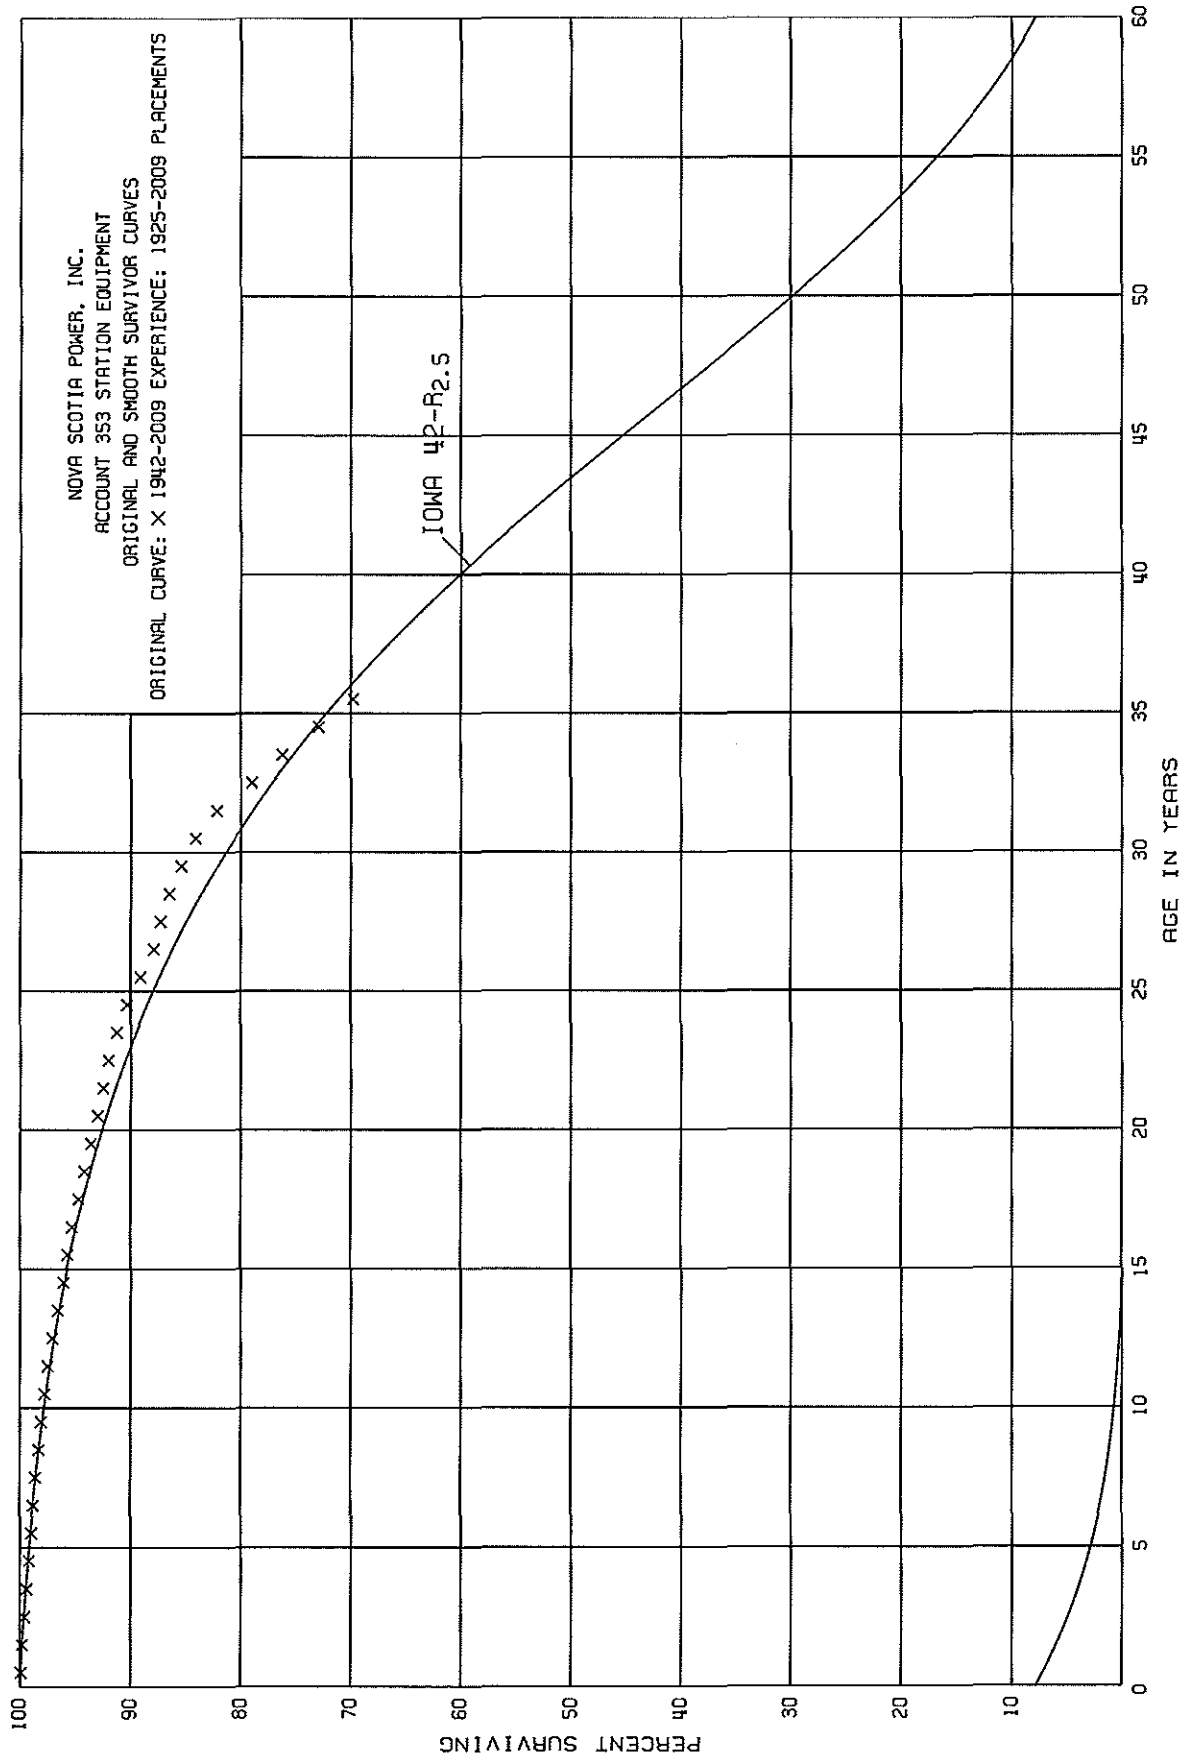
**(b) Please refer to Attachment 1. This attachment is Appendix A, page 69 from the Iowa State Survivor Curve 2010 Depreciation Report. This information indicates the life of station equipment to be 42 years. In this case, station equipment is defined to include electrical control equipment, station service, transformers, circuit breakers and other items used in the construction and operation of a substation. The statement "less than 45 years", which is explained in part (a) is based more on an engineering judgment and the history of the units at Kempt Road than a scientific or statistical analysis.**
