**Request IR-1:**

**Reference to Page 1 of 6, NS Power notes: “Pursuant to Section 11.2 of the CEJC, related CIs for Steam projects include “work completed on the same asset (turbine, boiler, etc.) and on the same unit (Lingan Unit #3, for example)”:**

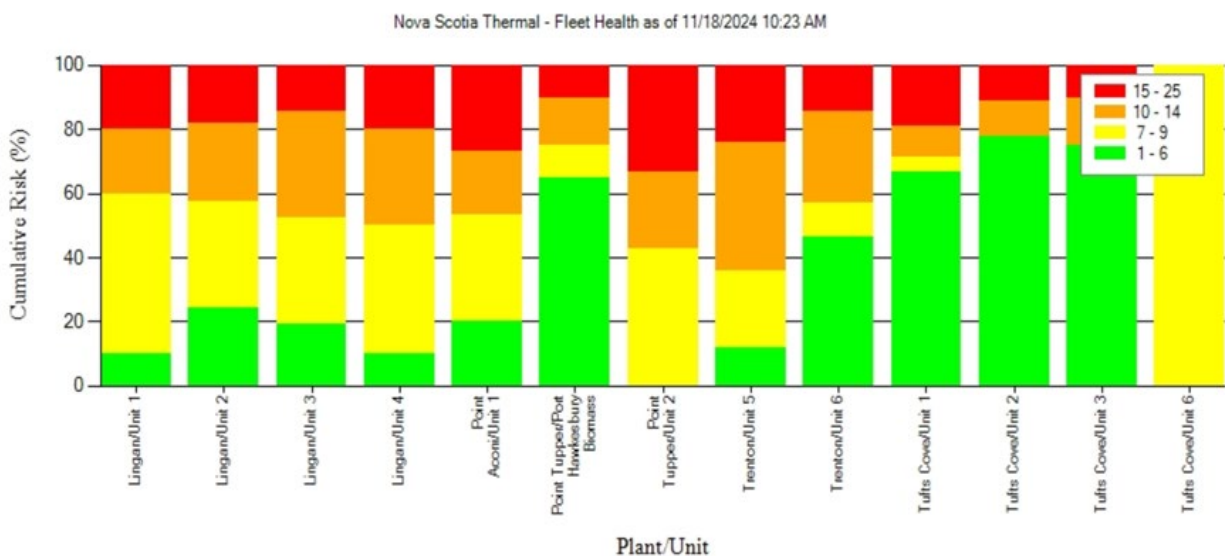
This information is compiled and used to develop the boiler risk profiles for each site, represented below for each Unit.

- Boiler Tube Failure Reports generated for any failure events that result in unit outages.
- Annual Boiler Inspection Reports conducted by NS Power's maintenance contractor under Boiler Asset Strategy Committee supervision.
- Header Inspection Program data, including ultrasonic thickness measurements and creep ranking calculations.
- Work Order history from NS Power's CMMS (DirectLine), used to identify recurring issues and validate maintenance effectiveness.
- Root Cause Analyses for past failures

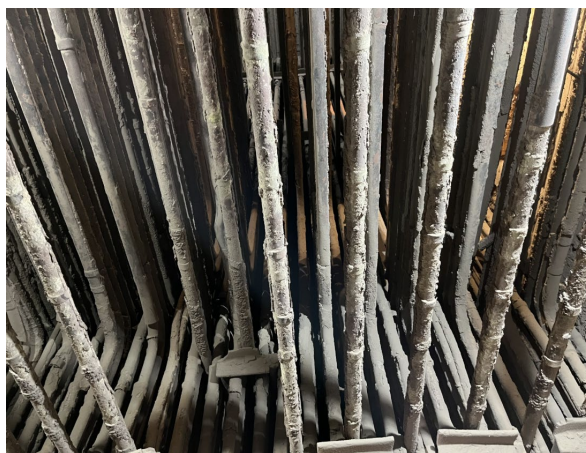
19 conditions. Below is the photo of a small section of Superheater 3 illustrating the density  
20 of boiler tubes inspected annually.

8  
9 The refurbishment scope is defined through annual inspections of pressure-retaining and  
10 non-pressure-retaining components. High-wear areas in the combustor section are 100%  
11 inspected, while the superheater, reheater, and economizer are fully visually inspected. Due  
12 to the large number of tubes (in excess of 5,000), 10–15 percent of superheater and reheater  
13 tubes are subject to ultrasonic thickness testing each year, with inspection areas rotated to  
14 ensure coverage over time. Components such as tube erosion shields or tubes found below  
15 minimum allowable thickness are replaced during the outage. Where large numbers of  
16 tubes in a localized area are at or near limits, projects are advanced as either “Unforeseen  
17 & Unbudgeted” or “ACE” initiatives to address those specific risks. This inspection-based  
18 methodology ensures scope definition is both systematic and responsive to current asset
