**Request IR-1:**

As the application noted, this project was approved as part of 2025 Annual Capital Expenditure (ACE) Plan with an estimated budget of \$2,478,537. This ATO application has increased the approved budget cost by \$4,358,247, bringing the total cost of the project to \$6,836,784. The project application noted that the L5004 is a 13.06-kilometer 69kV transmission line that was originally built in 1966 and this project includes the removal of nine existing wooden pole structures and replacing them with six new steel poles.

**Request IR-2:**

**Request IR-3:**

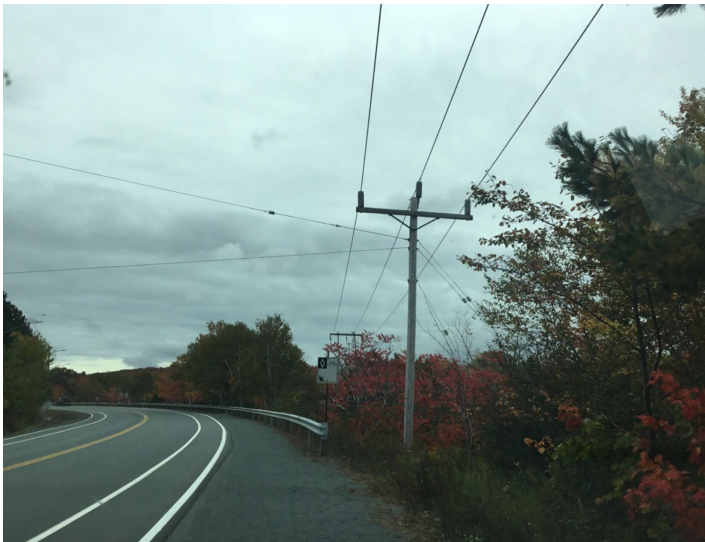
**Structure-46A Existing (to be removed)**

3  
4 (d) As the water crossing spans are modified/re-built in this project, NS Power is obligated to  
5 meet the latest CSA 22.3 standard clearance requirements. To meet Class 4 water body  
6 clearances, structures and poles that are to be replaced have to be over 100 feet tall and  
7 combined with the long span and line angles created due to the removal of the structure in  
8 the lake, such structures would need guying. There is limited transmission right-of-way  
9 easements in this area to construct guyed structures (please refer to images below). Both  
10 the importance of this transmission line to the overall Nova Scotia transmission system and  
11 the challenges in building in this urban location, the structure types for this project were  
12 selected accordingly.

1 Based on the transmission line design calculations and simulation results, wood pole  
2 structures are not considered a feasible long term reliable solution.

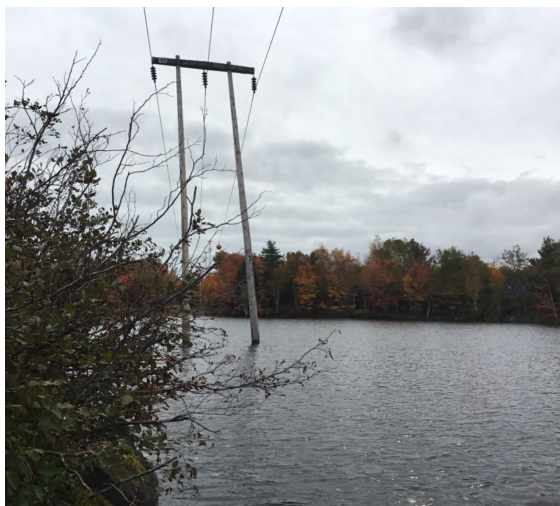
1      **Structure-47 Existing (to be removed from the lake)**

(a) Confirmed. One structure must be removed from Kearney Lake. Structure L5004-047 is currently located in the lake.

(d) For the removal of pole butts associated with the structure located within the lake, approval from the Nova Scotia Department of Natural Resources is required prior to undertaking any work. Removal activities shall be conducted in a manner that avoids any disturbance to the lakebed, shoreline, or surrounding aquatic environment. All other wooden structures will be removed and disposed of in accordance with NS Power's standard construction and disposal practices and all applicable regulatory requirements.

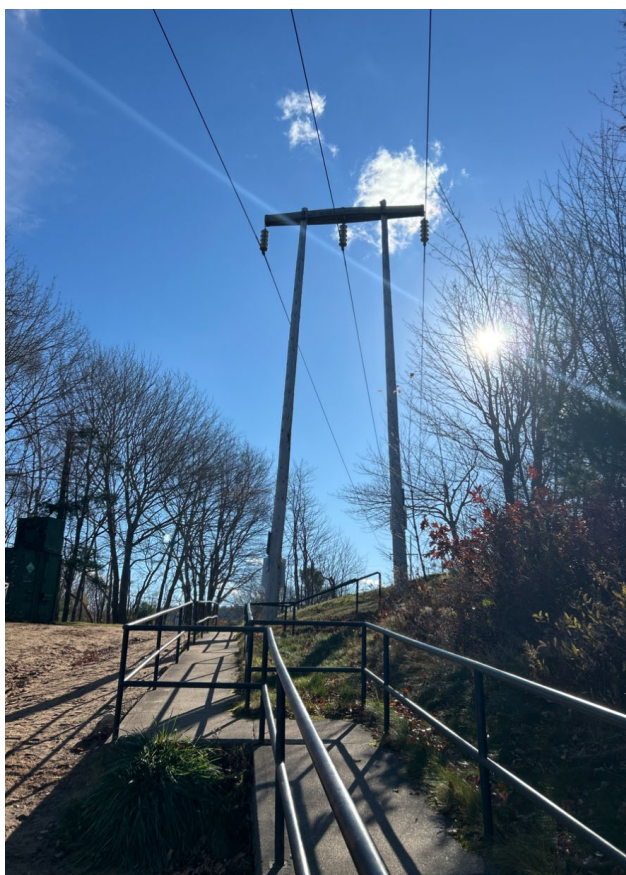
4      **Structure-48 Existing (on the beach)**

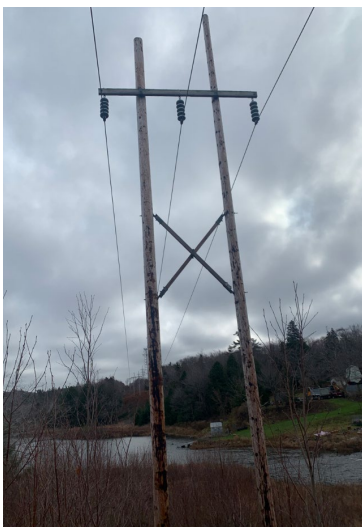
1      **Structure-49 Existing (to be eliminated)**
