# APPENDICES

BEC-M12795-Appendices

Proposal for Owner's Engineer Services:  
Factorydale Turbine Project – Town of Berwick Electric Commission

**Owner's Engineer for Factorydale  
Turbine Project**

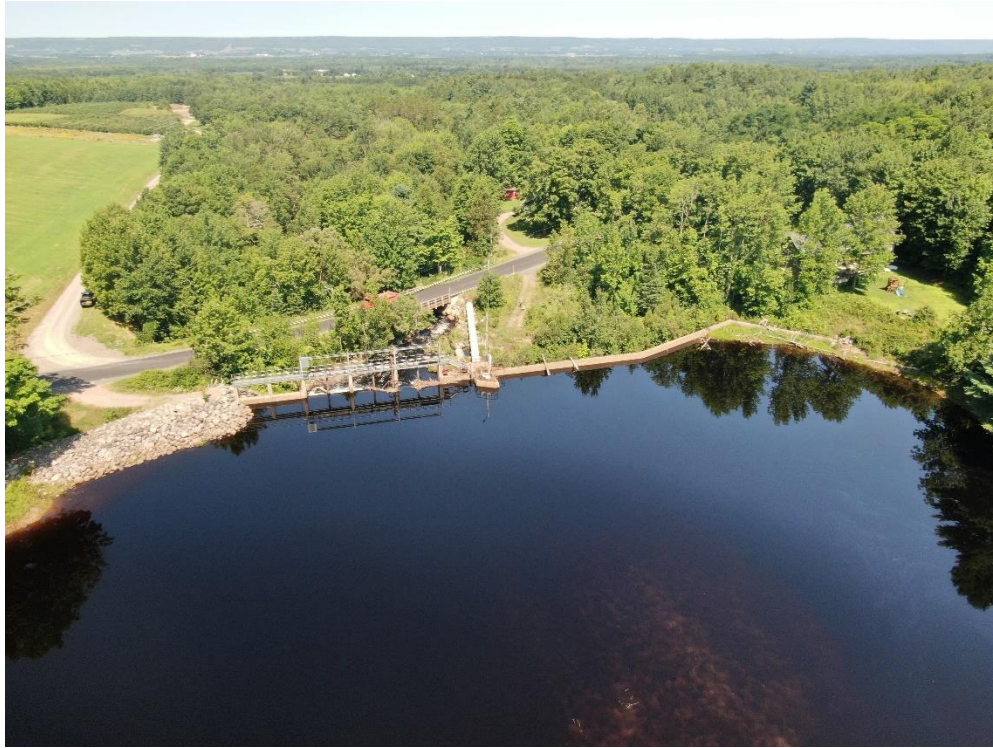
**Photo 1** Aerial View of Factorydale Dam

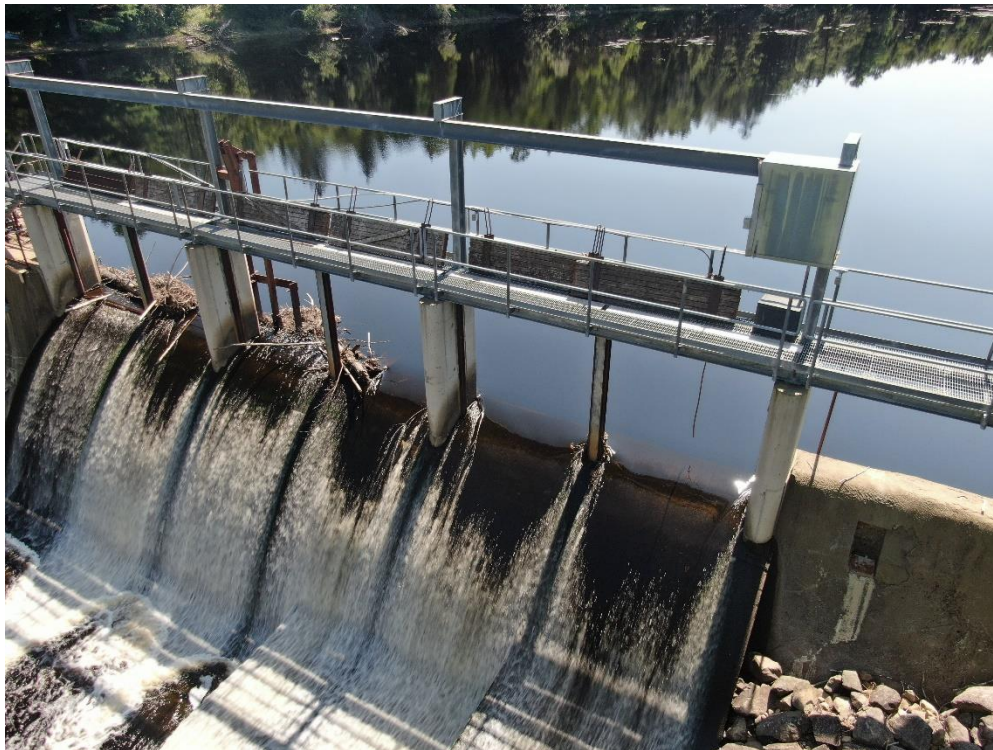
**Photo 2** Spillway Section

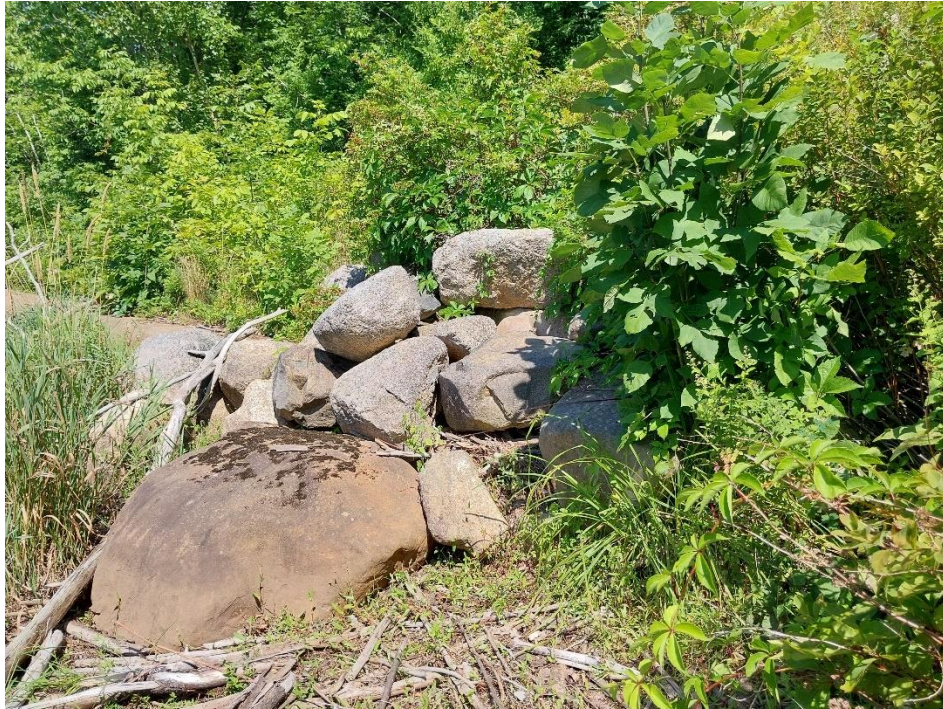
**Photo 23** Right Abutment

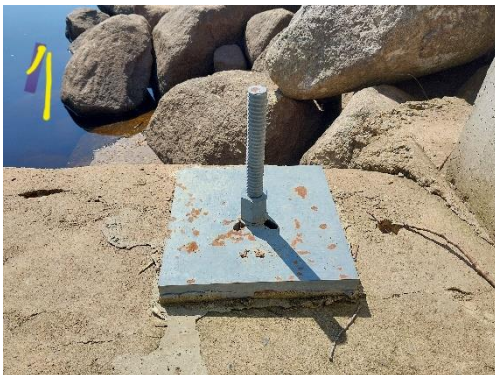
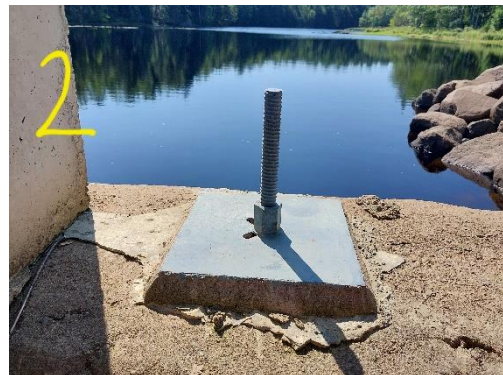
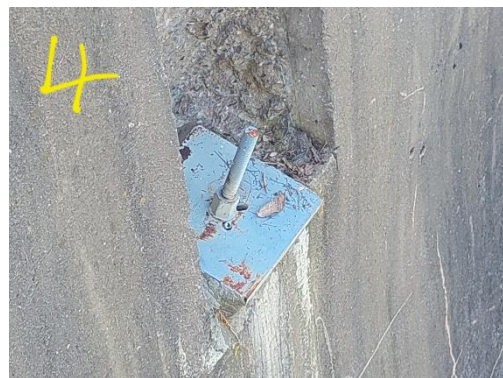
**Photo 32** Post Tensioned Anchor #1-4 Starting at Exposed Part of Left Dam Section

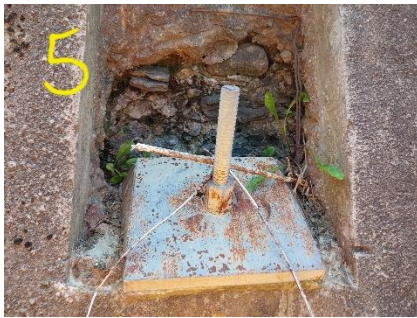
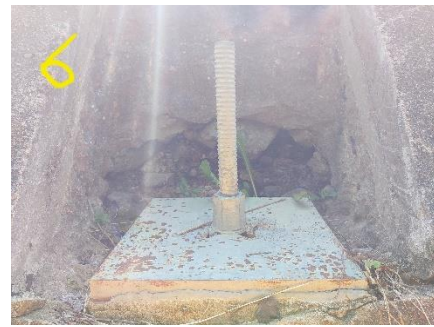
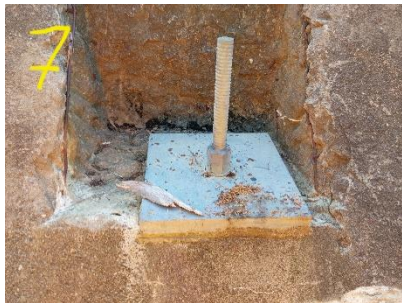
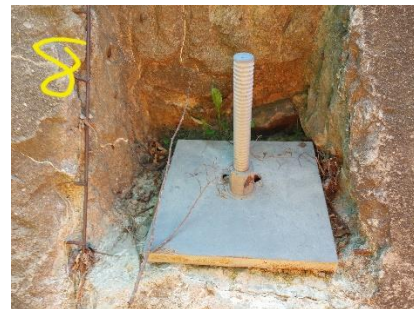
**Photo 33** Post Tensioned Anchor #5-8 in Downstream Face of Right Dam Section
